**CITY OF FRAMINGHAM  
CAPITAL PROJECT/EQUIPMENT REQUEST - FY2024-2033 CIP**

## **5. Exterior Envelope Repair Design - King Elementary and FHS**

# Exterior Envelope Repair Design - \$322,000

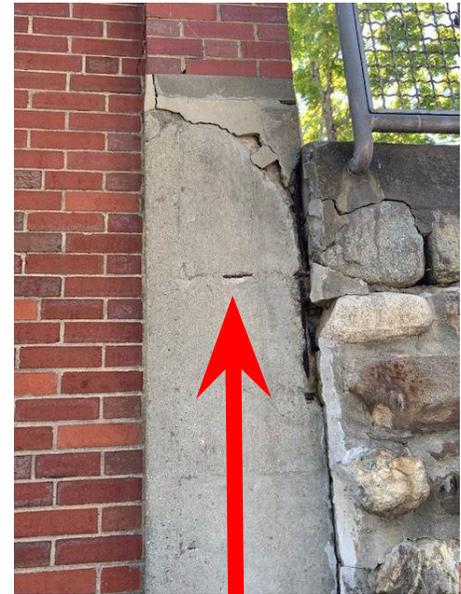
**KING ELEMENTARY SCHOOL**

Deteriorating foundation

Structural cracks, allowing moisture infiltration

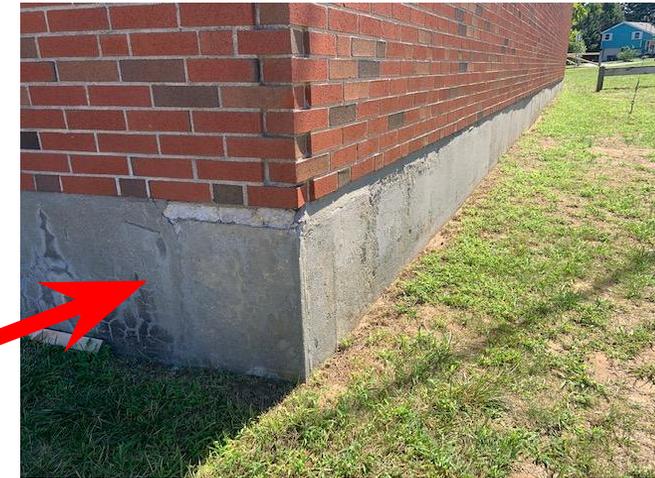
**FRAMINGHAM HIGH SCHOOL**

Crack and spalling foundation

Failing fascia

Deteriorating bricks, allowing moisture infiltration

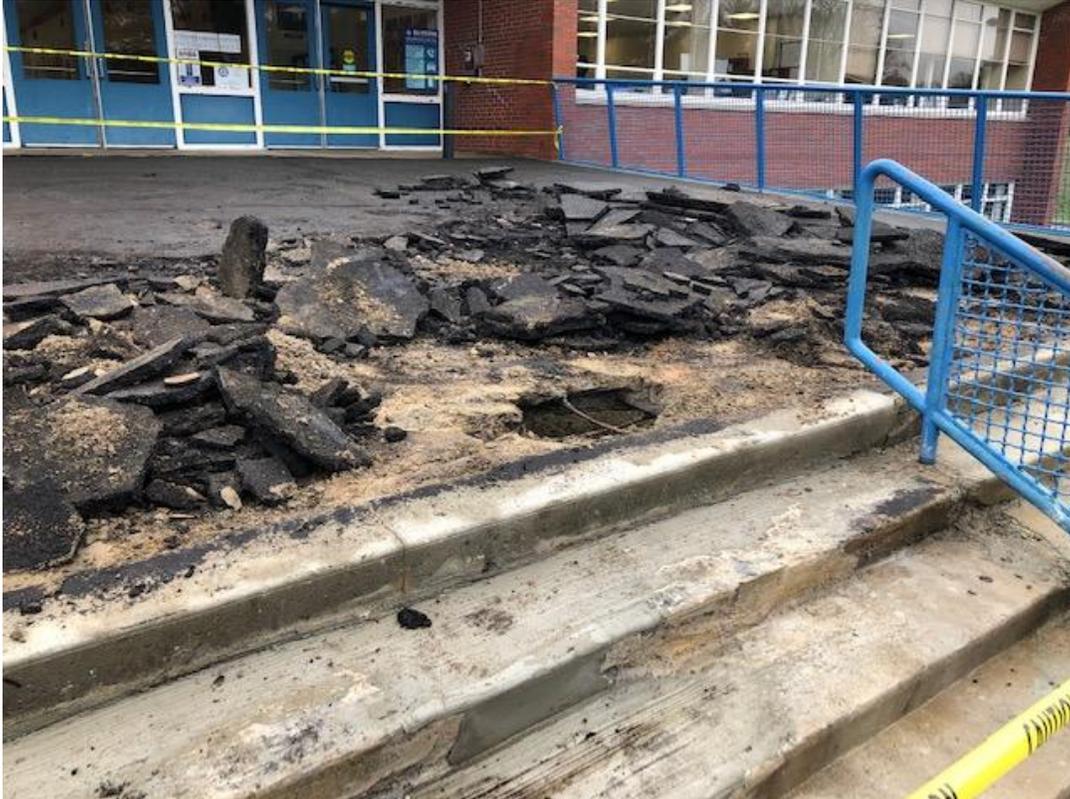
The bridge and concrete steps are in a deteriorated condition, with many areas of delamination and spalling on the surface of the steps, underside of the deck, and on the beams. Approximately eight years ago the surface of the deck was overlain with 1" of asphalt to provide a smooth walking surface over delamination and spalling that was occurring on the top surface of the deck. The asphalt is now heaving in places.

**Overall deterioration of front entrance slab and stairs**

This request for capital budget funding is for the full replacement of the front entrance to King Elementary School. During the spring of 2022, the Department contracted Newport Construction to perform repairs to the top slab of the entranceway in an effort to maintain accessibility. During excavation, it was discovered that the structural support of the entranceway had deteriorated beyond what was expected and required further investigation. Newport made minor repairs and sealed up the slab, ensuring it was safe for usage. The Department is currently working with Beta Design on conceptual renderings for a remodeled front entrance that will eliminate any structural concerns while maintaining accessibility.

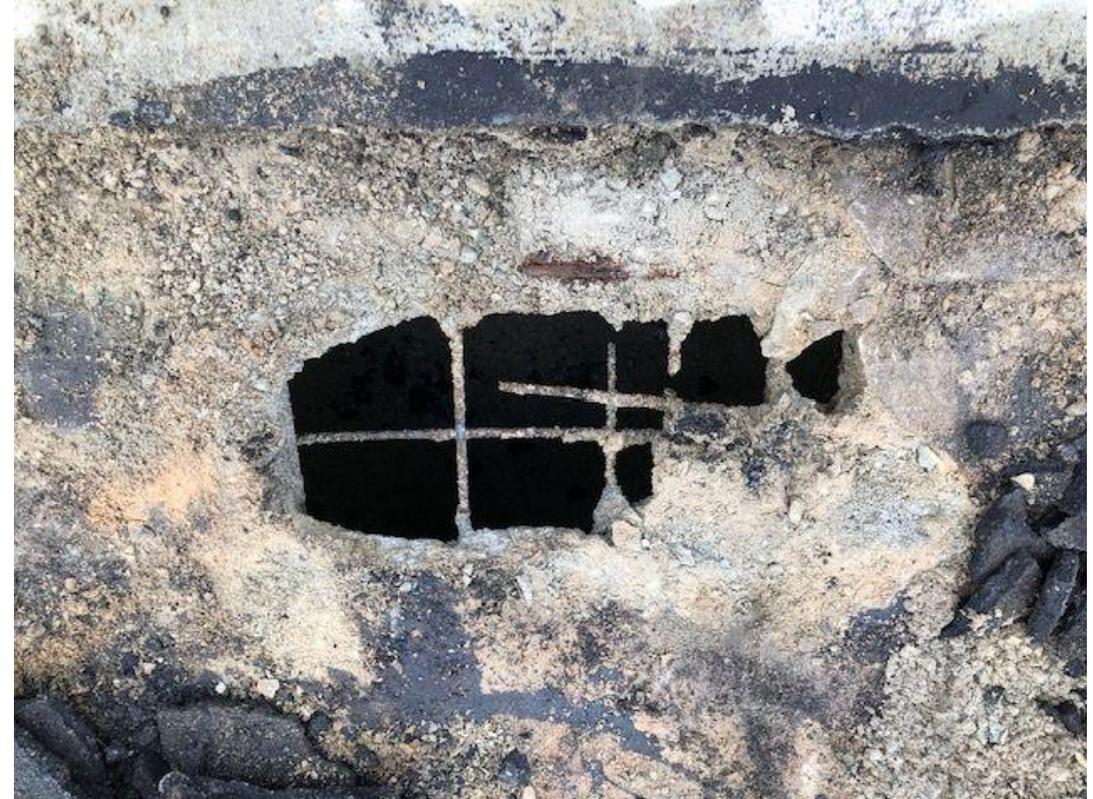
**Rebar deterioration at top slab**

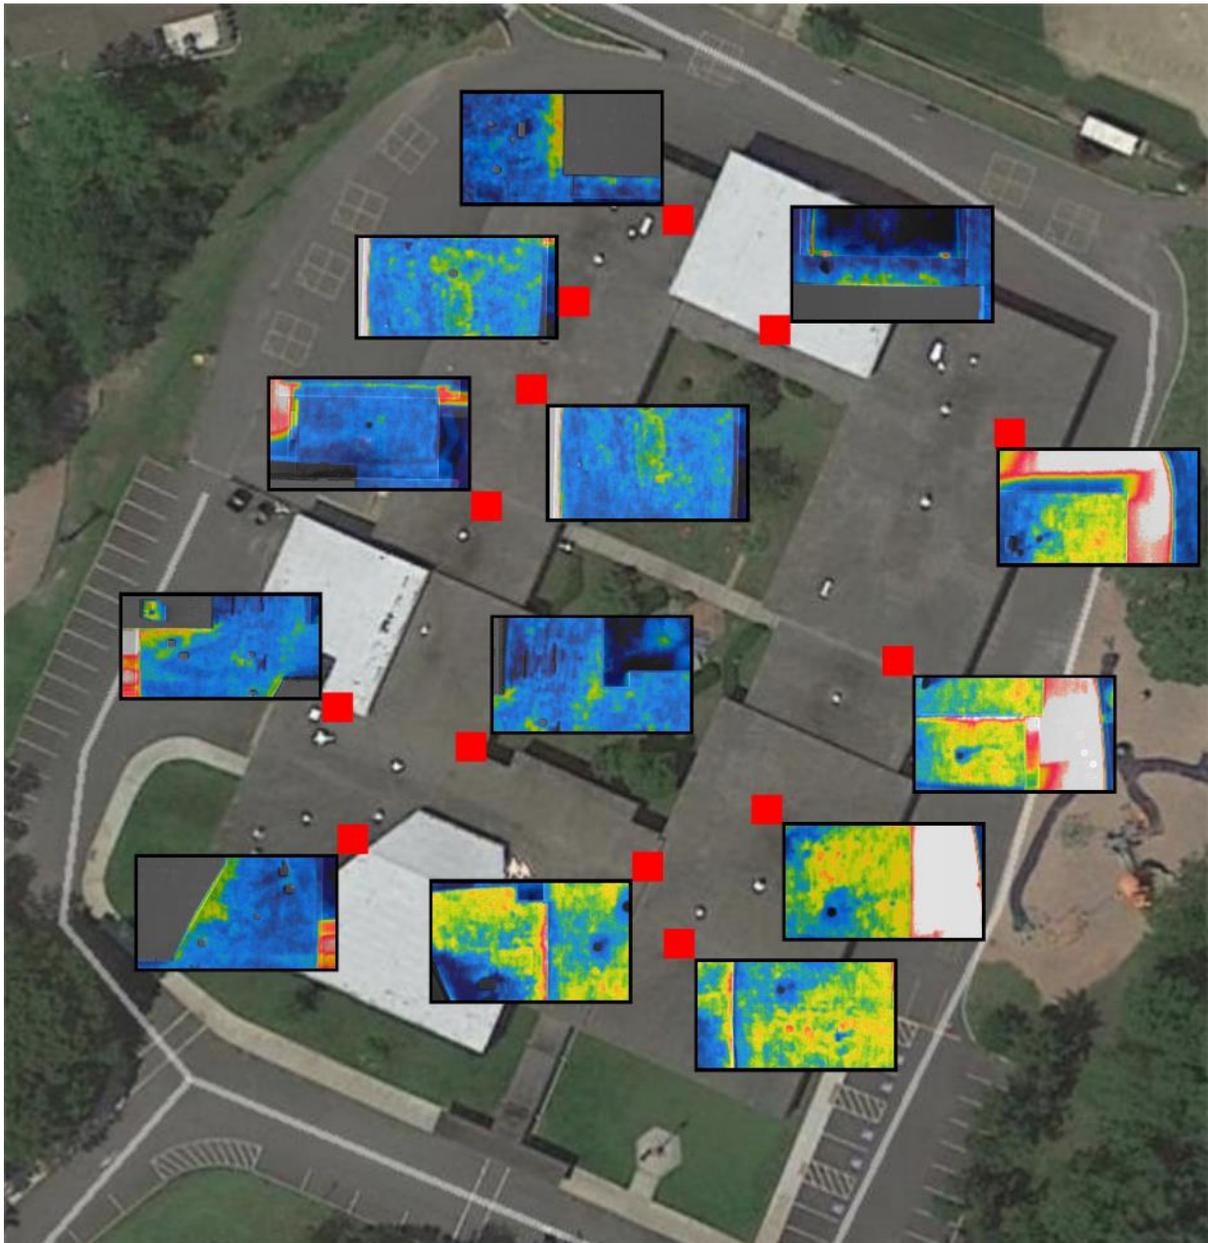
**Figure 2: Dunning Elementary School Roof Area Plan with Infrared Images Overlaid**

As part of the evaluation, Gale conducted a visual evaluation of the DES’s roof areas to observe the extent and location of defects as well as locate areas of potential moisture infiltration using non-destructive capacitance metering and infrared thermography. The following is a synopsis of the observations made during our visual evaluation.

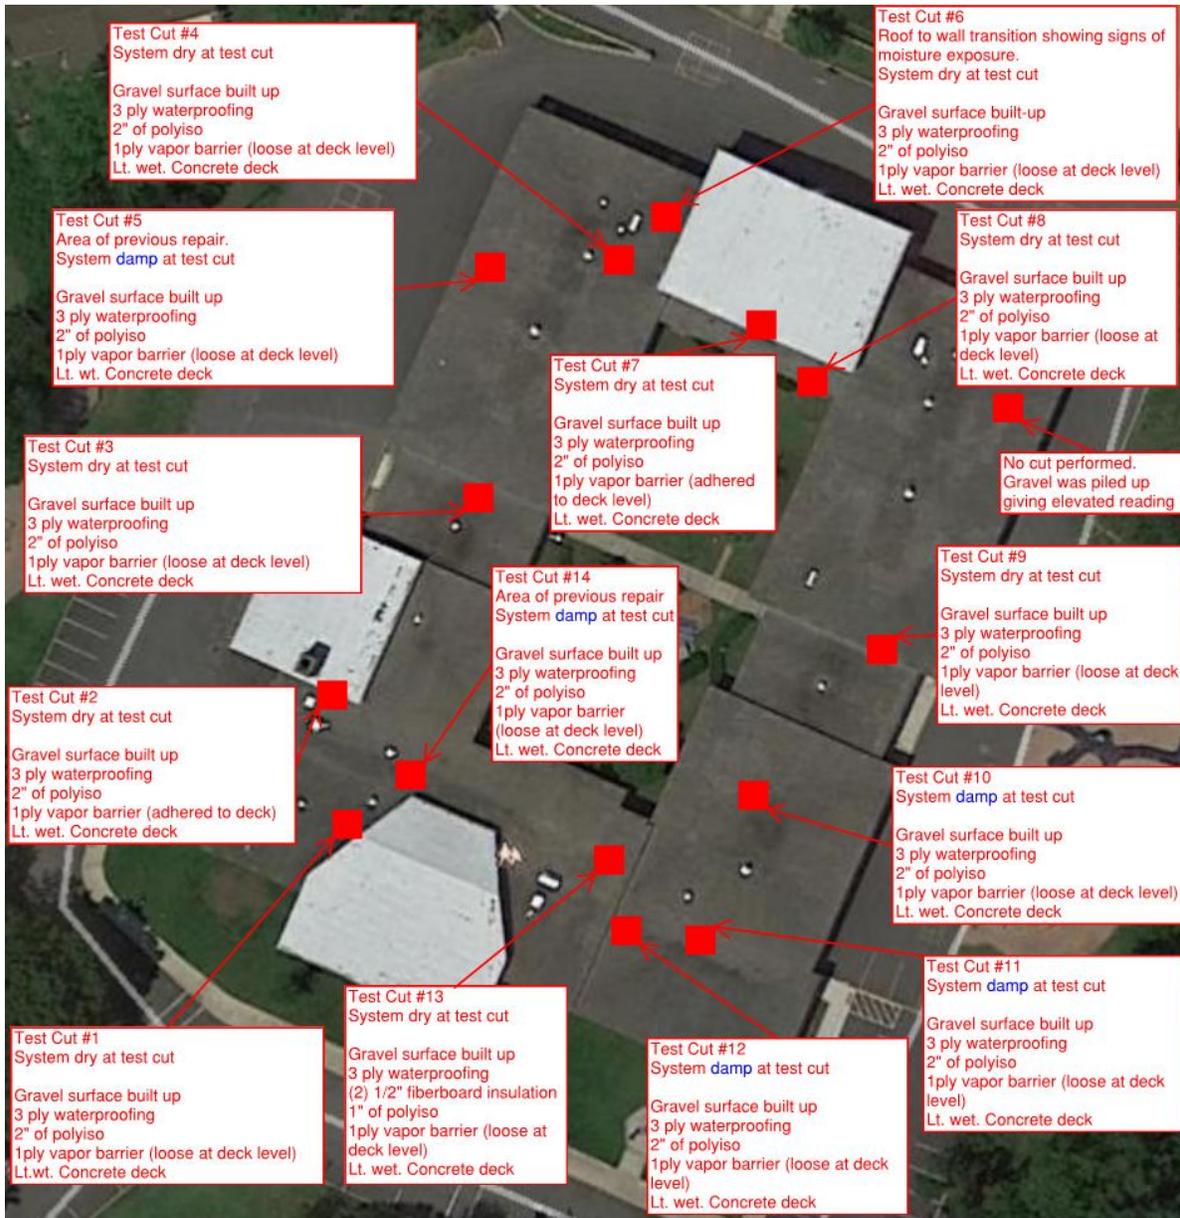
**Figure 2: Dunning Elementary School – Partial Roof Area Plan – Approximate Test Cut Locations**

<b>Test Cut #</b>	<b>Roof Area</b>	<b>Observed Condition</b>	
1	G	Dry	System components dry at test cut location
2	G	Dry	System components dry at test cut location
3	J	Dry	System components dry at test cut location
4	A	Dry	System components dry at test cut location
5	A	Wet	System damp at test cut location
6	A	Dry	System components dry at test cut location
7	C	Dry	System components dry at test cut location
8	C	Dry	System components dry at test cut location
9	D	Dry	System components dry at test cut location
10	F	Wet	System damp at test cut location
11	F	Wet	System damp at test cut location
12	F	Wet	System damp at test cut location
13	G	Dry	System components dry at test cut location
14	G	Wet	System damp at test cut location

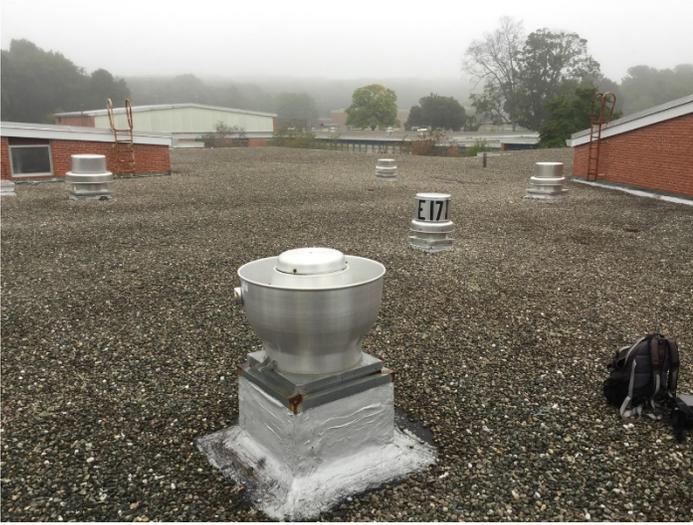
Photo 1 – The initial appearance of the existing conditions at the Dunning Elementary School Building appear to indicate a reasonably sound roofing system. The presence of stone ballast reduces the ability to identify deficiencies through visual evaluation alone.

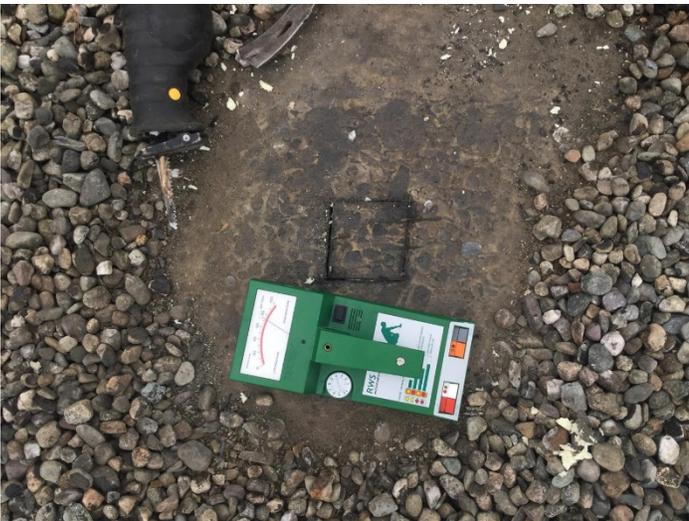
Photo 3 – In conjunction with the infrared roof scan, Gale utilized capacitance testing to determine the locations of test cuts.

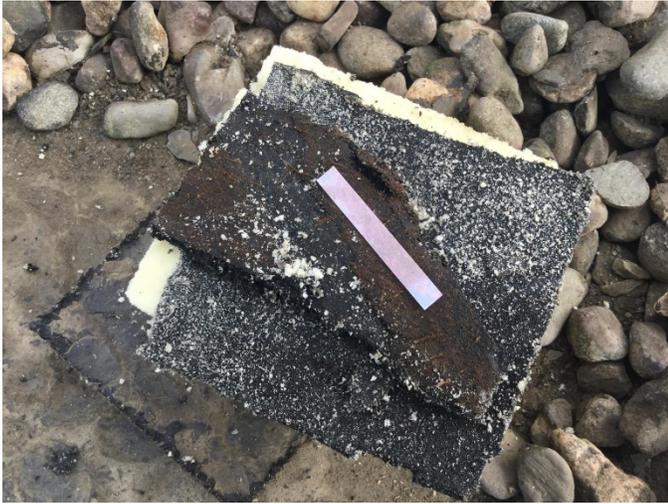
Photo 5 – The presence of moisture within the roofing system components was confirmed with the use of moisture sensitive test strips. Varying levels of moisture were observed at each of the test locations where moisture was found.

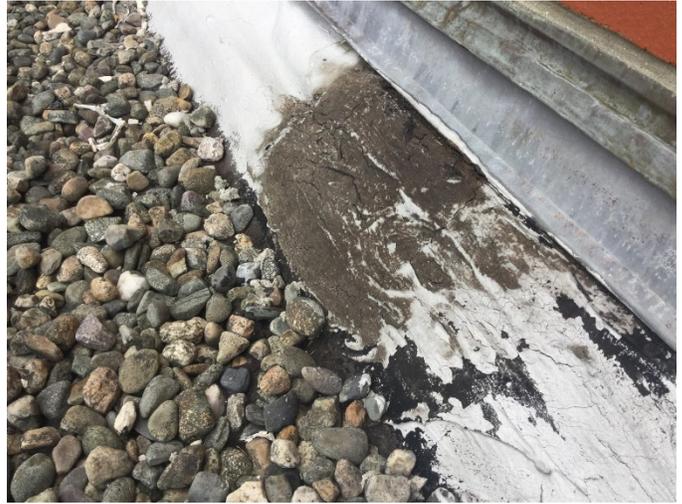
Photo 6 – Typical deteriorated roof to wall flashing condition.

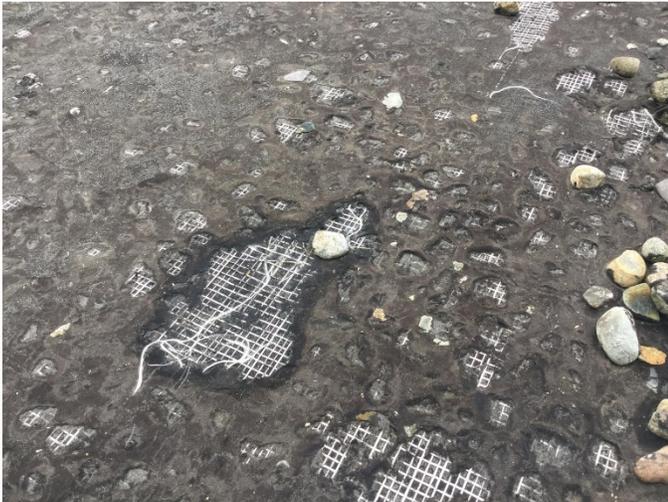
Photo 7 – Roofing system degradation resulting in exposed reinforcing fabric that could provide a path for water to enter into the roofing system.

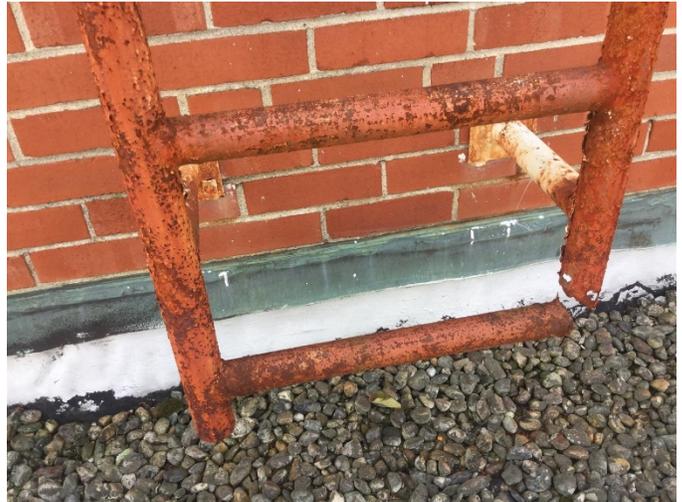
Photo 8 – Damaged and deteriorated roof access ladder to access Roof Areas B and H.

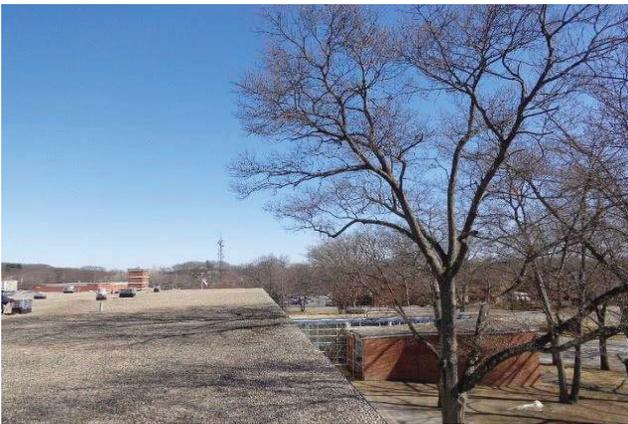
Tree limbs overhanging the roof surface.

Work Beyond Scope of Maintenance Agreement (Customer Responsibility)			
Task	Year	Project \$	Task Description
Repairs Required, Minor	2014		Recommend repointing the chimney.
Repairs Required, Minor	2014		Recommend installing a safety approved railing around hatch.
Repairs Required, Minor	2014		Recommend raising wall mounted ladder to OSHA approved height.
Tree Work	2014		Recommend trimming back the tree limbs that overhang the roof surface.

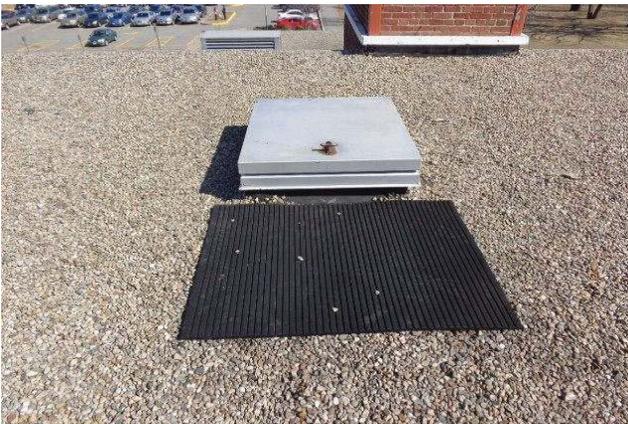
Missing fall protection.

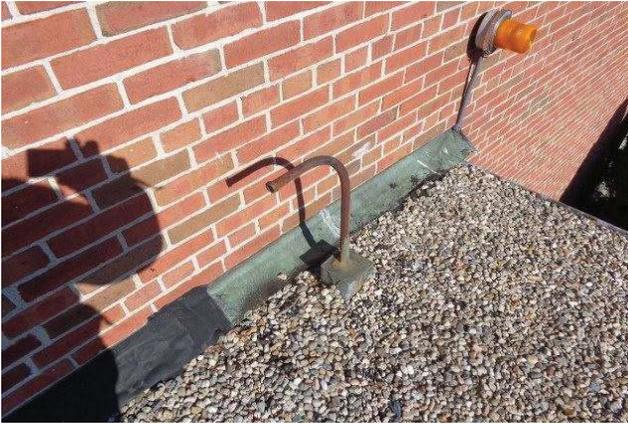
Obsolete pitch pocket & conduit.

Work Beyond Scope of Maintenance Agreement (Customer Responsibility)			
Task	Year	Project \$	Task Description
Recommendation	2014		Recommend removing the obsolete pitch pocket and conduit pipe from the roof.
Repairs Required, Minor	2014		Recommend sealing the open window sills.
Repairs Required, Minor	2014		Recommend repairing the crack in the brick wall.
Repairs Required, Minor	2014		Recommend coating the weathered wall flashings.

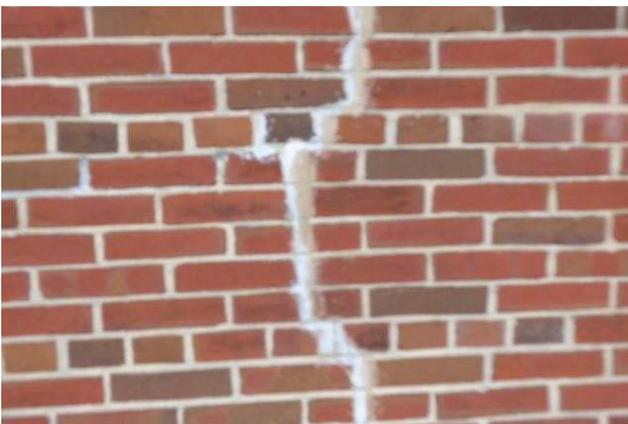
Open mortar joints.

Work Beyond Scope of Maintenance Agreement (Customer Responsibility)			
Task	Year	Project \$	Task Description
Repairs Required, Minor	2014		Recommend coating the wall and curb flashings.
Repairs Required, Minor	2014		Recommend having a masonry contractor tuckpoint the brick walls.

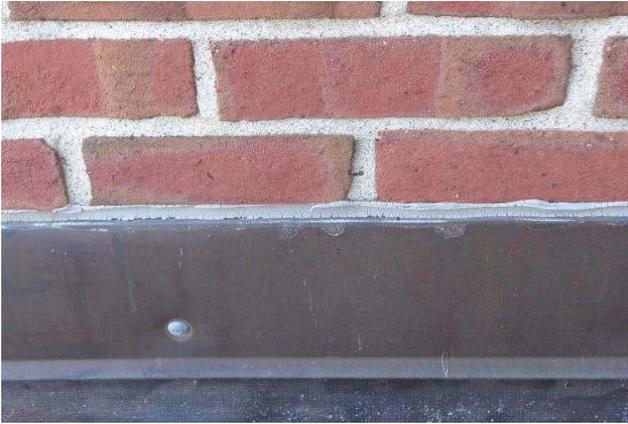
Open counterflashing.

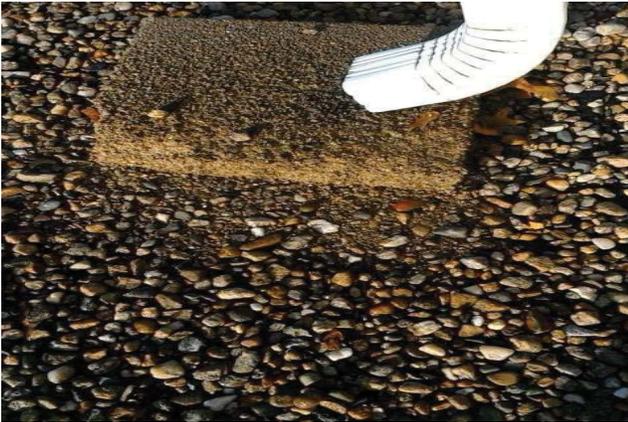
Deteriorating splash block.

Work Beyond Scope of Maintenance Agreement (Customer Responsibility)			
Task	Year	Project \$	Task Description
Repairs Required, Minor	2018		Recommend repairing approximately 30 linear feet of lead flashing under the windows.
Repairs Required, Minor	2018		Recommend coating the weathered curb flashing.
Repairs Required, Minor	2018		Recommend replacing 4 deteriorating splash blocks.

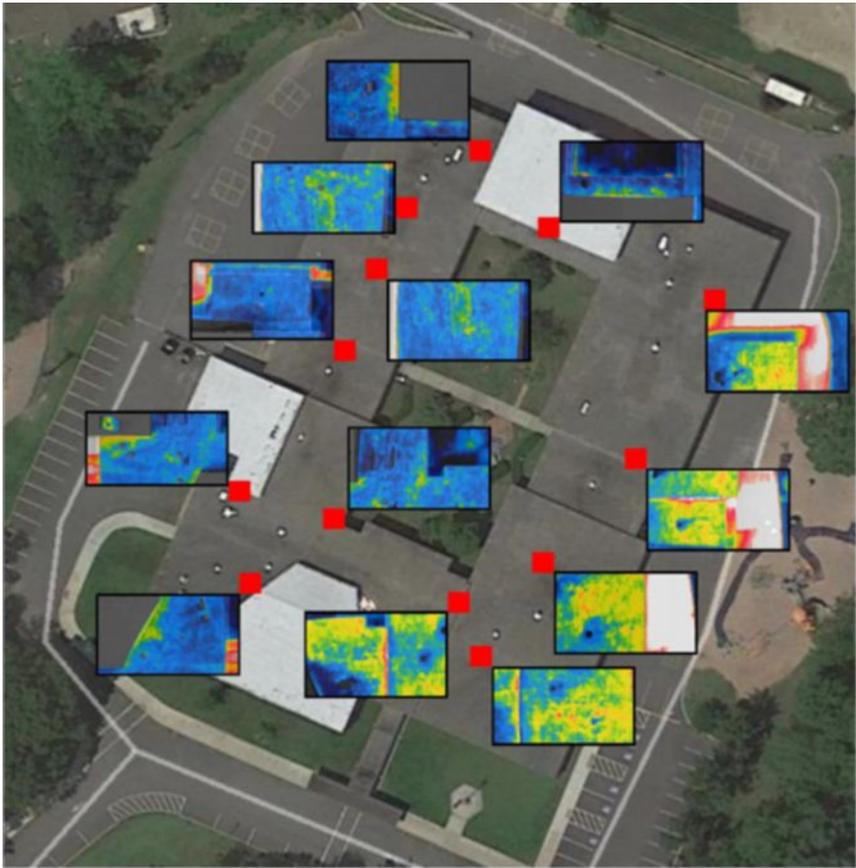
**Infrared Scans Showing Moisture Infiltration Of Roof - Dunning**

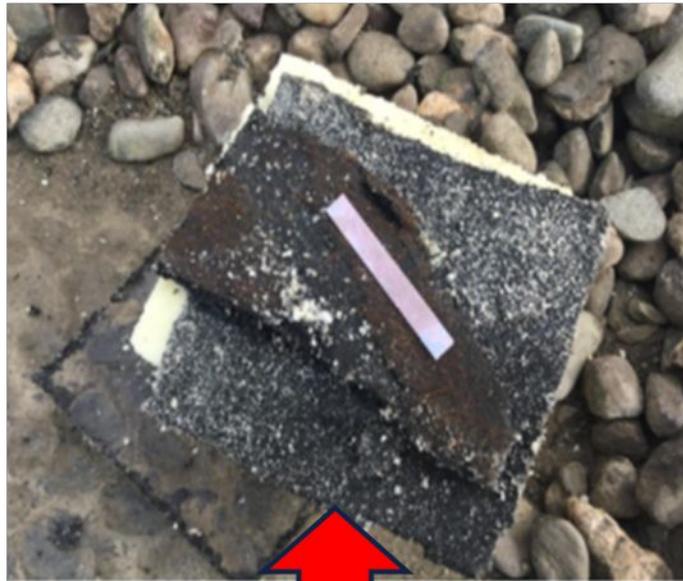
**Test Pit At Roof Exposing Water Infiltration**

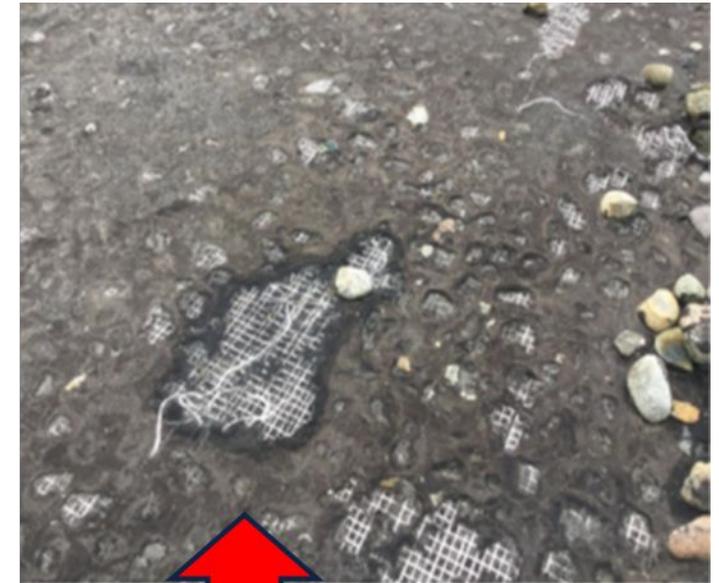
**Roofing System Degradation Resulting in Exposed Reinforcing Fabric**

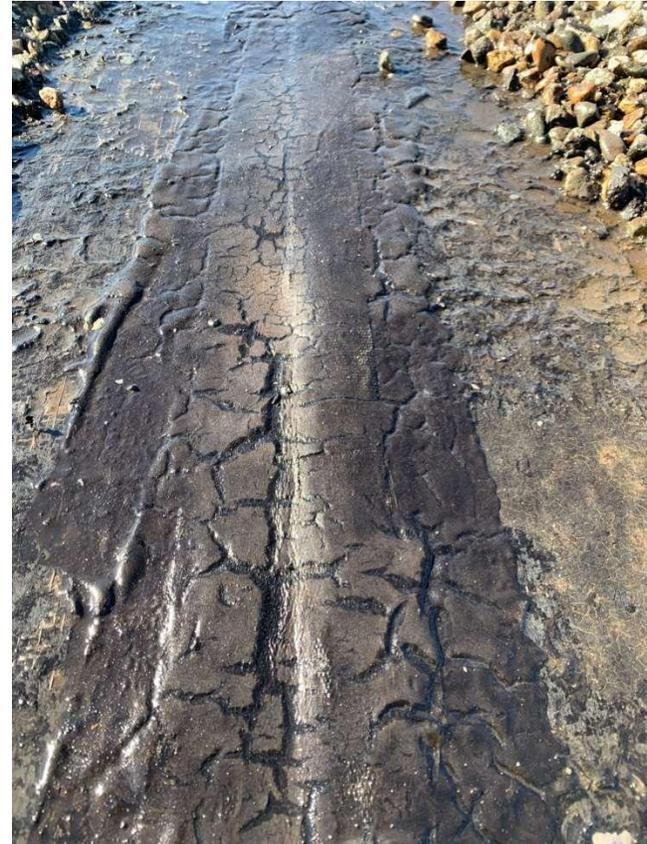
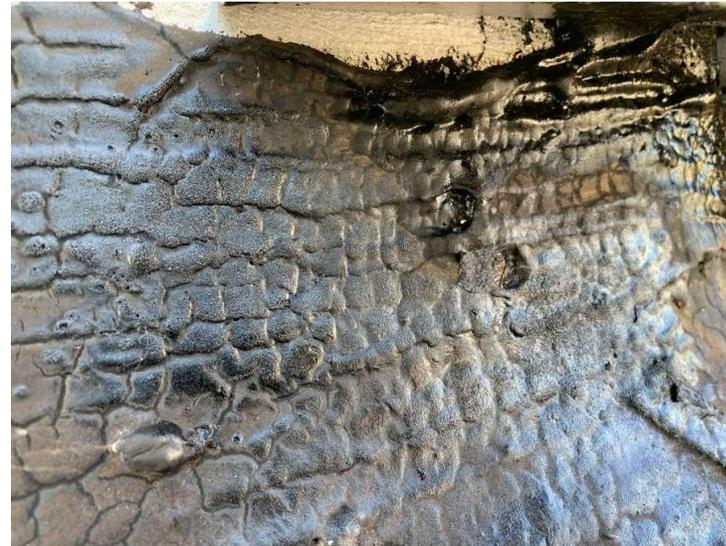
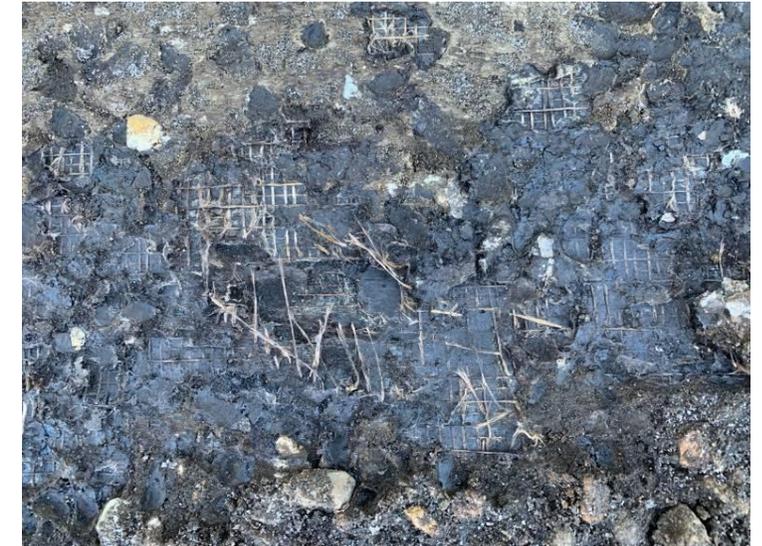
**Deterioration of Roof Membranes at Potter Road and Brophy  
Leading to Failing Systems and Water Infiltration, Further  
Damaging Building Infrastructure**
