**CITY OF FRAMINGHAM
CAPITAL PROJECT/EQUIPMENT REQUEST - FY2025-2034 CIP**

<p>AFLUO Company</p>	<p>PROJECT</p> <p>Town of Framingham Roof Survey</p> <p>Memorial Building</p> <p>150 Concord Street, Framingham, MA</p>	<p>SCALE:</p> <p>AS NOTED</p>
		<p>DATE:</p> <p>21 JUNE 2013</p>

Framingham Fire Station #7
789 Water Street

(ROOF INSPECTION DATA – INTERIM/PRELIMINARY REPORT)

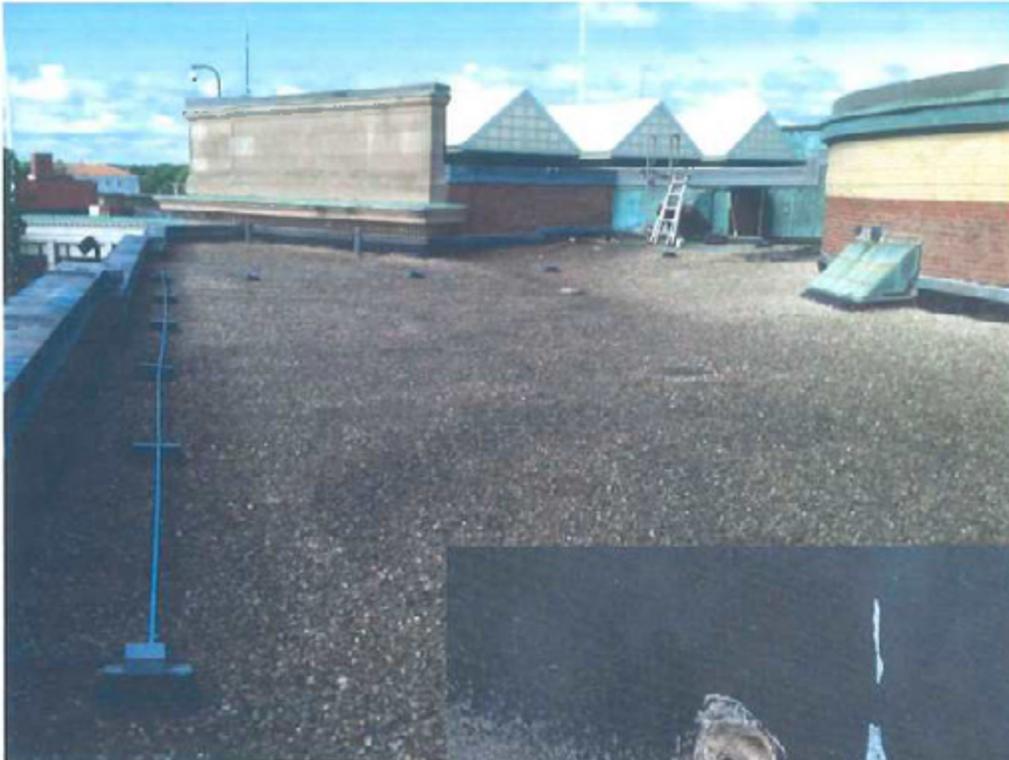
PHOTO #1 - View of Main East Roof looking towards Upper South Roof. Note electrical conduit run over roof surface (Above).

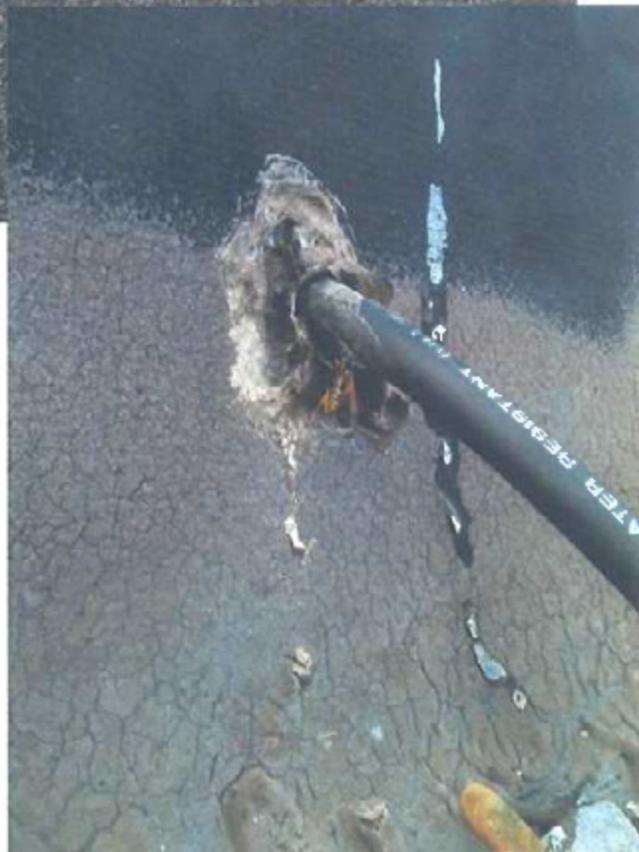
PHOTO #2 - Electrical has been fed in through flashing causing openings in roof flashing as indicated by bee entering wall flashing (Right).

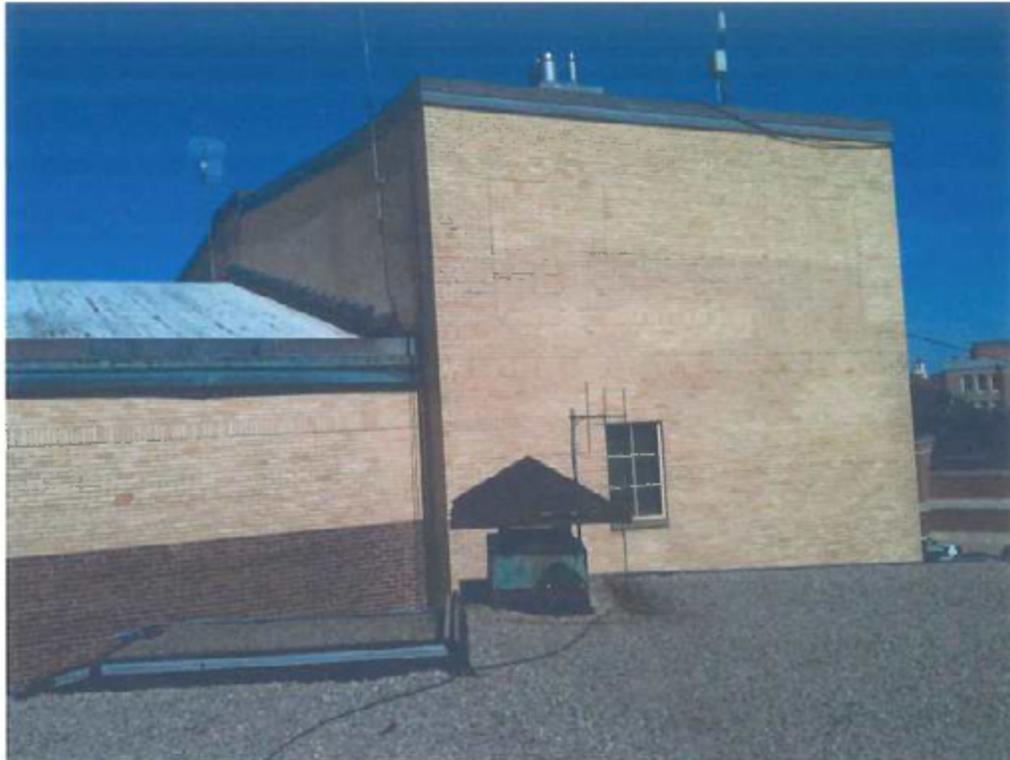
PHOTO #3 - View of Upper Stage and Auditorium Roof looking north at Elevator Roof and rusted gravity vent (Above).

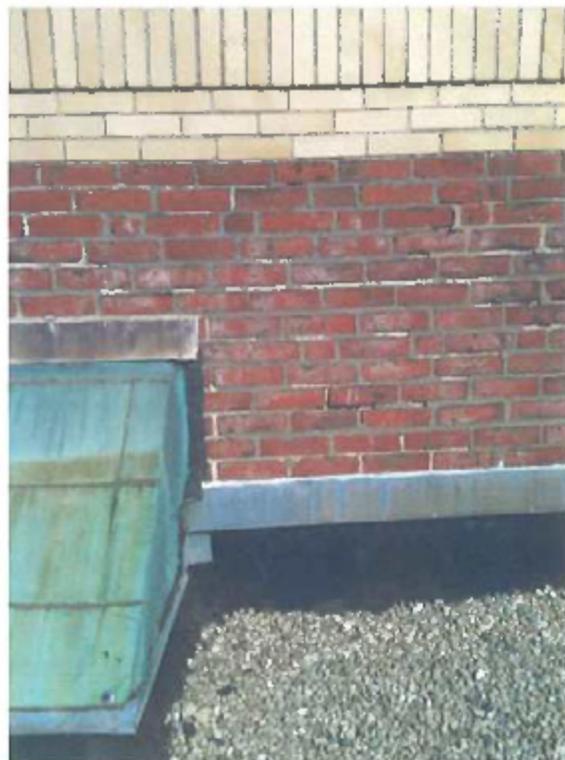
PHOTO #4 - Note open masonry joints prevalent in stage masonry wall (Above) and at masonry wall of Auditorium (Right)

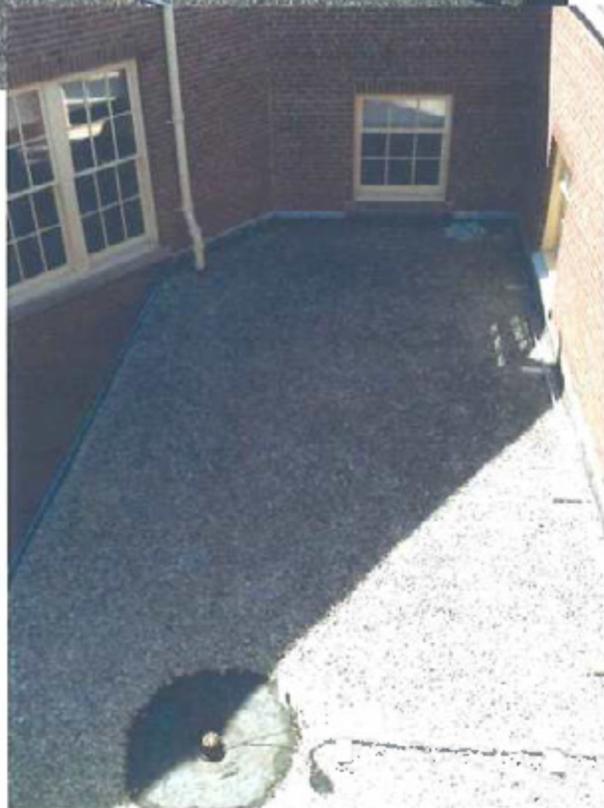
PHOTO #6 - Overview of lower roof. Note recently repaired roof drain (Right).

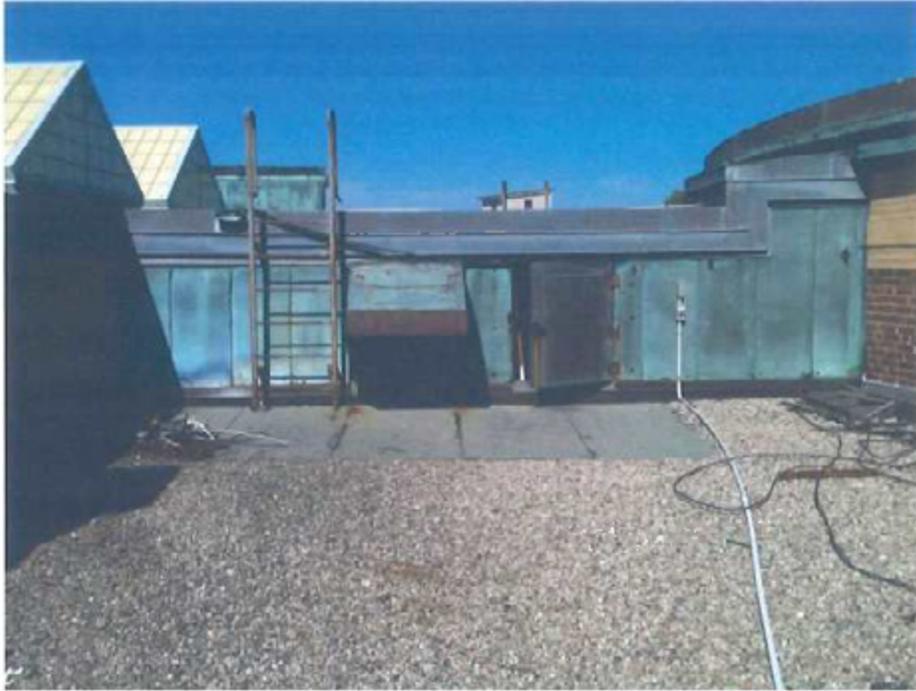
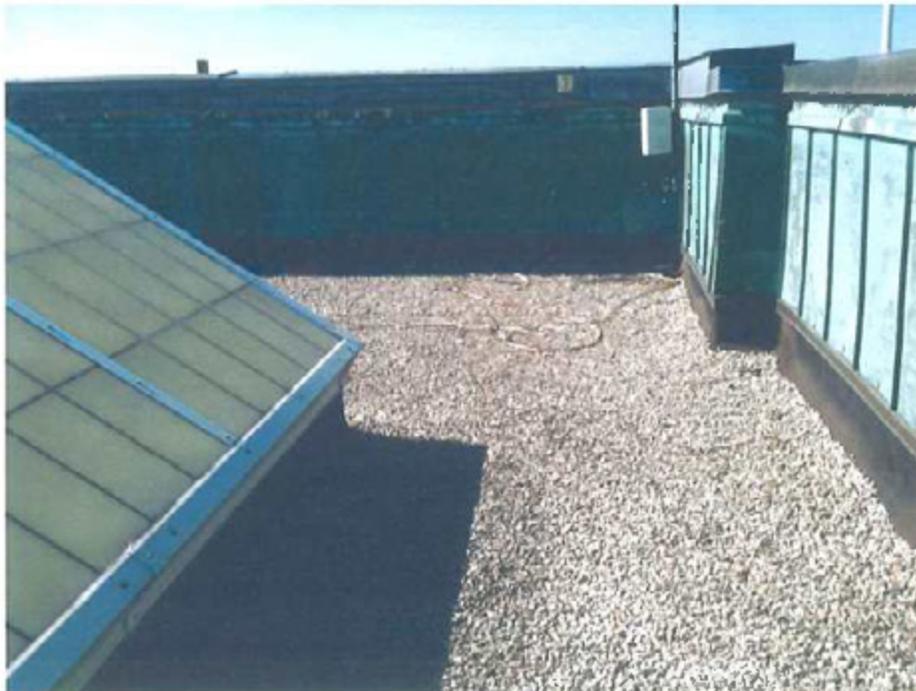
PHOTO #7 - Copper cladding and roof access door in sidewall of Upper South Roof (Above). Note accumulation of debris on roof surface and on Upper South Roof (Below) **PHOTO #8**.

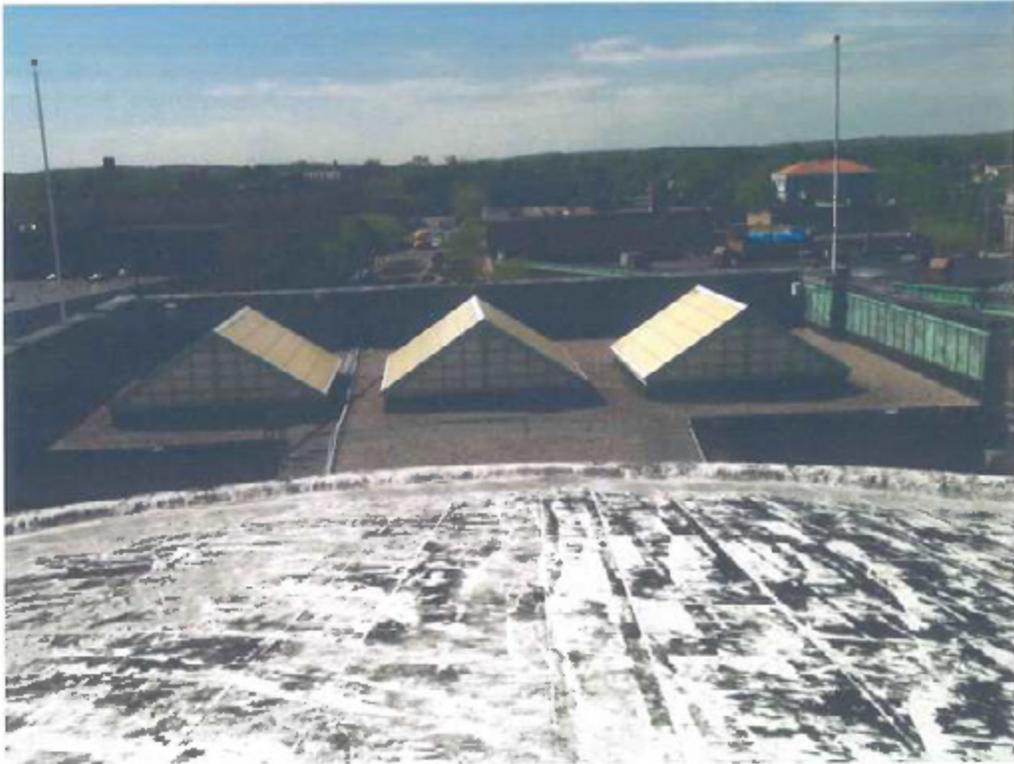
PHOTO #9 - Overview of Upper South Roof and skylights as seen from Auditorium Roof (Above). Note that Auditorium Roof coating has weathered and is in need of re-coating.

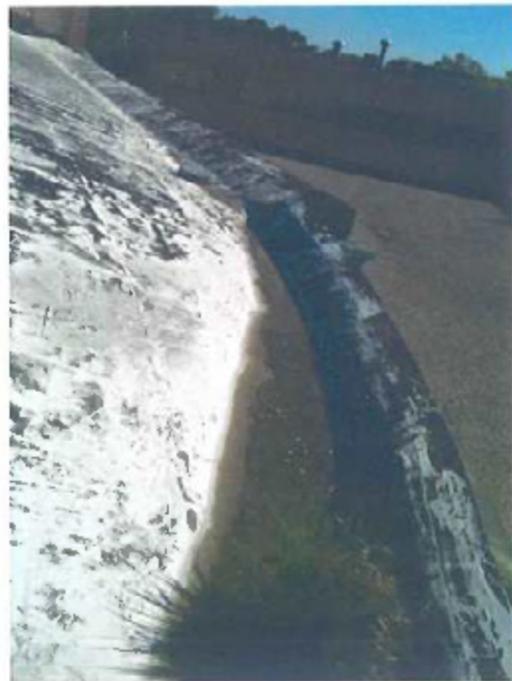
Photo #10 - The perimeter "gutter" has areas where drainage is blocked and is causing vegetation to grow in areas of standing water (Right). Membrane has deteriorated in these spots as indicated below (**Photo #11**)

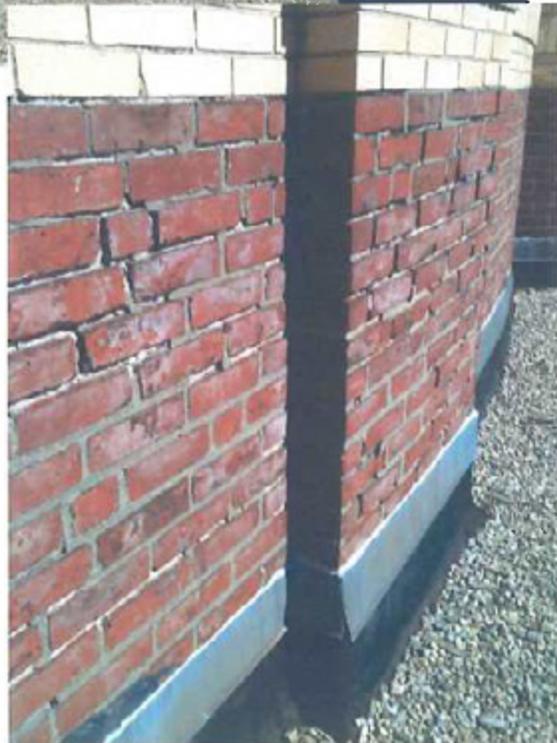
PHOTO #13 – Close-up of open masonry joints in rising Auditorium Walls (Right). Note that red brick mortar appears in much worse shape than yellow brick mortar.

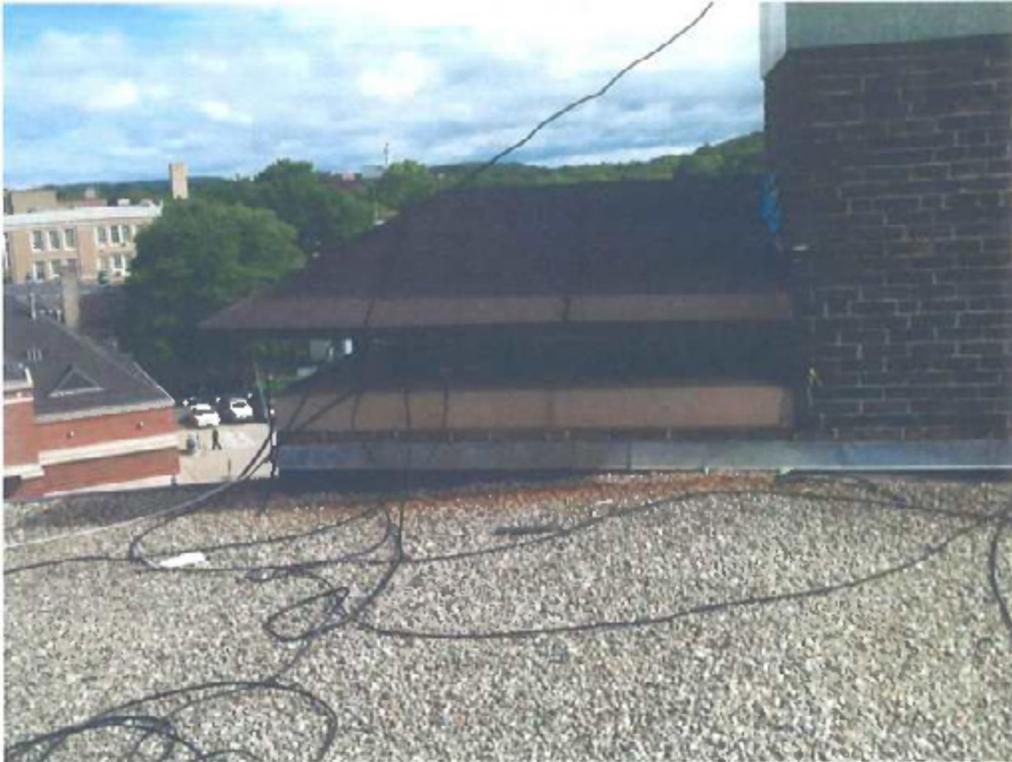
PHOTO #14 - Rusted gravity vent and masonry chimney construction on Upper Stage Roof. Note cable runs over roof surface and into gravity vent (Above).

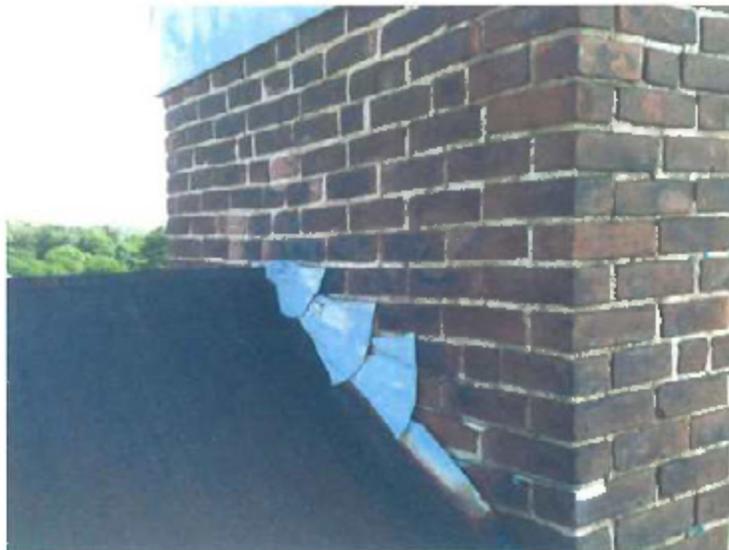
PHOTO #15 - Masonry Chimney is missing flashing at gravity vent (both sides) and is in need of re-pointing of mortar joints (Right).

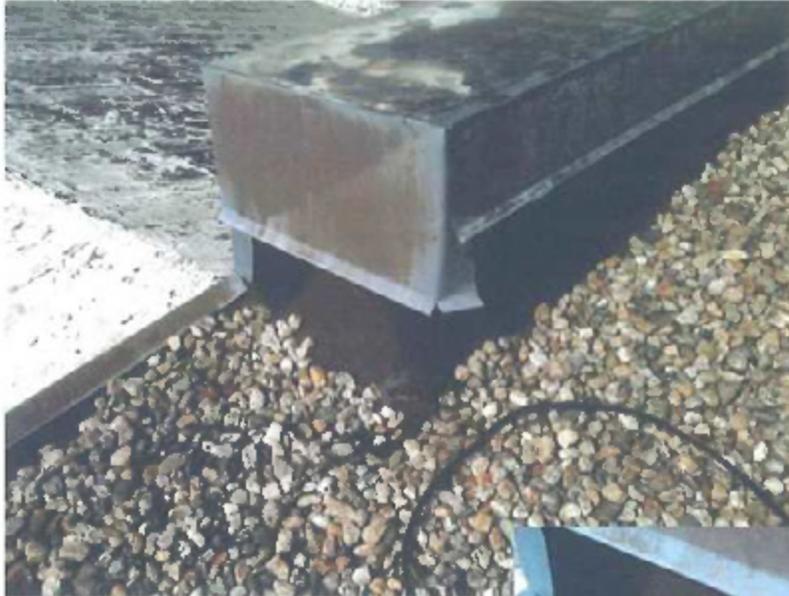
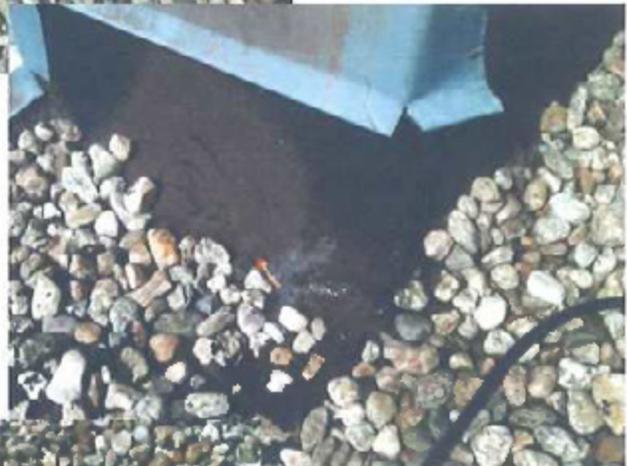
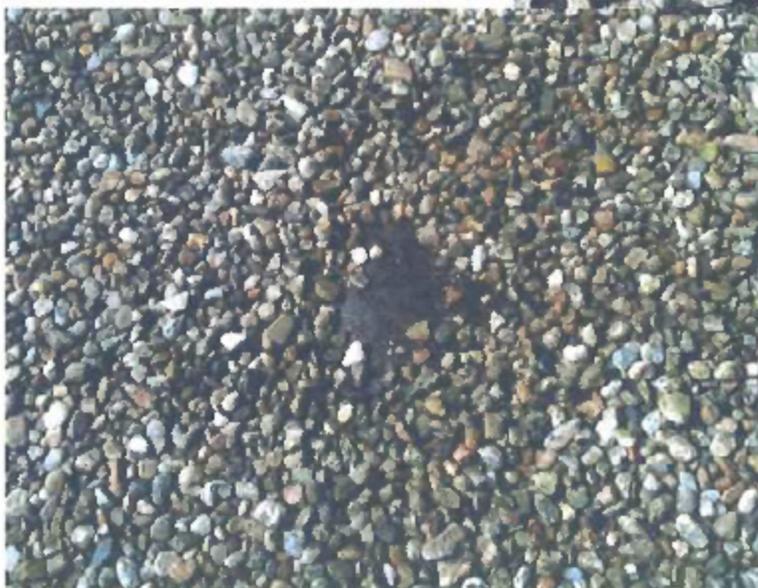
PHOTO #16 – Upper Stage Roof small parapet has opening in corner of base flashing which should be repaired (Above). **PHOTO #17** - Reinforcing is also visible at corners, which should be re-coated with mastic (Right). This condition is typical of all corner flashing and any flashing joints at all roof levels. **PHOTO #18** - Field of Upper Stage Roof has a blister which should be cut out and new plies stripped in (Below).

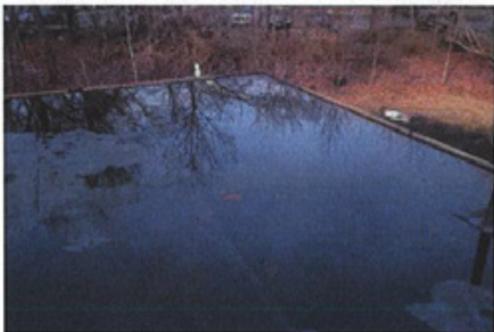
Defect(s)	Magnitude	Severity
Blocked Drains	Extensive	Critical
Ponding	Moderate	Moderate

Ponding water.

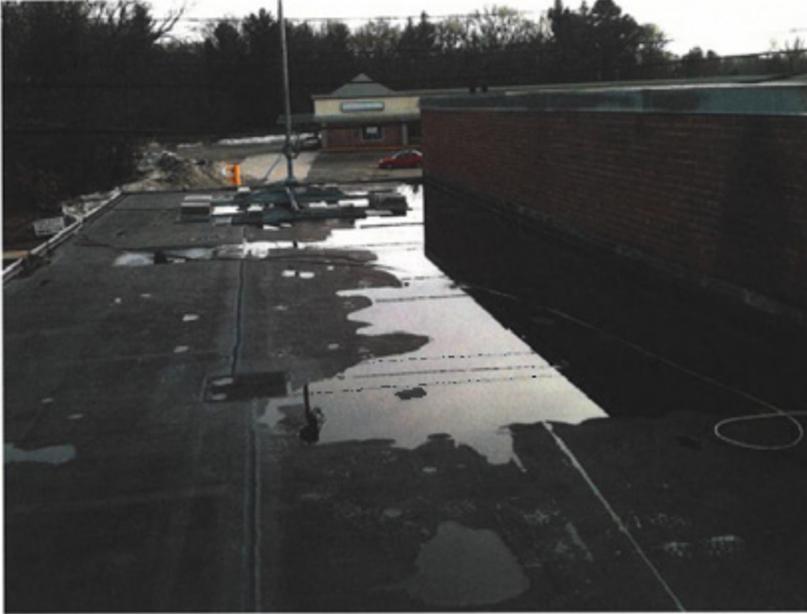
PHOTO #44: Lower EPDM roof showing large area of poor drainage and ponding.

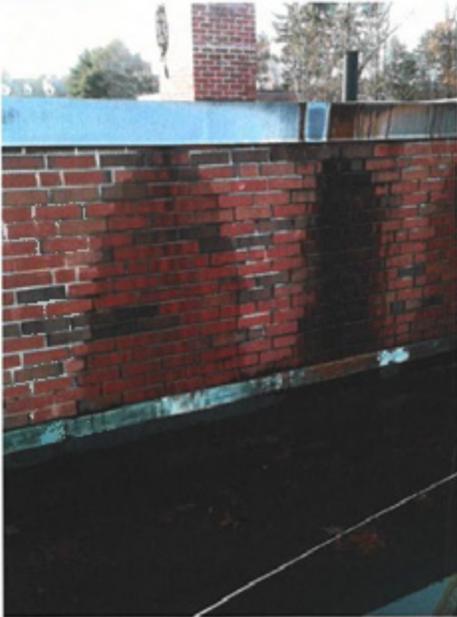
PHOTO #45: Photo showing water cascading over the masonry wall that separates the upper/lower roof levels. Masonry is becoming damaged, leading to larger-scale repairs.

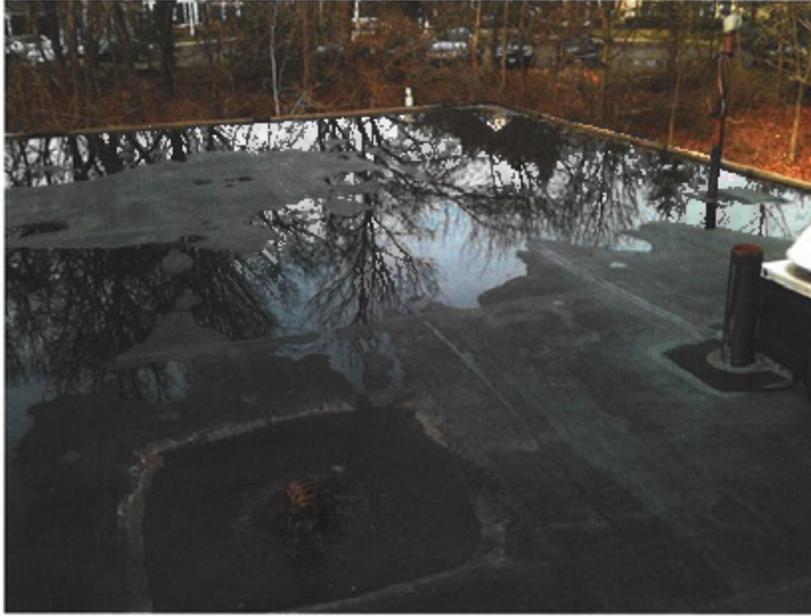
PHOTO #46: Lower EPDM roof showing large area of poor drainage and ponding at rear of roof.

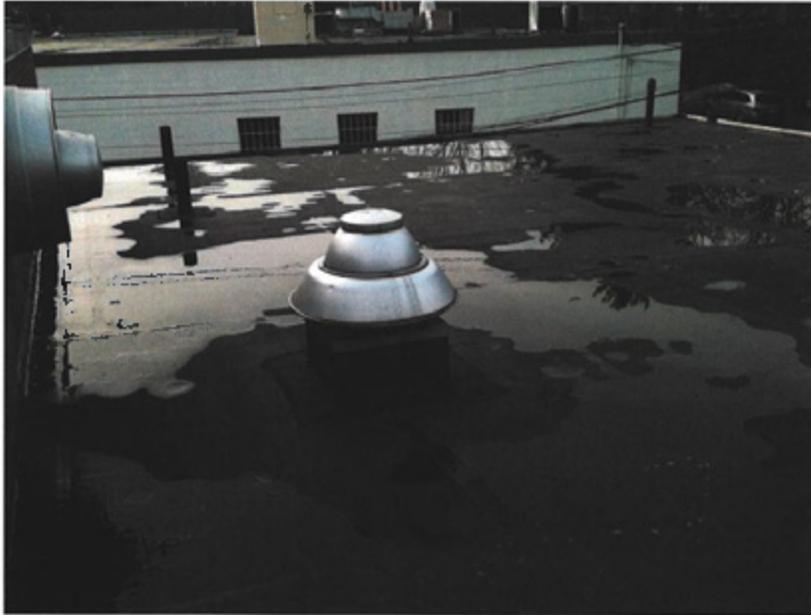
PHOTO #47: Lower EPDM roof showing more evidence of poor drainage and standing water in many areas.

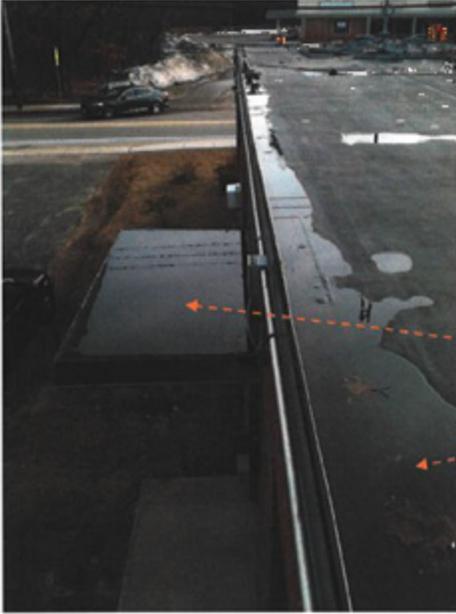
STANDING-WATER.

PHOTO #48: Virtually no form of drainage exists on the side canopy roof system. Water also collects along the edge of the main/upper roof area, leaving these areas vulnerable to leakage problems.

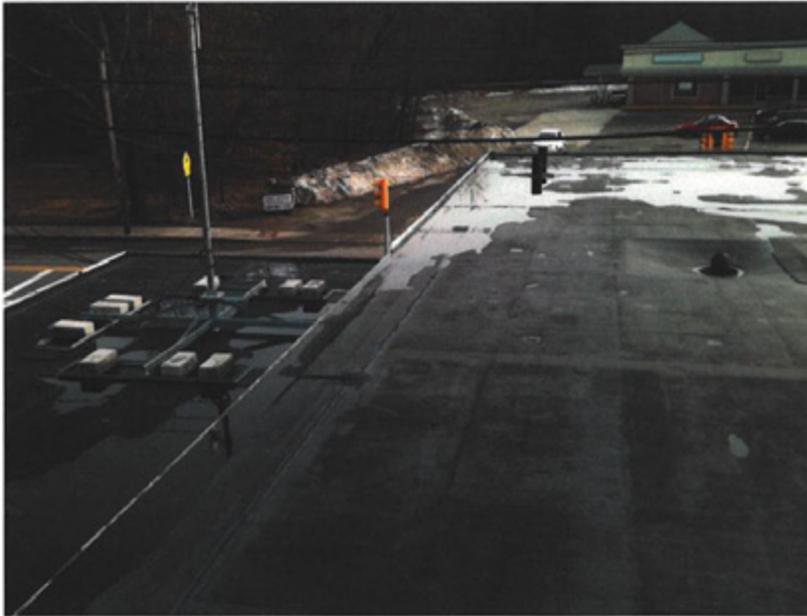
PHOTO #49: More evidence of poor-drainage - water cascades over the edge and down outside wall.

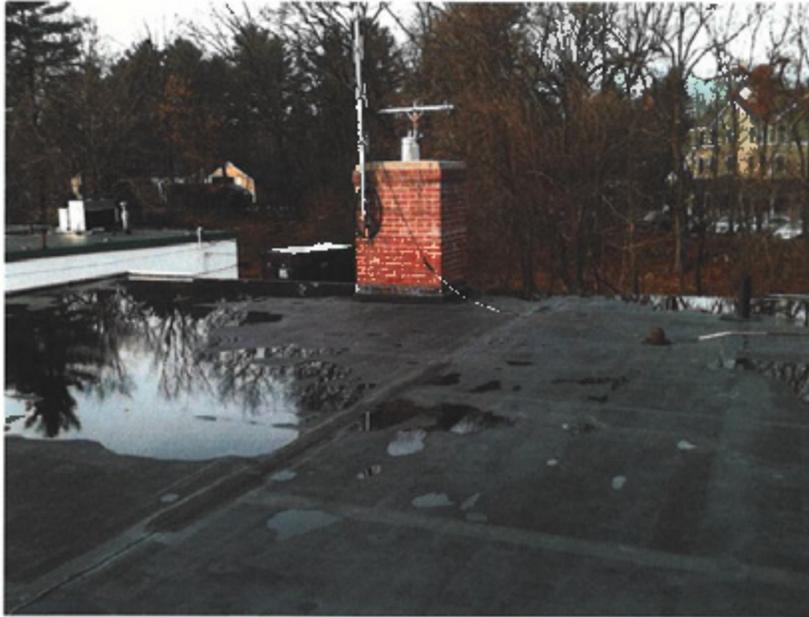
PHOTO #50: - Upper EPDM roof showing large area of poor drainage and standing-water.

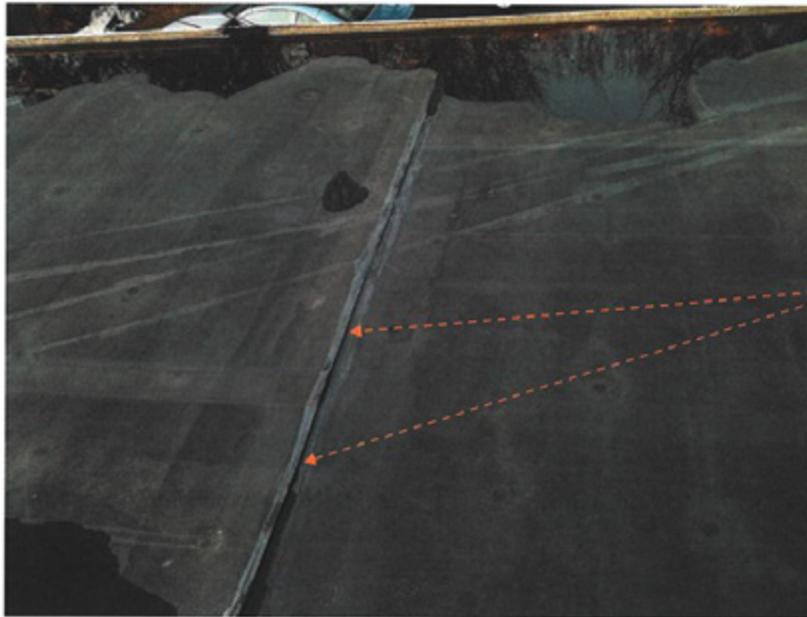
FAILING LAP/SEAM IN THE
EPDM ROOFING SYSTEM (TYP.
CONDITION).

PHOTO #51: Open/failing field-seam in the EPDM membrane roof system (typical condition throughout the roof system).

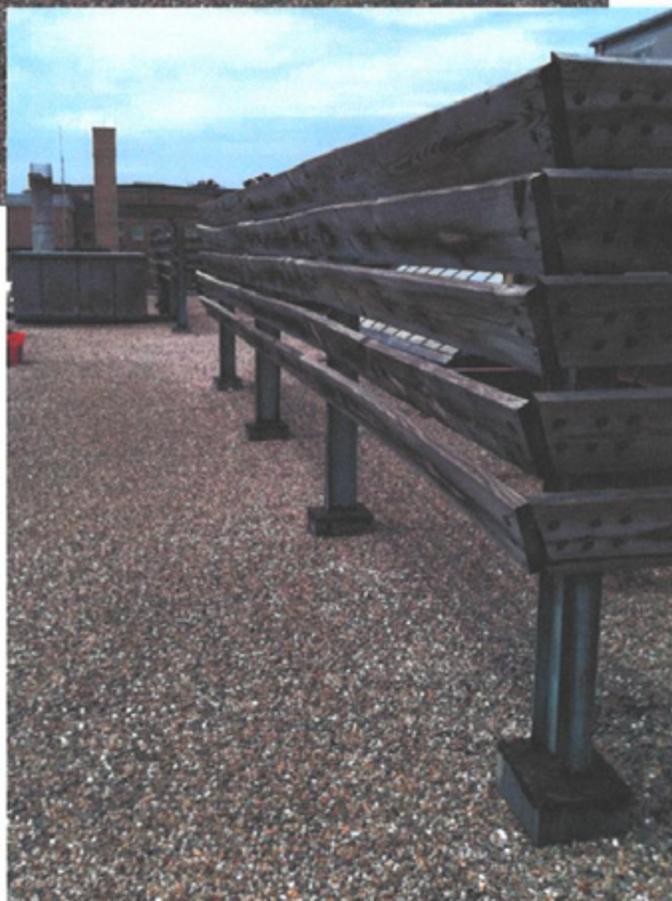
PHOTO #2 - Detail of wooden equipment screen (Right). Note that while steel structure is in good condition the wooden screen and related fasteners has deteriorated.

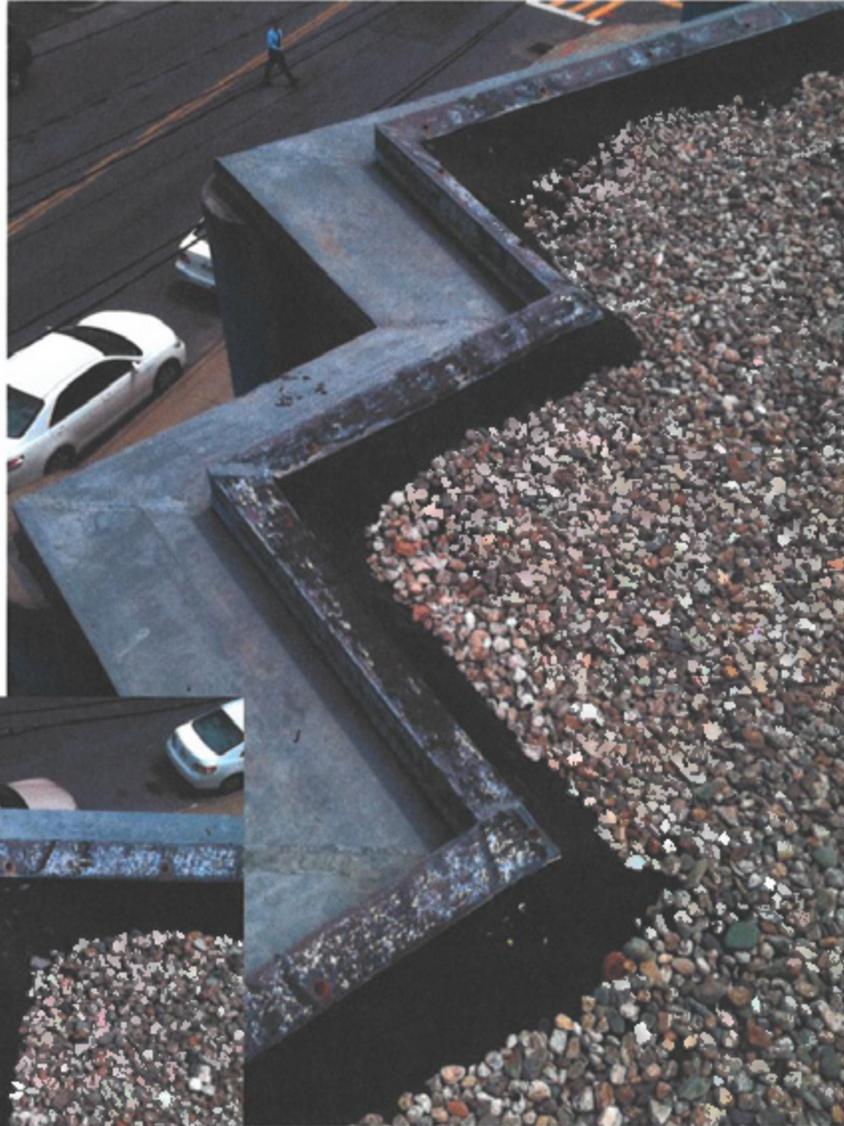
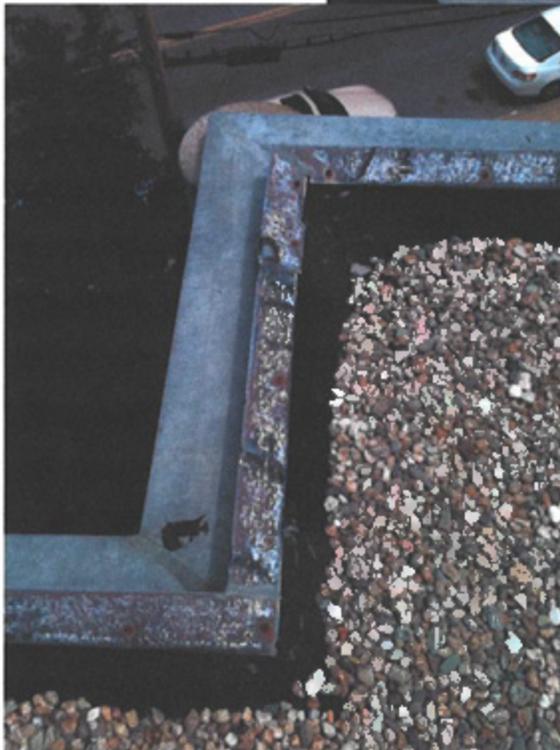
PHOTO #5 – The East side of the Main roof features a welded stepped copper cap at projected windows (Right & PHOTO #6 – Below). Note that screws have all rusted. Perimeter stripping is showing signs of wear and could be re-coated with roof mastic to extend service life.

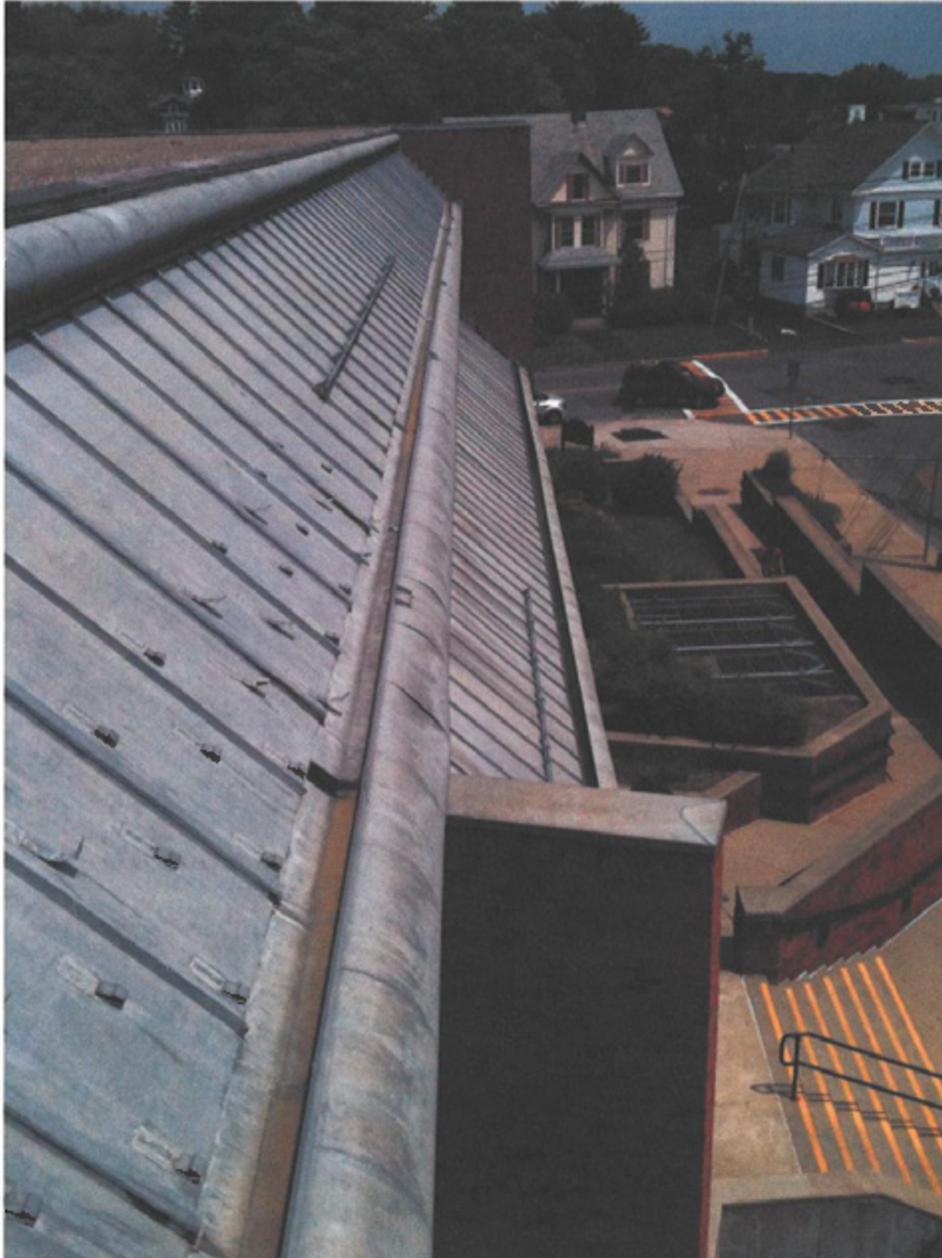
PHOTO #7 – The South side of the Main Roof is made up of cascading standing seam copper roofs with built-in gutters (Above). Note that lower gutter is blocked and is full of water.

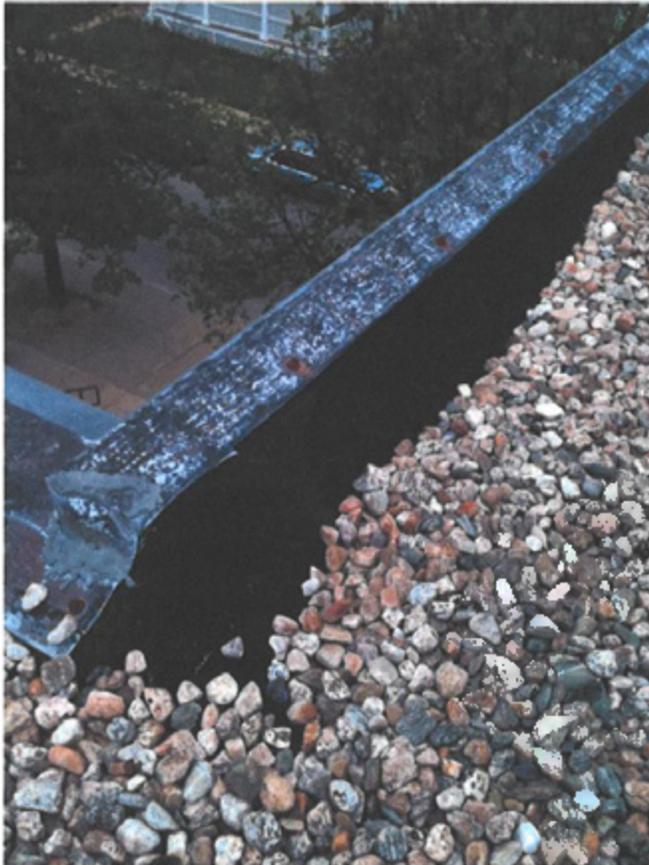
PHOTO #8 -- Copper perimeter fascia is stripped into BUR roof with membrane flashing (Left). Note that screws have all rusted. Perimeter stripping is showing signs of wear, some reinforcing fabric is visible, and could be re-coated with roof mastic to extend service life.

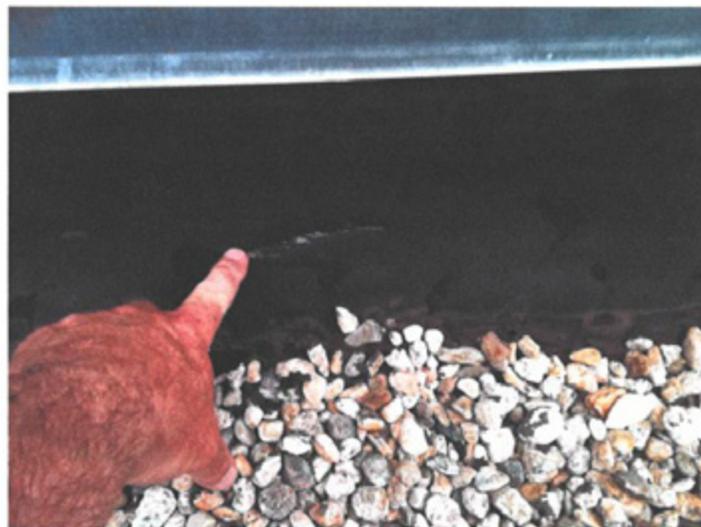
PHOTO #9 -- Although flashing in general appears to be in good shape it should be reviewed closely for damage (as noted Below) and wear and be repaired / re-coated to extend service life.
