## FIELD NOTES SUMMARY

**Customer:** City of Framingham  
**Pond Name:** Big Farm Pond  
**Site Location:** Framingham, MA  
**Date:** 5/29/24

**Customer:** City of Framingham  
**Pond Name:** Gleason Pond  
**Site Location:** Framingham, MA  
**Date:** 5/29/24

**Customer:** City of Framingham  
**Pond Name:** Learned Pond  
**Site Location:** Framingham, MA  
**Date:** 5/29/24

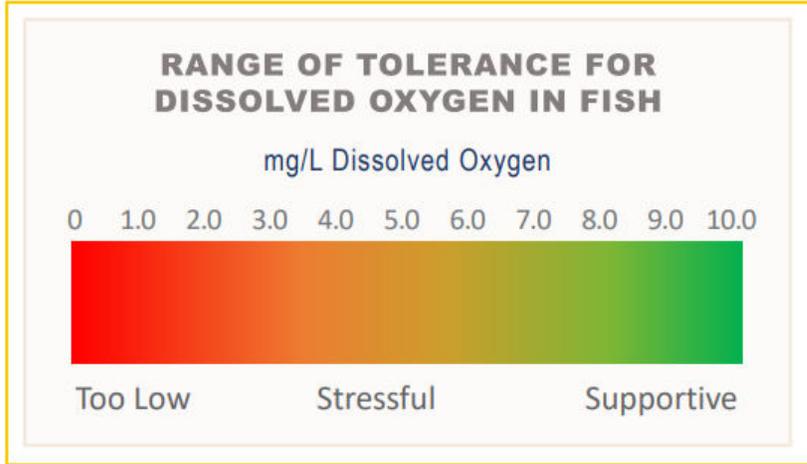
organisms. DO is necessary to support fish spawning, growth, and activity. Tolerance varies by species, but the figure below provides a general range of fish tolerance (Source: epa.gov). Dissolved oxygen can be affected by many outside factors, such as: temperature, time of day, and pollution. Dissolved oxygen levels are typically lowest early in the morning. Healthy water should generally have concentrations of about 6.5-8+ mg/L.

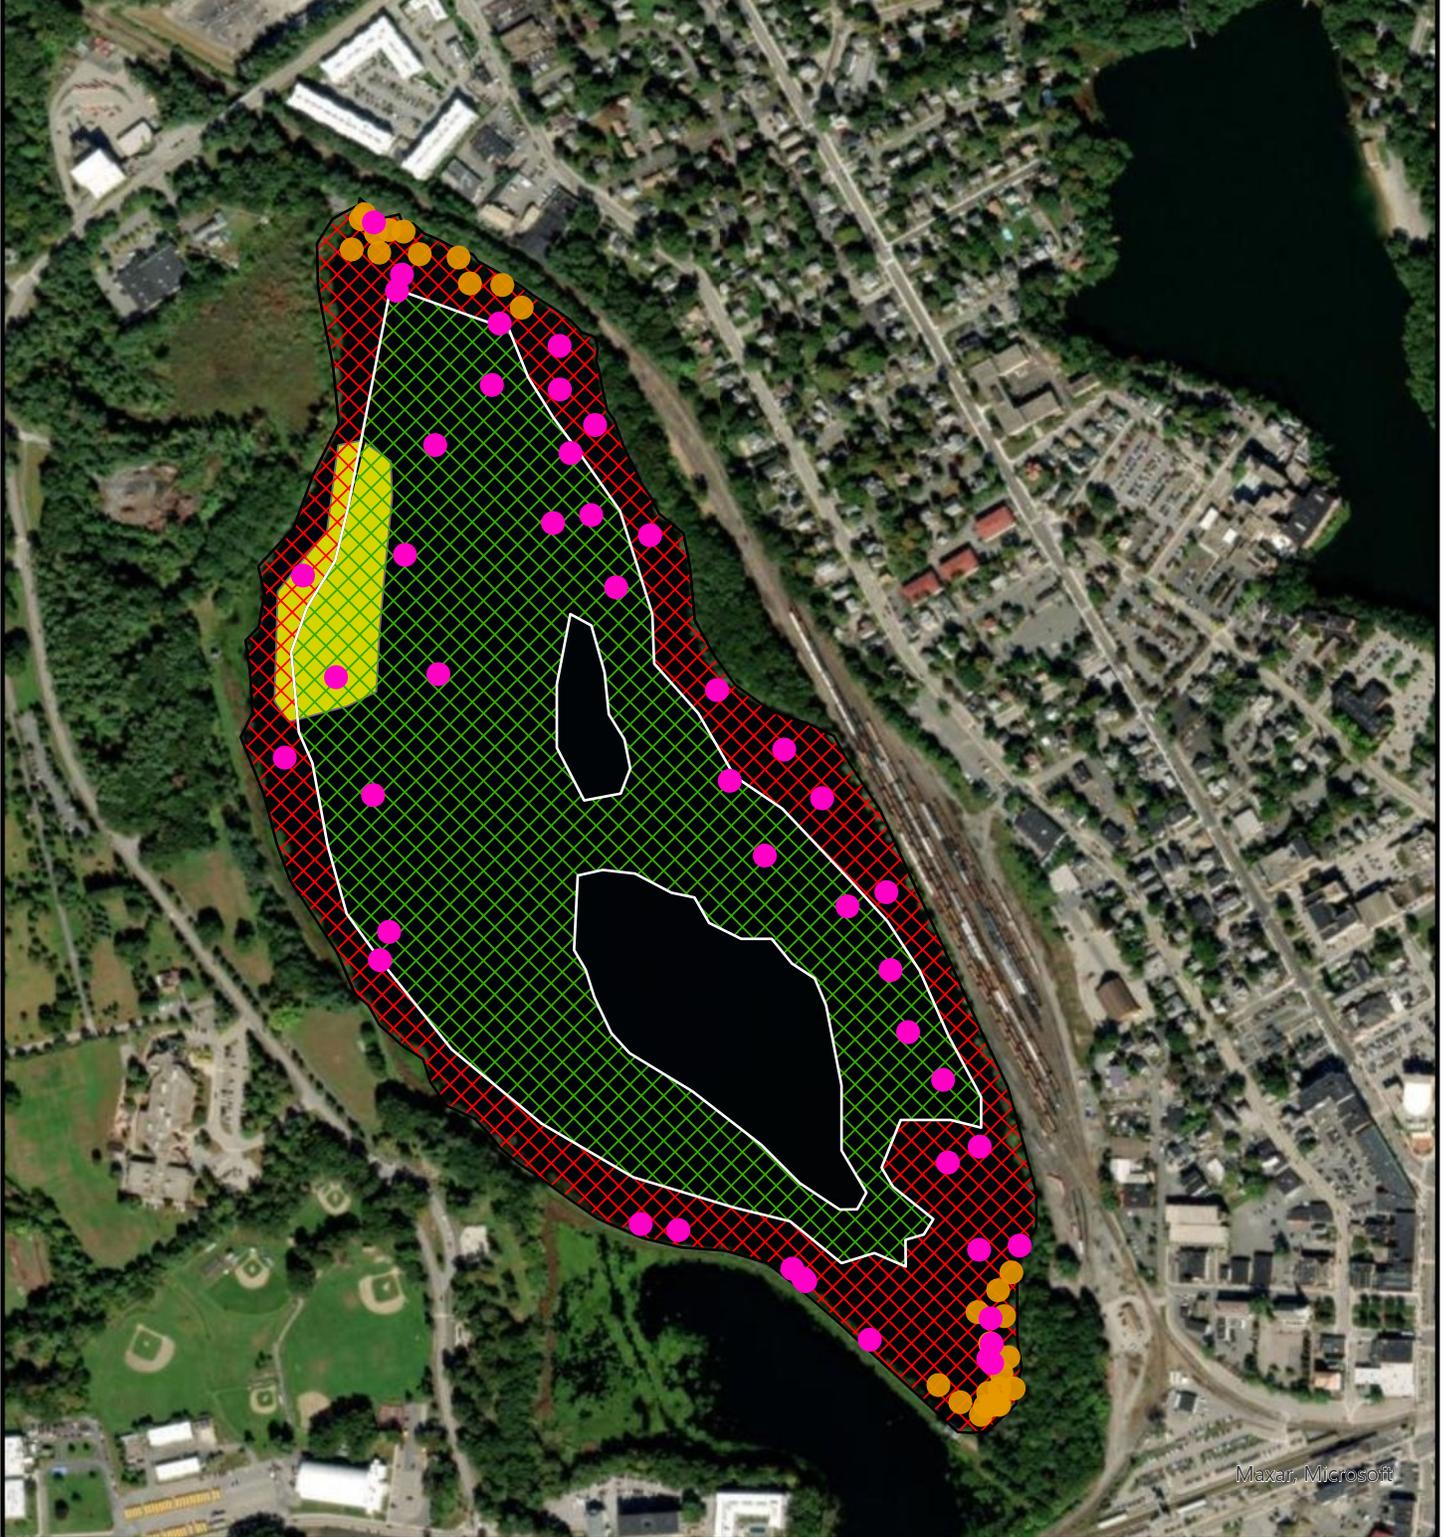
**Big Farm Pond**  
 Vegetation Assemblage  
 Framingham, MA

Invasive species documented in Big Farm Pond are consistent with those documented during the 2023 season. The most dominant invasive species was Eurasian watermilfoil. This species was found in varying densities ranging from trace to dense. Curly-leaf pondweed was the second most prevalent invasive species. This was found scattered within the Eurasian milfoil in trace to moderate densities. Water chestnut was found at the northern and southern points of the pond. Native species were also identified throughout the pond. The dominant native species include Robbin’s pondweed, coontail, and common waterweed (elodea). A full list of the species found during the survey is included above. Several swans were noted during the survey. Water samples were collected, preserved, and shipped to the lab for analysis.

- Water Chestnut
- Curly-leaf Pondweed
- ▽ Scattered Eurasian Milfoil and Curly-leaf; Sparse to Dense Robbins' Pondweed, Thin-leaf Pondweed, Coontail, and Clapsing-Leaf Pondweed
- ▨ Sparse to Dense Eurasian Milfoil
- Sparse to Moderate Clapsing-leaf Pondweed

Given the Natural Heritage Endangered Species Program restrictions, no management will occur in 2024. It is worth considering hand-pulling of water chestnut if NHESP allows. Water chestnut spreads rapidly and requires long-term management given the reproductive cycle of this plant. If managed before further spread, it will help long-term and allow for hand-pulling of this species to continue in lieu of treatment.

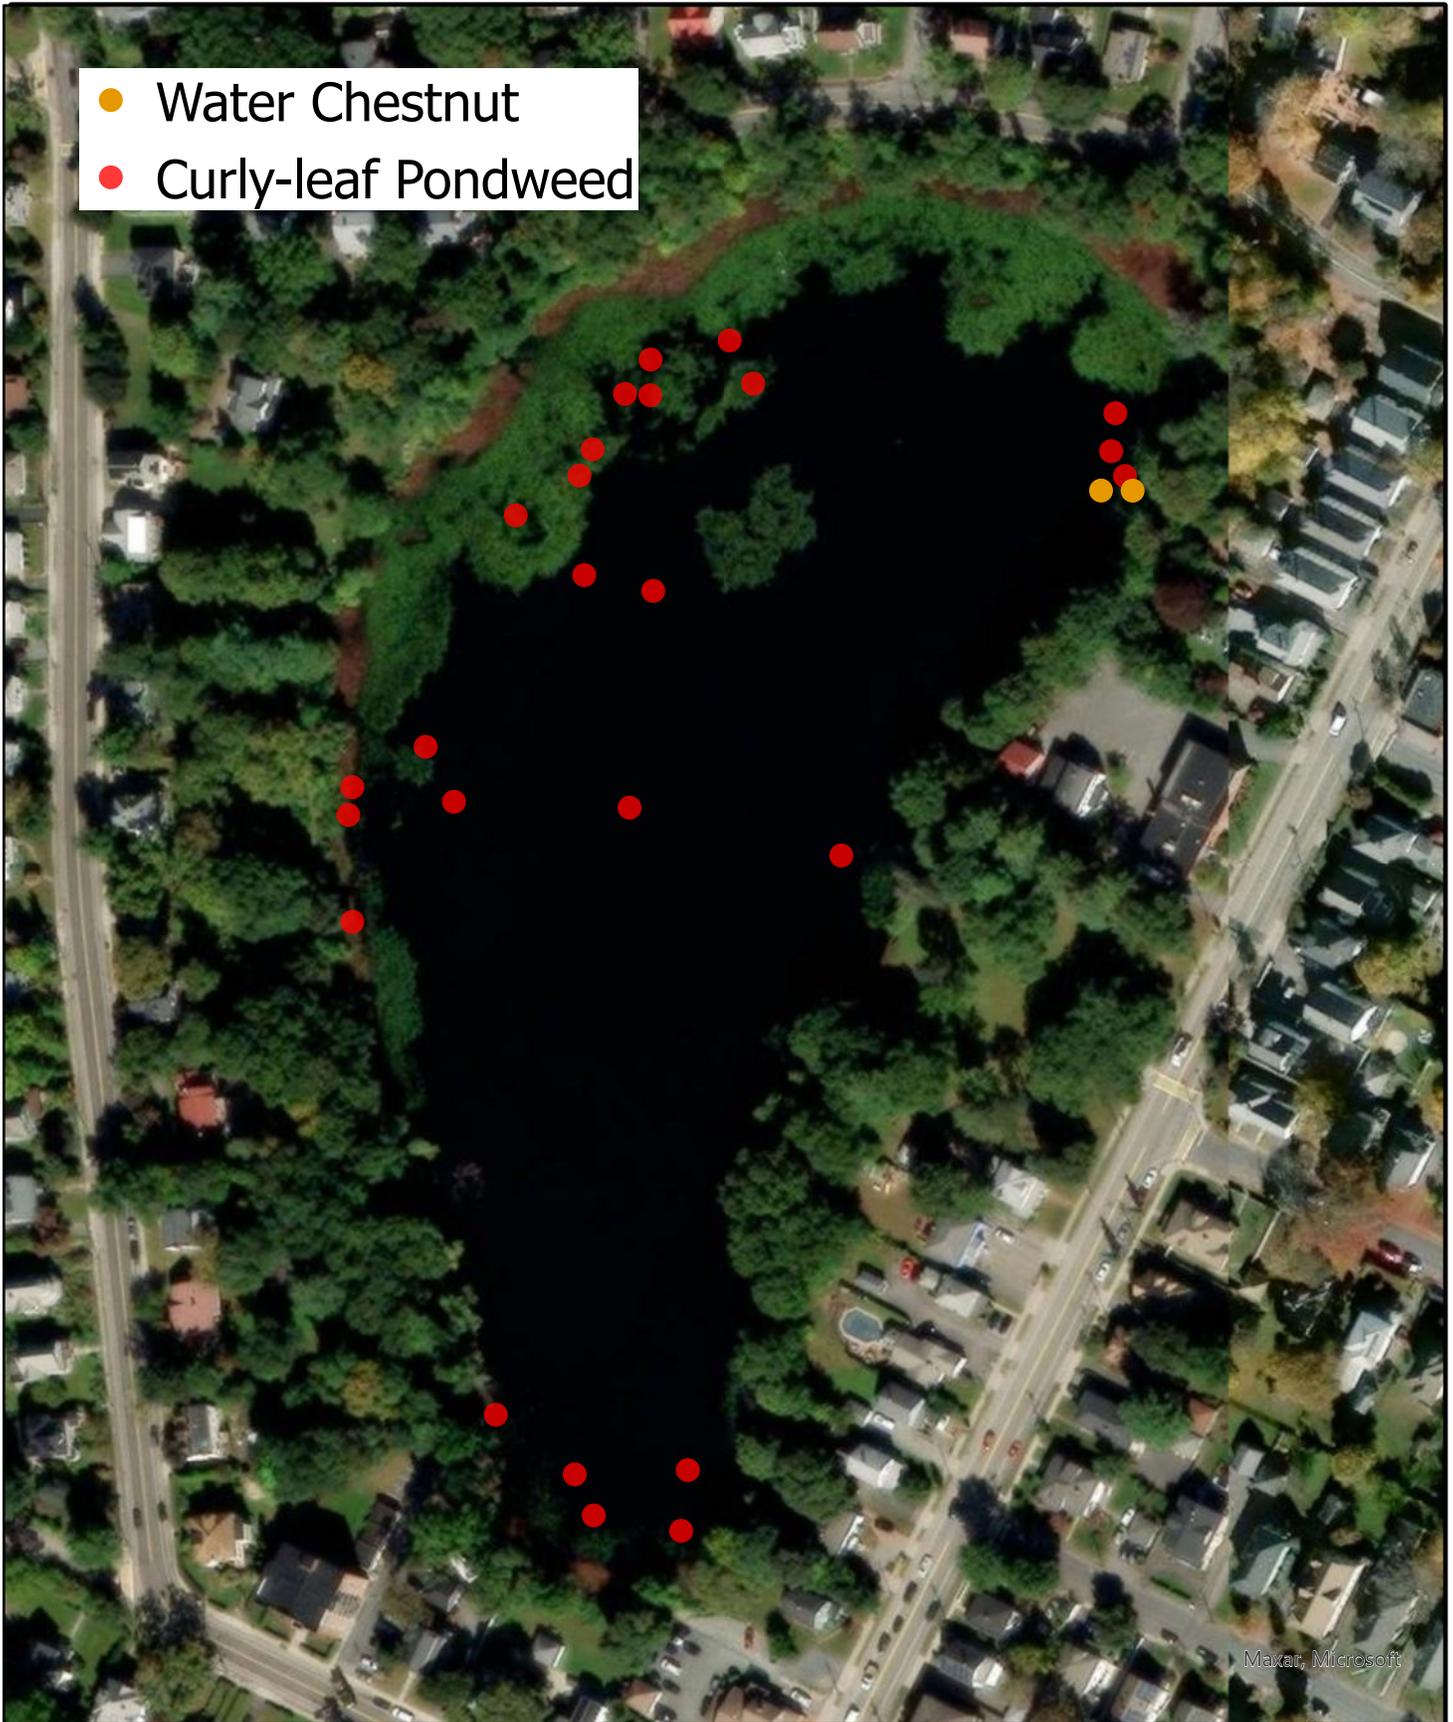
**Gleason Pond**  
 Invasive Species Distribution  
 Framingham, MA

- Water Chestnut
- Curly-leaf Pondweed

Based on the survey, treatment of curly-leaf pondweed may be warranted, given that this species is invasive. Water chestnut should be hand-pulled later in the season, prior to seeds dropping (typically in mid-August). This could either be accomplished by volunteers, or Water & Wetland could provide a crew to hand-pull the invasive water chestnut.

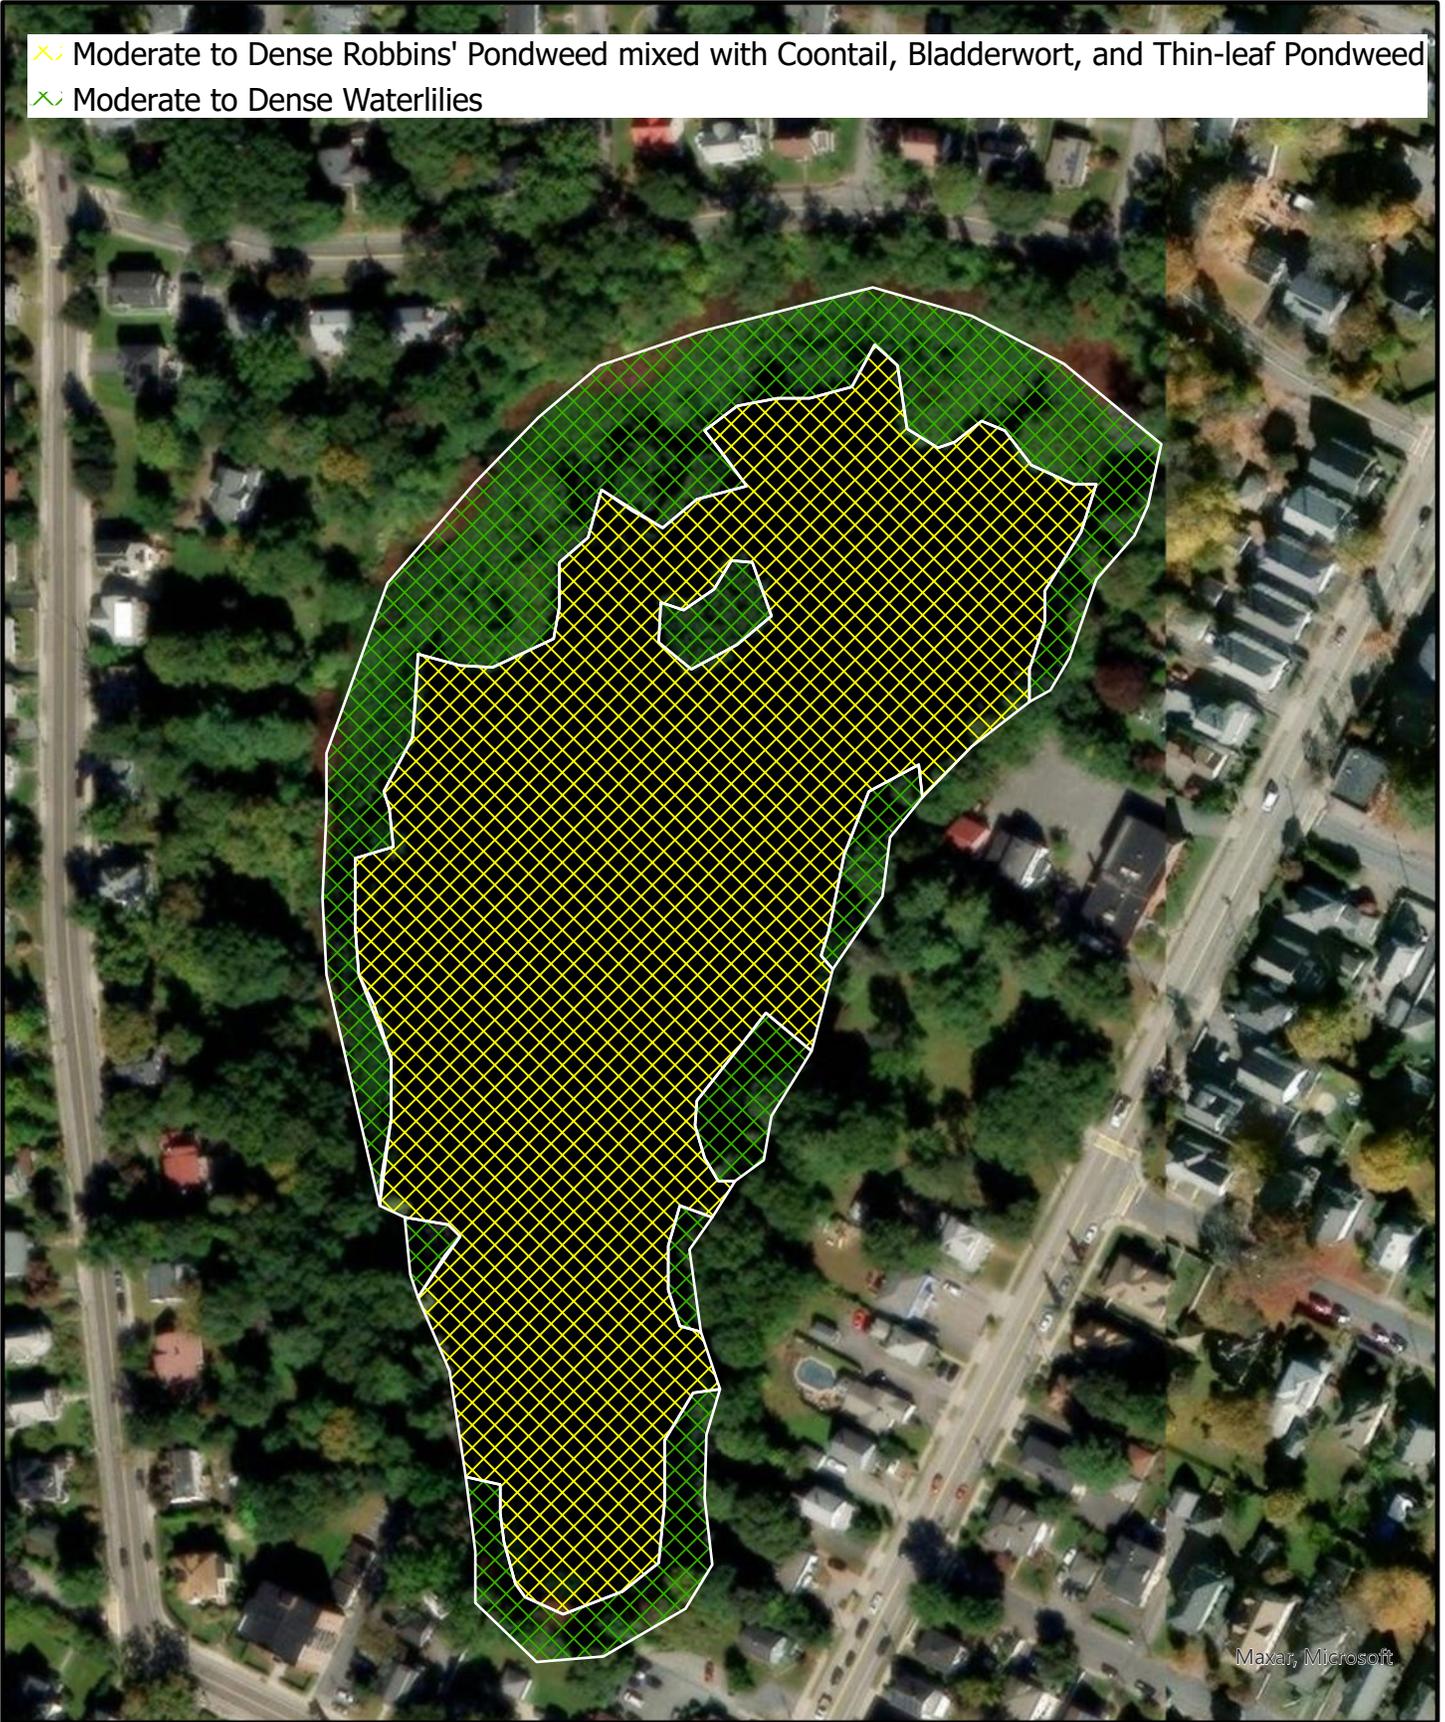
**Gleason Pond**  
Native Species Assemblage  
Framingham, MA

Several native species were documented during the survey. These predominantly included Robbin's pondweed and waterlilies; however, bladderwort was also found. Filamentous algae was mixed in within the vegetation and occasionally on the surface. Two invasive species were documented. These include curly-leaf pondweed which was found along some shorelines in intermittent clusters (see map). Water chestnut was established within the water column along the eastern shoreline. Pollen was noted on the surface along wind-blown shorelines. This is not to be confused with microscopic algae. Water samples were collected, preserved, and shipped to the lab for analysis.

- ✘ Moderate to Dense Robbins' Pondweed mixed with Coontail, Bladderwort, and Thin-leaf Pondweed
- ✘ Moderate to Dense Waterlilies

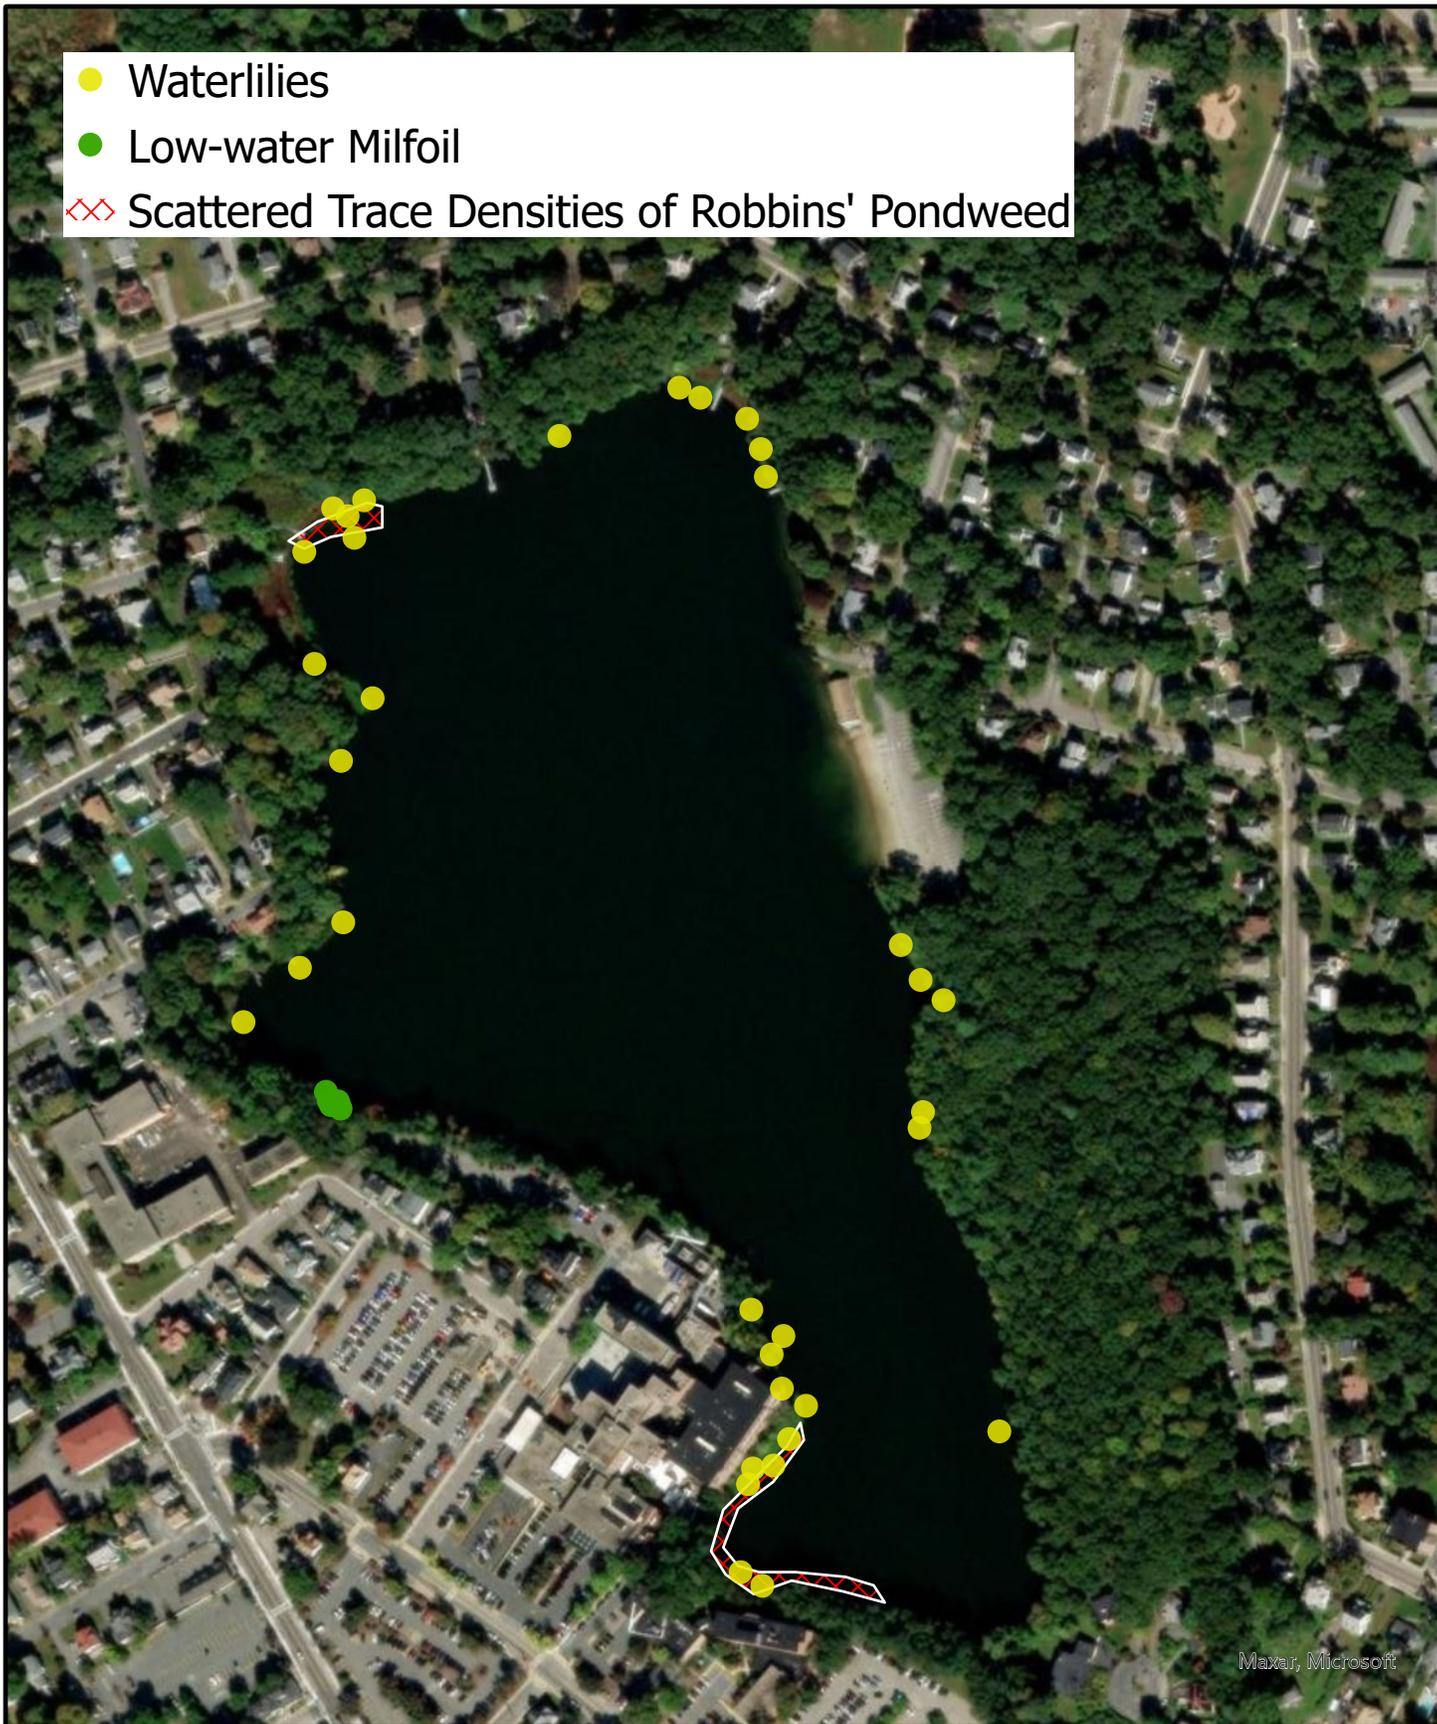
**Learned Pond**  
Vegetation Assemblage  
Framingham, MA

Consistent with previous years at Learned Pond, no invasive species were found. The water clarity was excellent. A healthy assemblage of native species was documented. One patch of low-water milfoil was found. This is a native milfoil. Cattails were documented along the shoreline in healthy densities. Pollen was found along the surface in wind-blown areas, which is common this time of year. This is not to be confused with microscopic algae. In addition to the water quality parameters collected on-site, samples were collected, preserved, and shipped to the lab for analysis.

- Waterlilies
- Low-water Milfoil
- ◇◇◇ Scattered Trace Densities of Robbins' Pondweed

Based on the survey, we do not recommend management/treatment at this time.

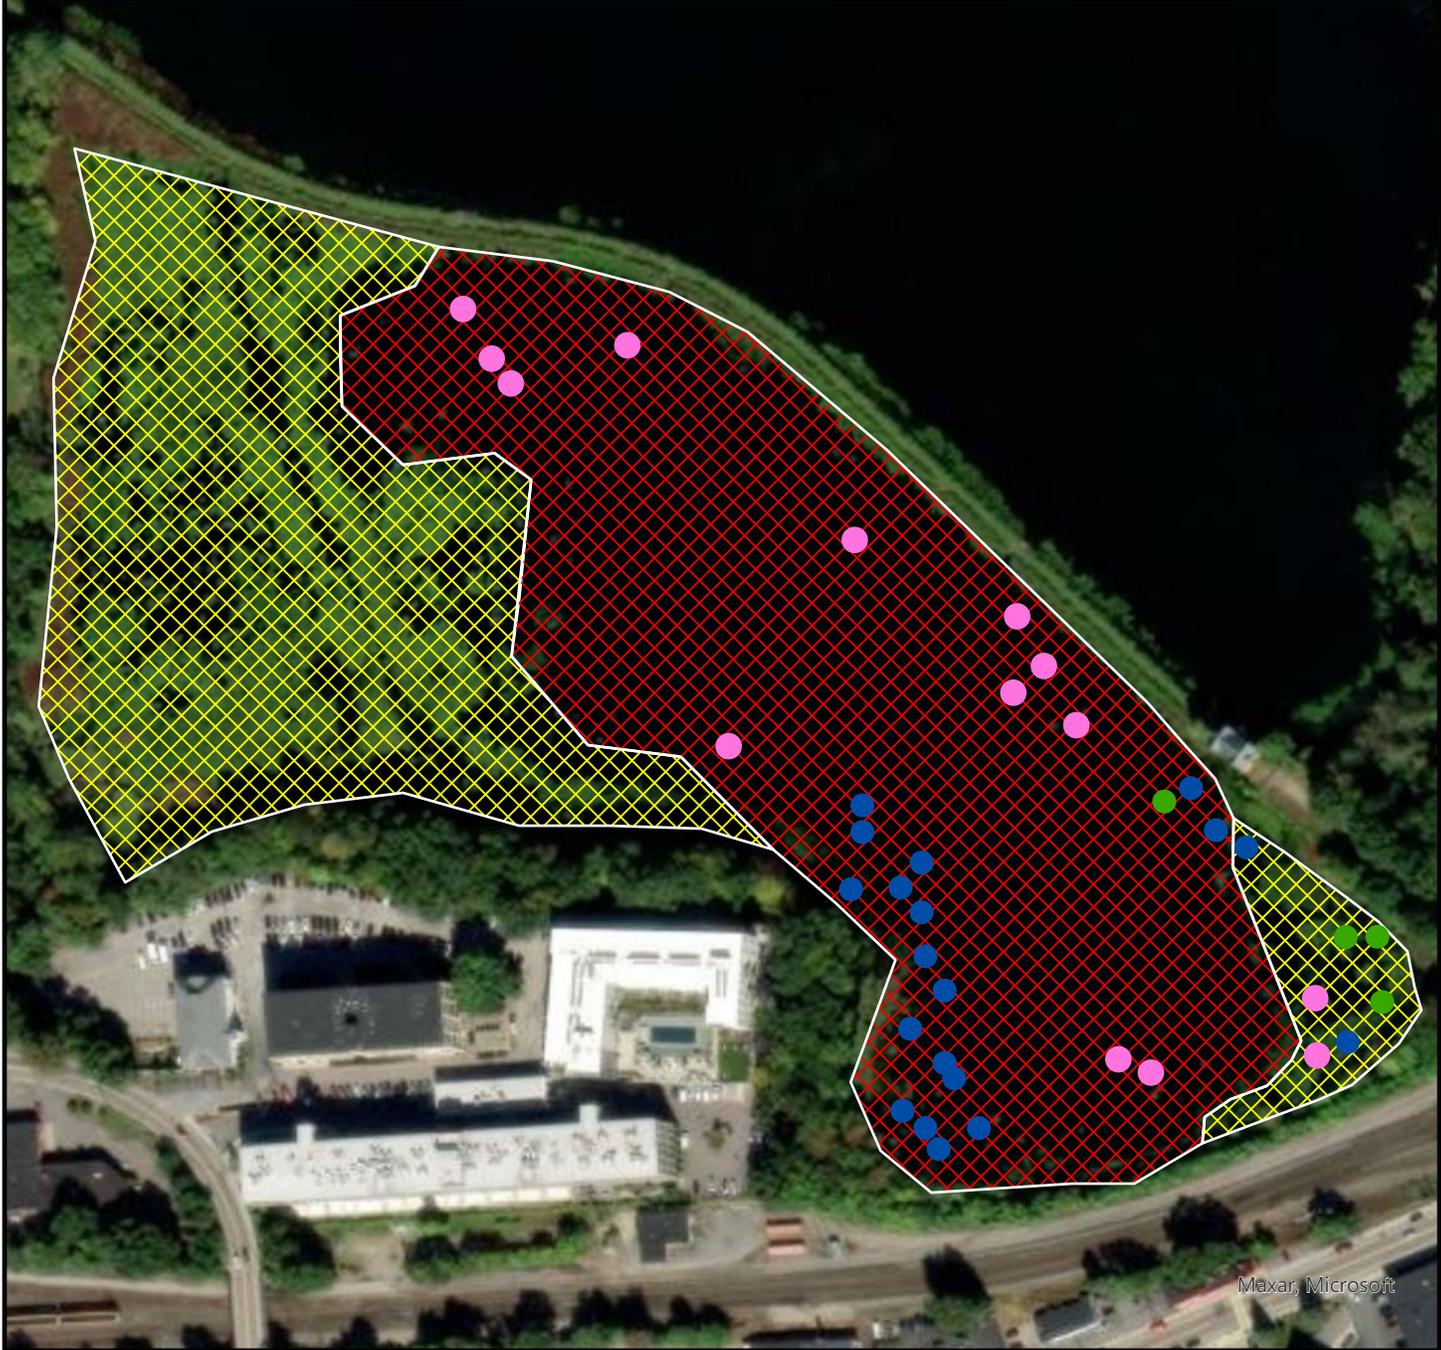
**Little Farm Pond**  
 Vegetation Assemblage  
 Framingham, MA

Species composition appears to have remained relatively similar to that of the 2023 spring survey. Dominant invasive species included Eurasian watermilfoil and curly-leaf pondweed. These species were documented in varying densities. Water chestnut was scattered throughout the waterlily patches, especially along the southeastern shoreline. The densest areas of cattails were along the western and northern shorelines. The densest area of waterlilies was in the western corner of the pond. Native species such as Robbin's pondweed, elodea, and coontail were found at similar densities to Big Farm Pond. Water samples were collected, preserved, and shipped to the lab for analysis.

- Water Chestnut
- Curly-leaf Pondweed
- Eurasian Milfoil
- ⊠ Moderate to Dense Elodea, Coontail, and Robbins' Pondweed
- ⊠ Moderate to Dense Waterlilies

Due to Natural Heritage Endangered Species Program restrictions, no management will occur in 2024. At a minimum, consideration should be given to seeking NHESP approval to allow for hand-pulling of the invasive water chestnut. If this approval is gained, this could likely be completed by volunteers.

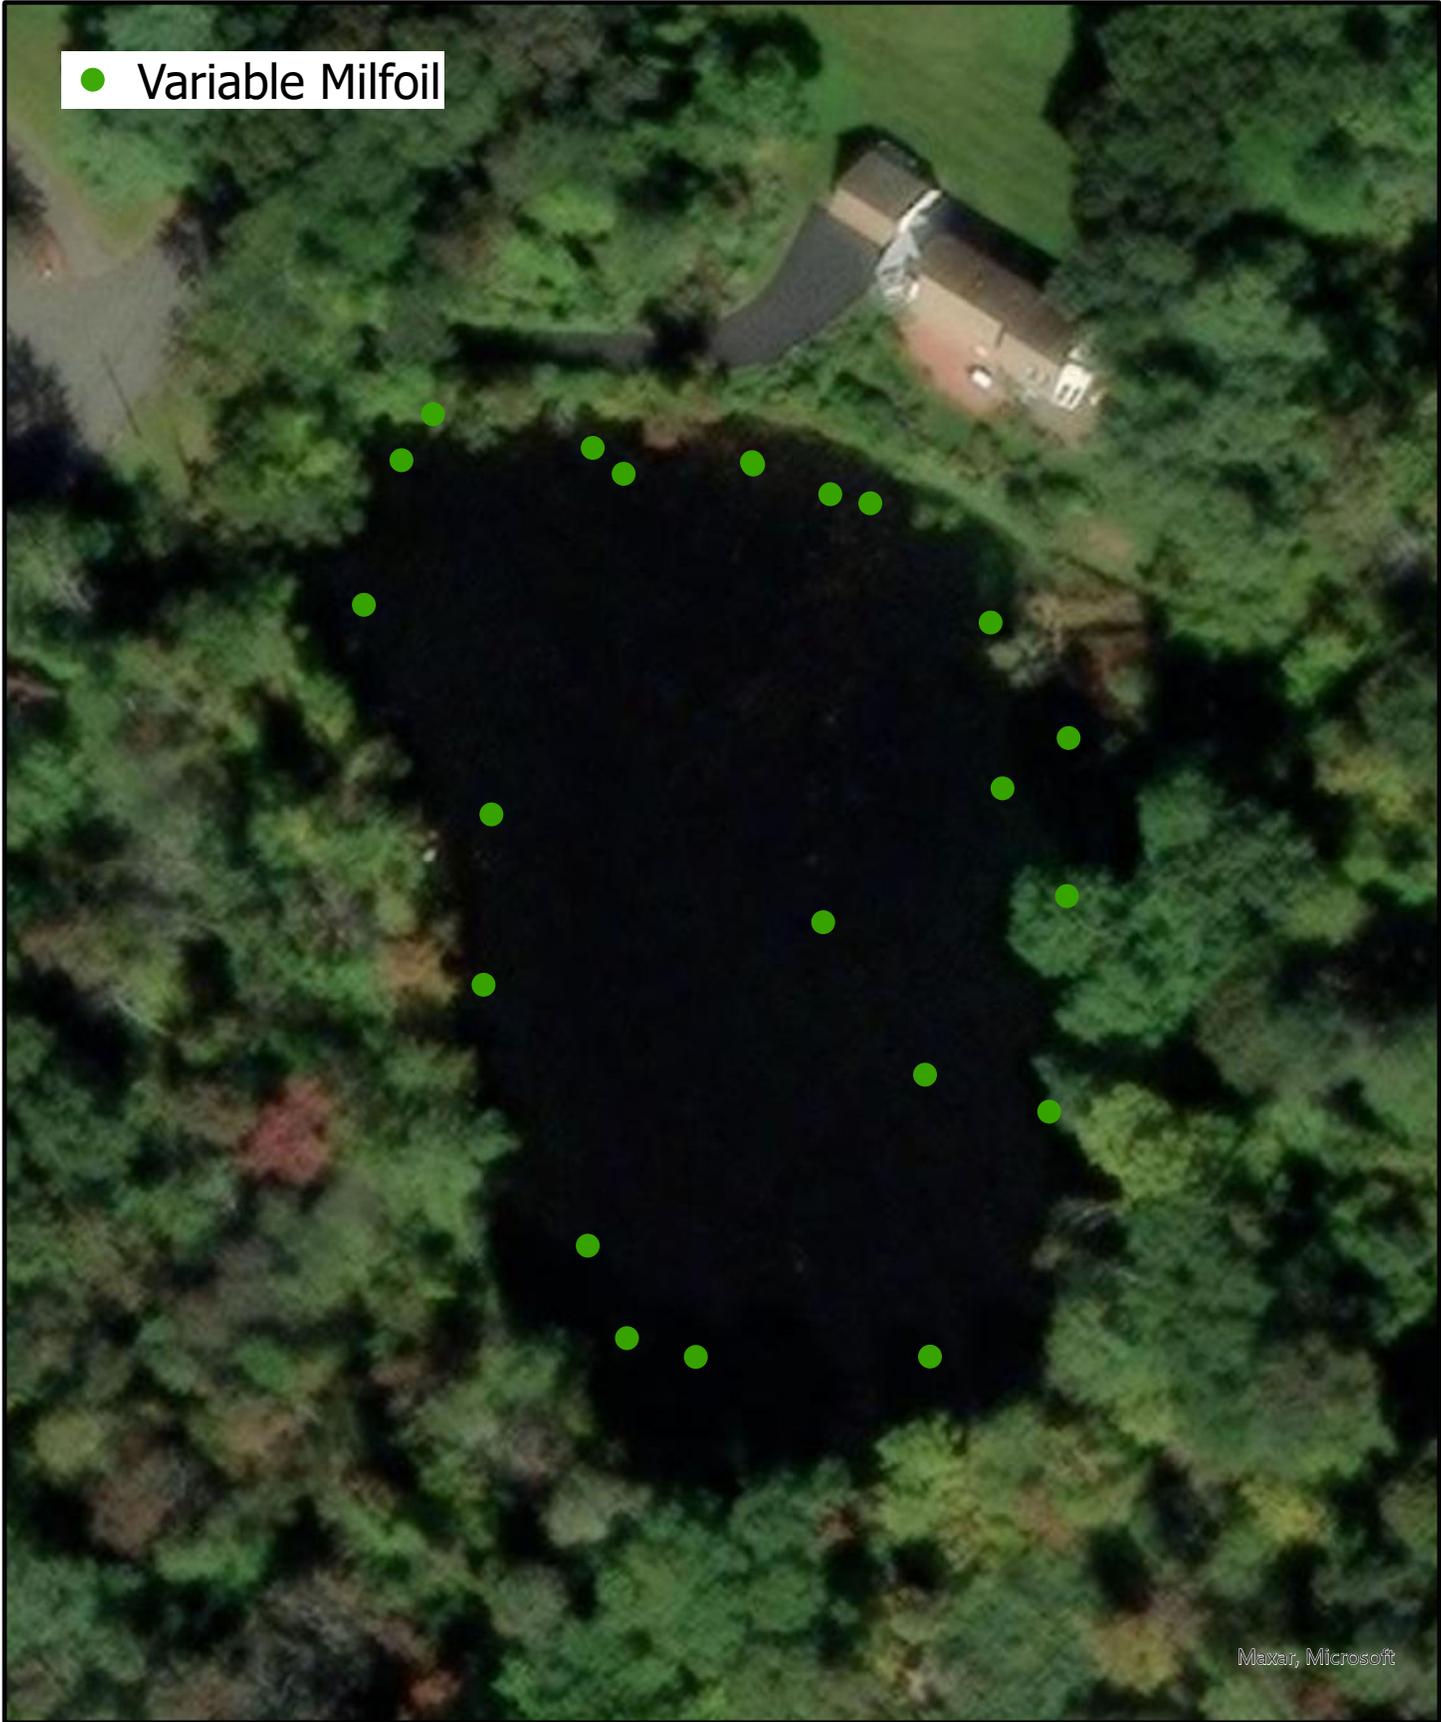
*Additional Notes from the Biologist*
Consistent with historical records, one invasive species was found during the survey. This includes variable watermilfoil which was found scattered in isolated patches. It's still somewhat early in the season, but the milfoil was found in only trace to sparse densities. It does appear however that the milfoil presence has increased from 2023. While not dense, the population was documented growing throughout the water column and occasionally surfacing. Filamentous algae and waterlilies were also noted. These species were scattered around the shoreline of the pond. Native cattails were noted along the northwestern shoreline. Pollen was noted on the surface.
Based on the survey, management of invasive variable milfoil is recommended.

● Variable Milfoil

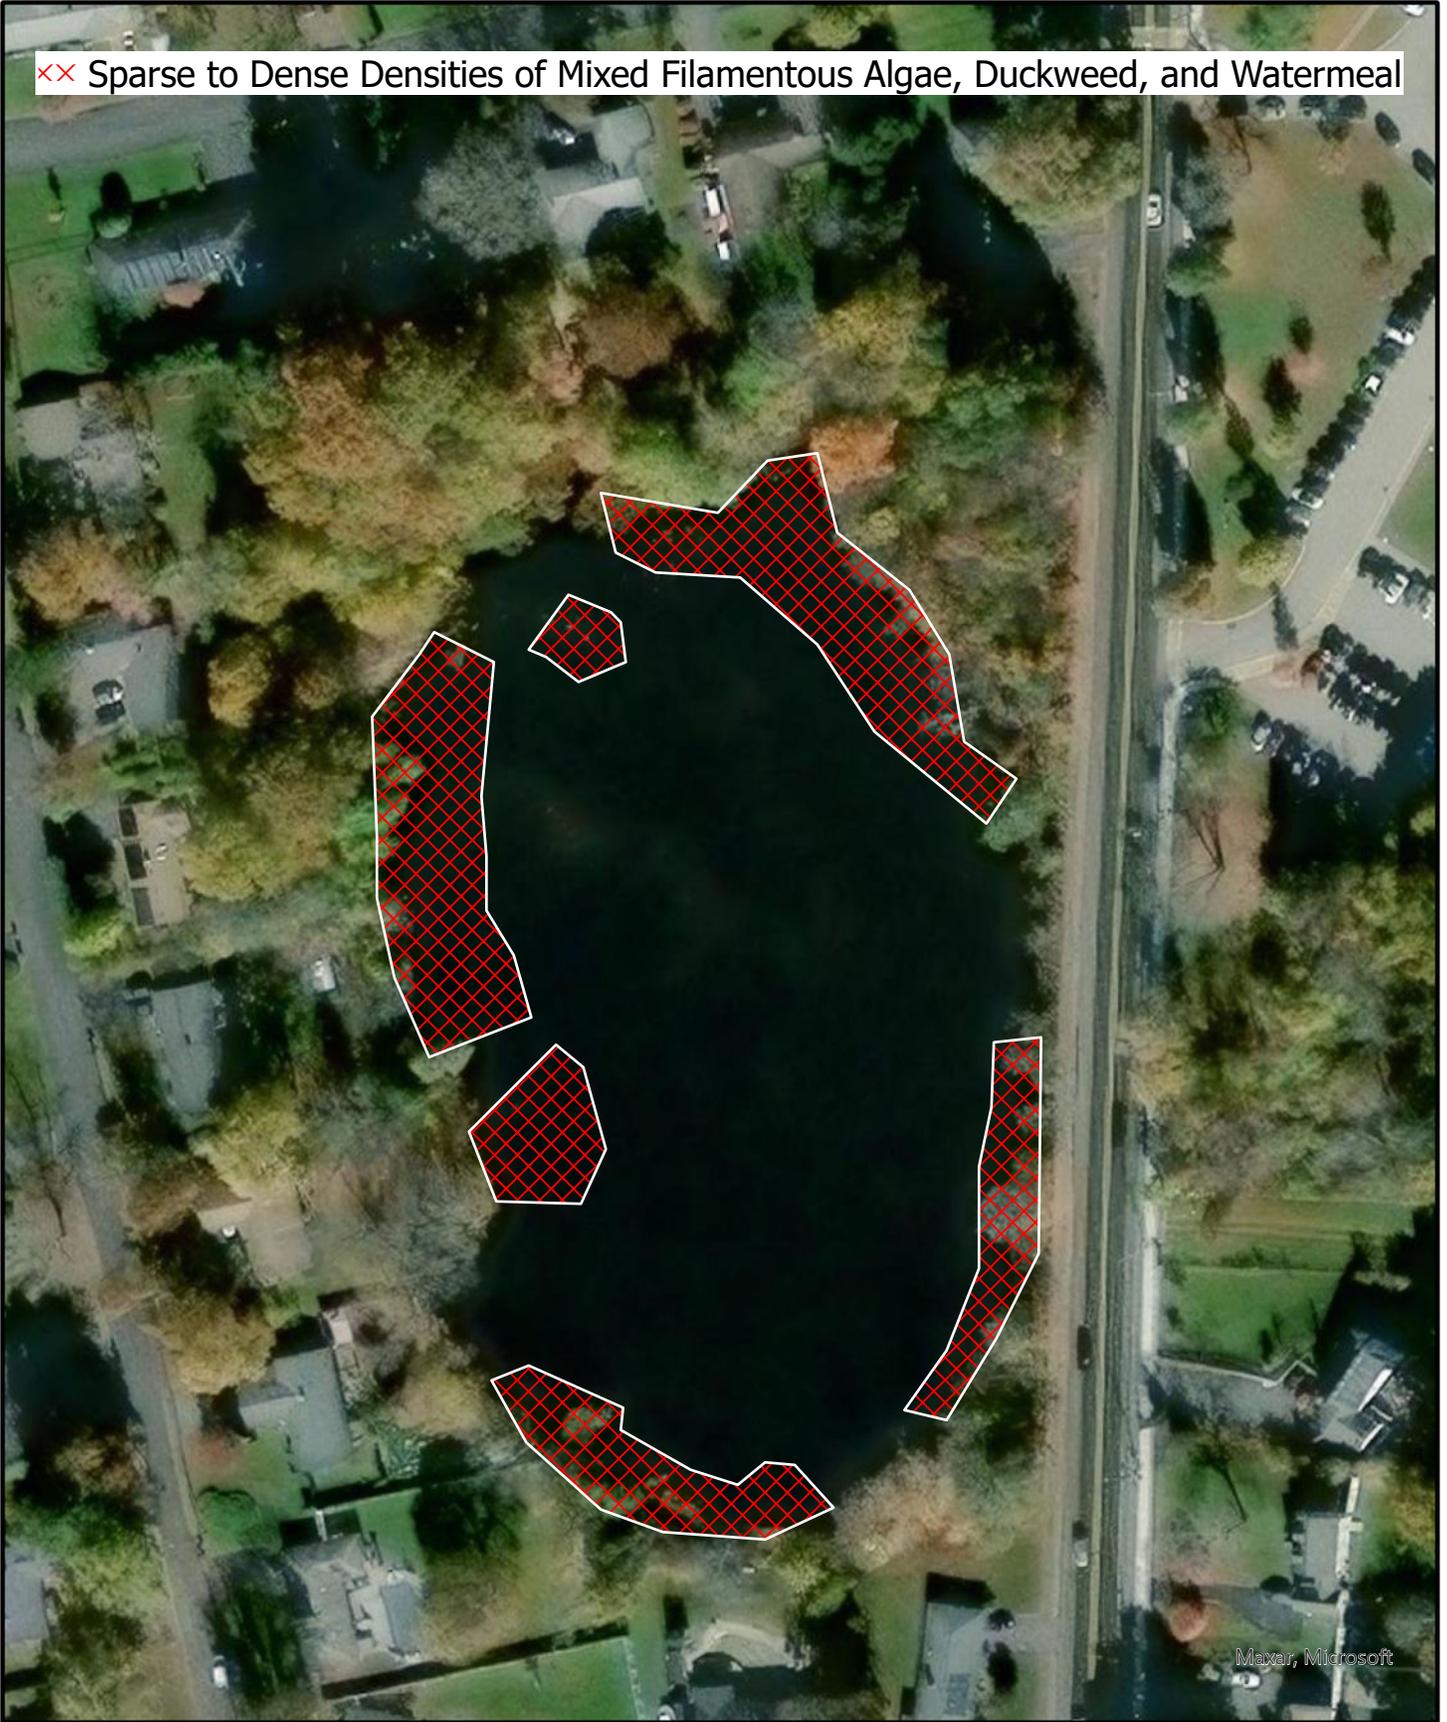
*Additional Notes from the Biologist*
No invasive species were found during the survey. Watermeal, duckweed, and filamentous algae were found around the edges of the pond. Densities varies from sparse to dense. The middle of the pond was all open-water habitat. Pollen was found on the surface at the middle of the pond and also mixed in with the duckweed, watermeal, and algae along the shoreline. Water samples were collected, preserved, and shipped to the lab for analysis.
Watermeal, duckweed, and filamentous algae have the ability to cover the majority of shallow pond such as Norton Pond. At this time, densities likely do not warrant management of these native species. We recommend an additional visit in June and potentially additional visits throughout the summer months. If densities of these species increase, treatment will likely be warranted at that time.

×× Sparse to Dense Densities of Mixed Filamentous Algae, Duckweed, and Watermeal

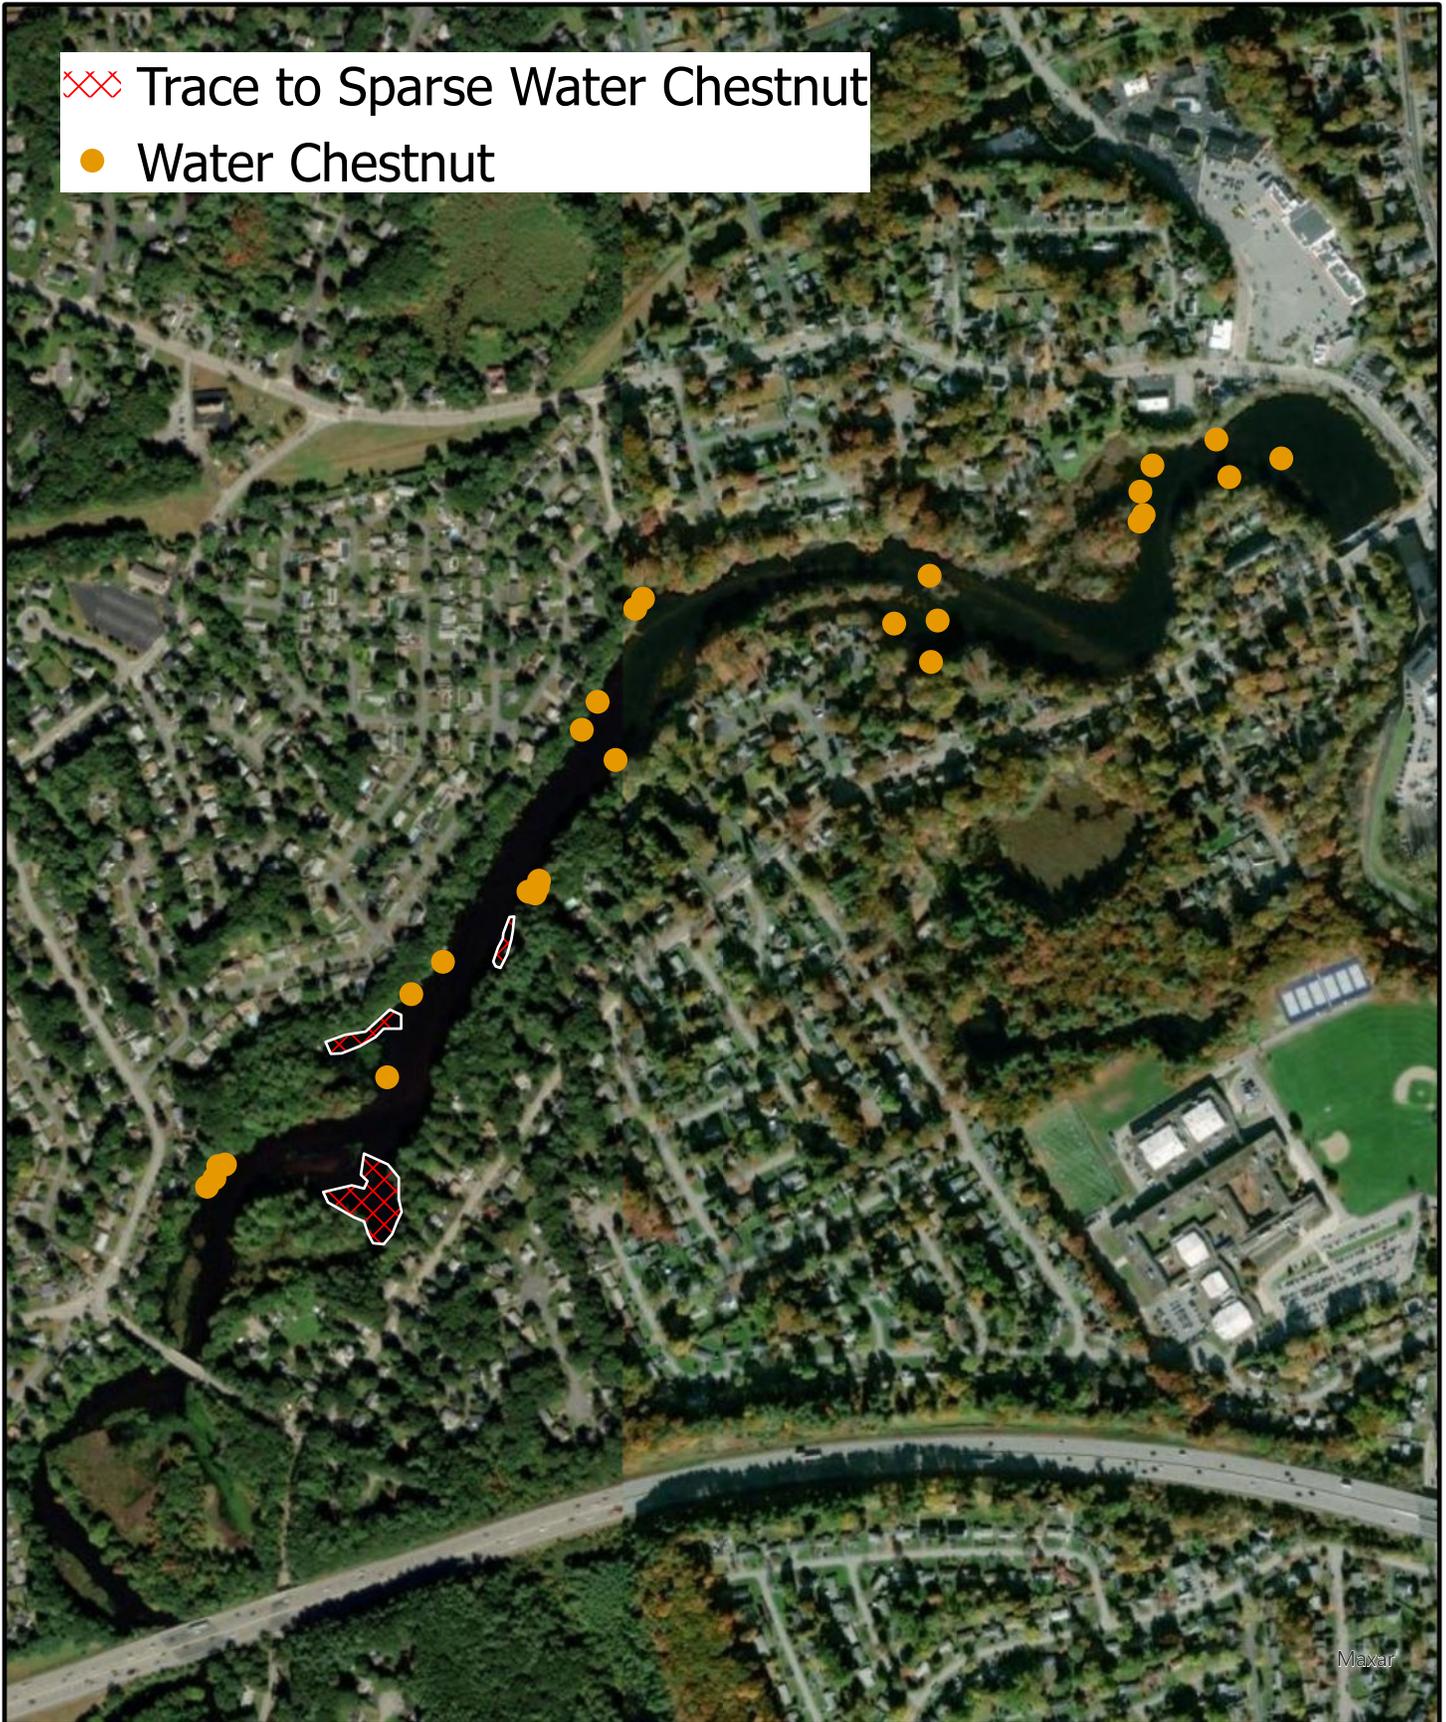
Water chestnut densities have been greatly reduced over the years within this stretch of the Sudbury River. Some chestnut was surfaced whereas some was still within the water column. The chestnut is scattered in fairly low density “clumps” or groupings. The water chestnut was predominantly located in the shallow, more stagnant areas. Several water chestnut seeds were observed floating on the surface of the water. Consistent with previous years, several other invasive species are also present within this stretch of the river including variable milfoil, Eurasian milfoil, fanwort, and curly-leaf pondweed. There was a strong presence of native waterlilies along the shoreline. Pollen was noted along the surface in various locations. Water samples were collected, preserved, and shipped to the lab for analysis.

Trace to Sparse Water Chestnut  
● Water Chestnut

Based on the survey, management of water chestnut is still recommended to prevent seeds from dropping and thus adding to the seed bed which has been depleted through several years of management. We anticipate treatment initially. In lieu of follow-ups, we recommend that the water chestnut be hand-pulled, which is similar to what we did during the 2023 season.
