## FIELD NOTES SUMMARY

**Customer:** City of Framingham  
**Pond Name:** Big Farm Pond  
**Site Location:** Framingham, MA  
**Date:** 5/29/24

**Customer:** City of Framingham  
**Pond Name:** Gleason Pond  
**Site Location:** Framingham, MA  
**Date:** 5/29/24

**Customer:** City of Framingham  
**Pond Name:** Learned Pond  
**Site Location:** Framingham, MA  
**Date:** 5/29/24

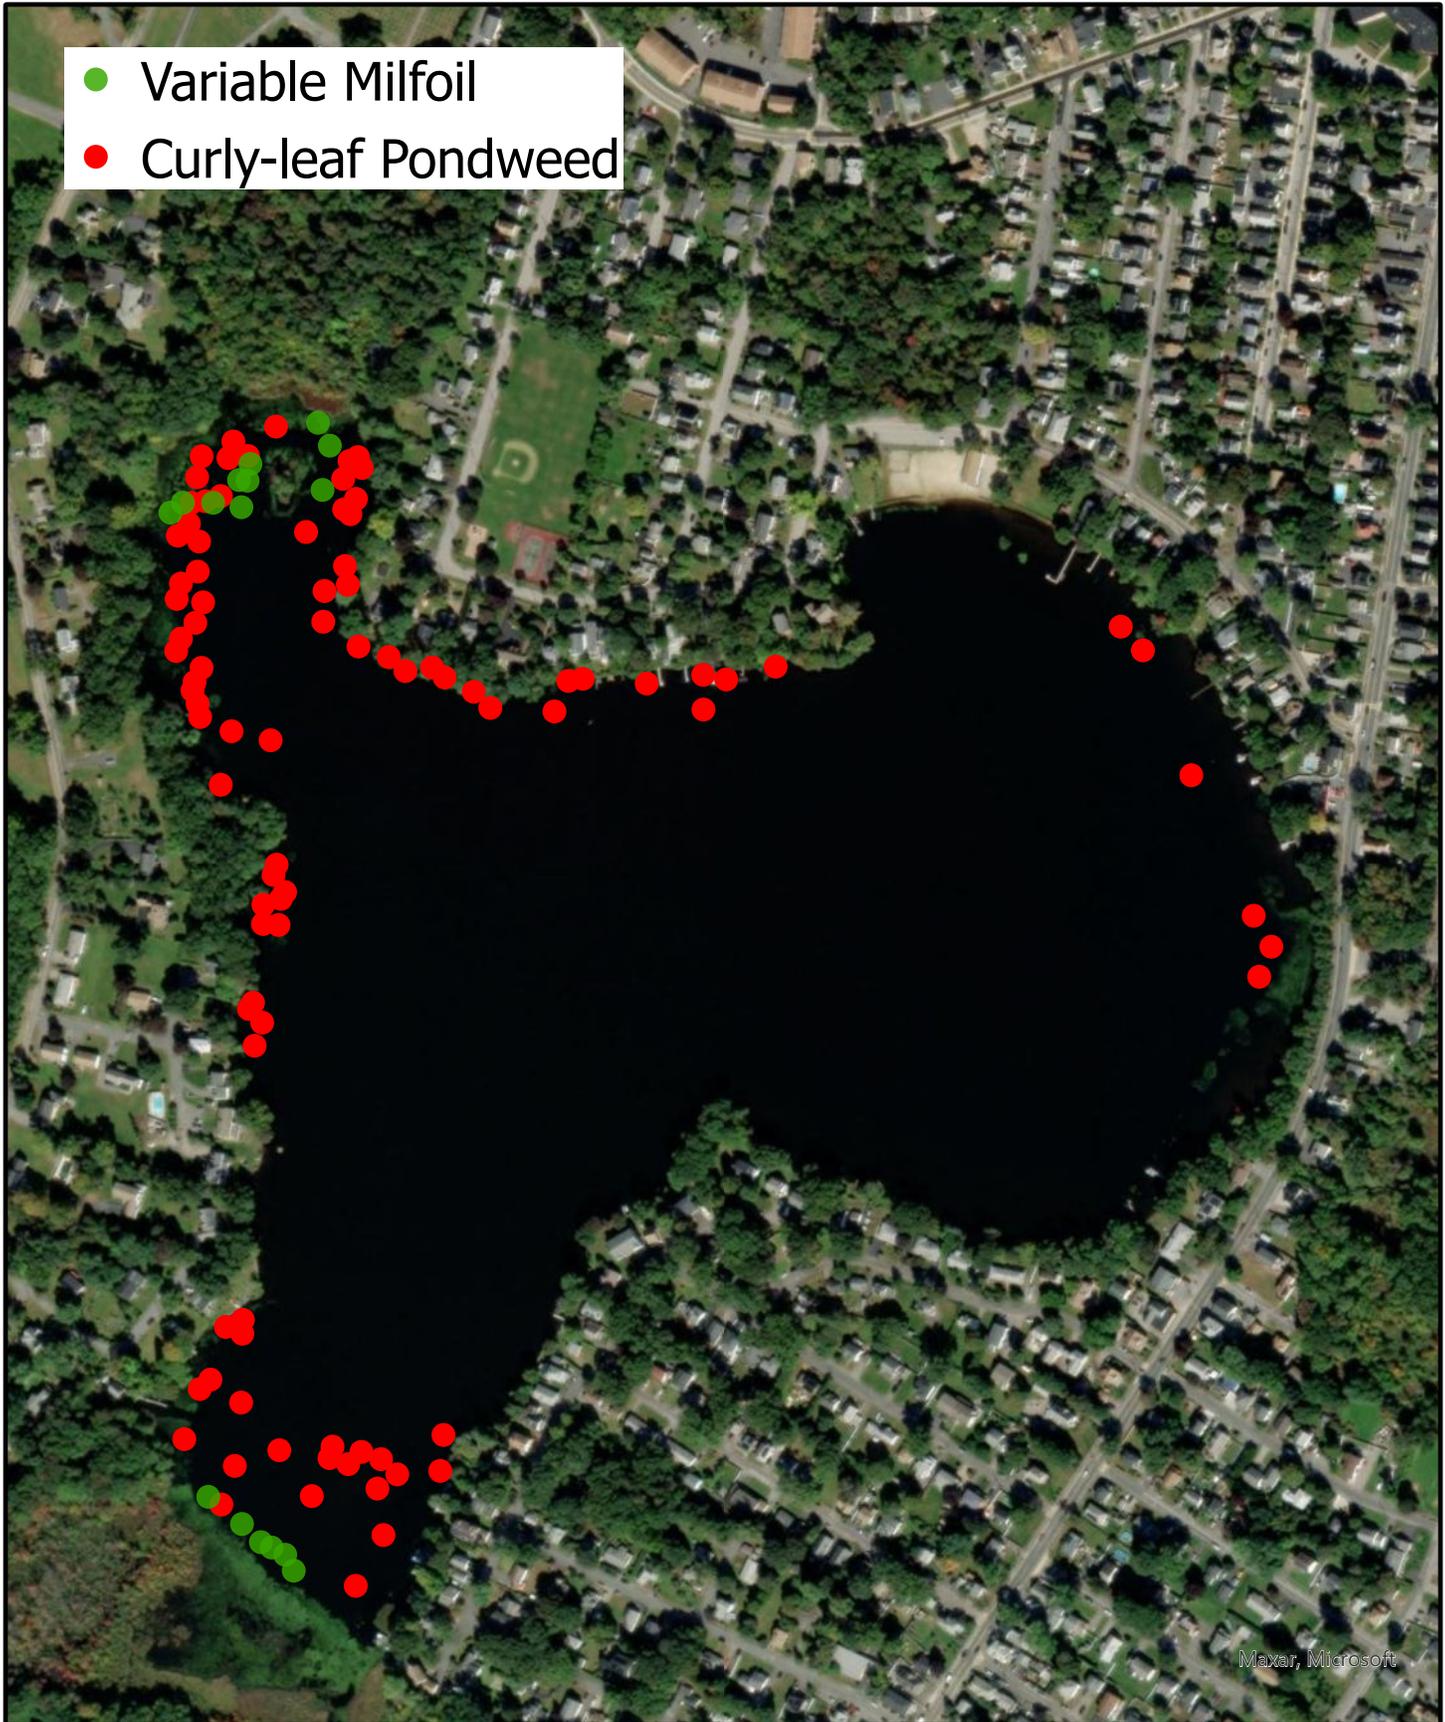
Consistent with historical records, two invasive species were documented during the survey. These include curly-leaf pondweed and variable milfoil. These species have expanded since 2023. Curly-leaf pondweed was the primary invasive species located throughout the littoral zone (see map). Many native species were observed including thin-leaf pondweed, elodea, clasping leaf pondweed, waterlilies, and coontail. Clasping leaf pondweed, coontail, and elodea were the most prominent species documented. Waterlilies were seen around the perimeter of the pond. Cattails were also noted at the shoreline in a handful of locations. Smartweed was also seen growing along the shoreline. Water samples were collected, preserved, and shipped to the lab for analysis. There were no signs of an algal bloom. Pollen was seen along wind-blown shorelines and should not be confused with microscopic algae.

- Variable Milfoil
- Curly-leaf Pondweed

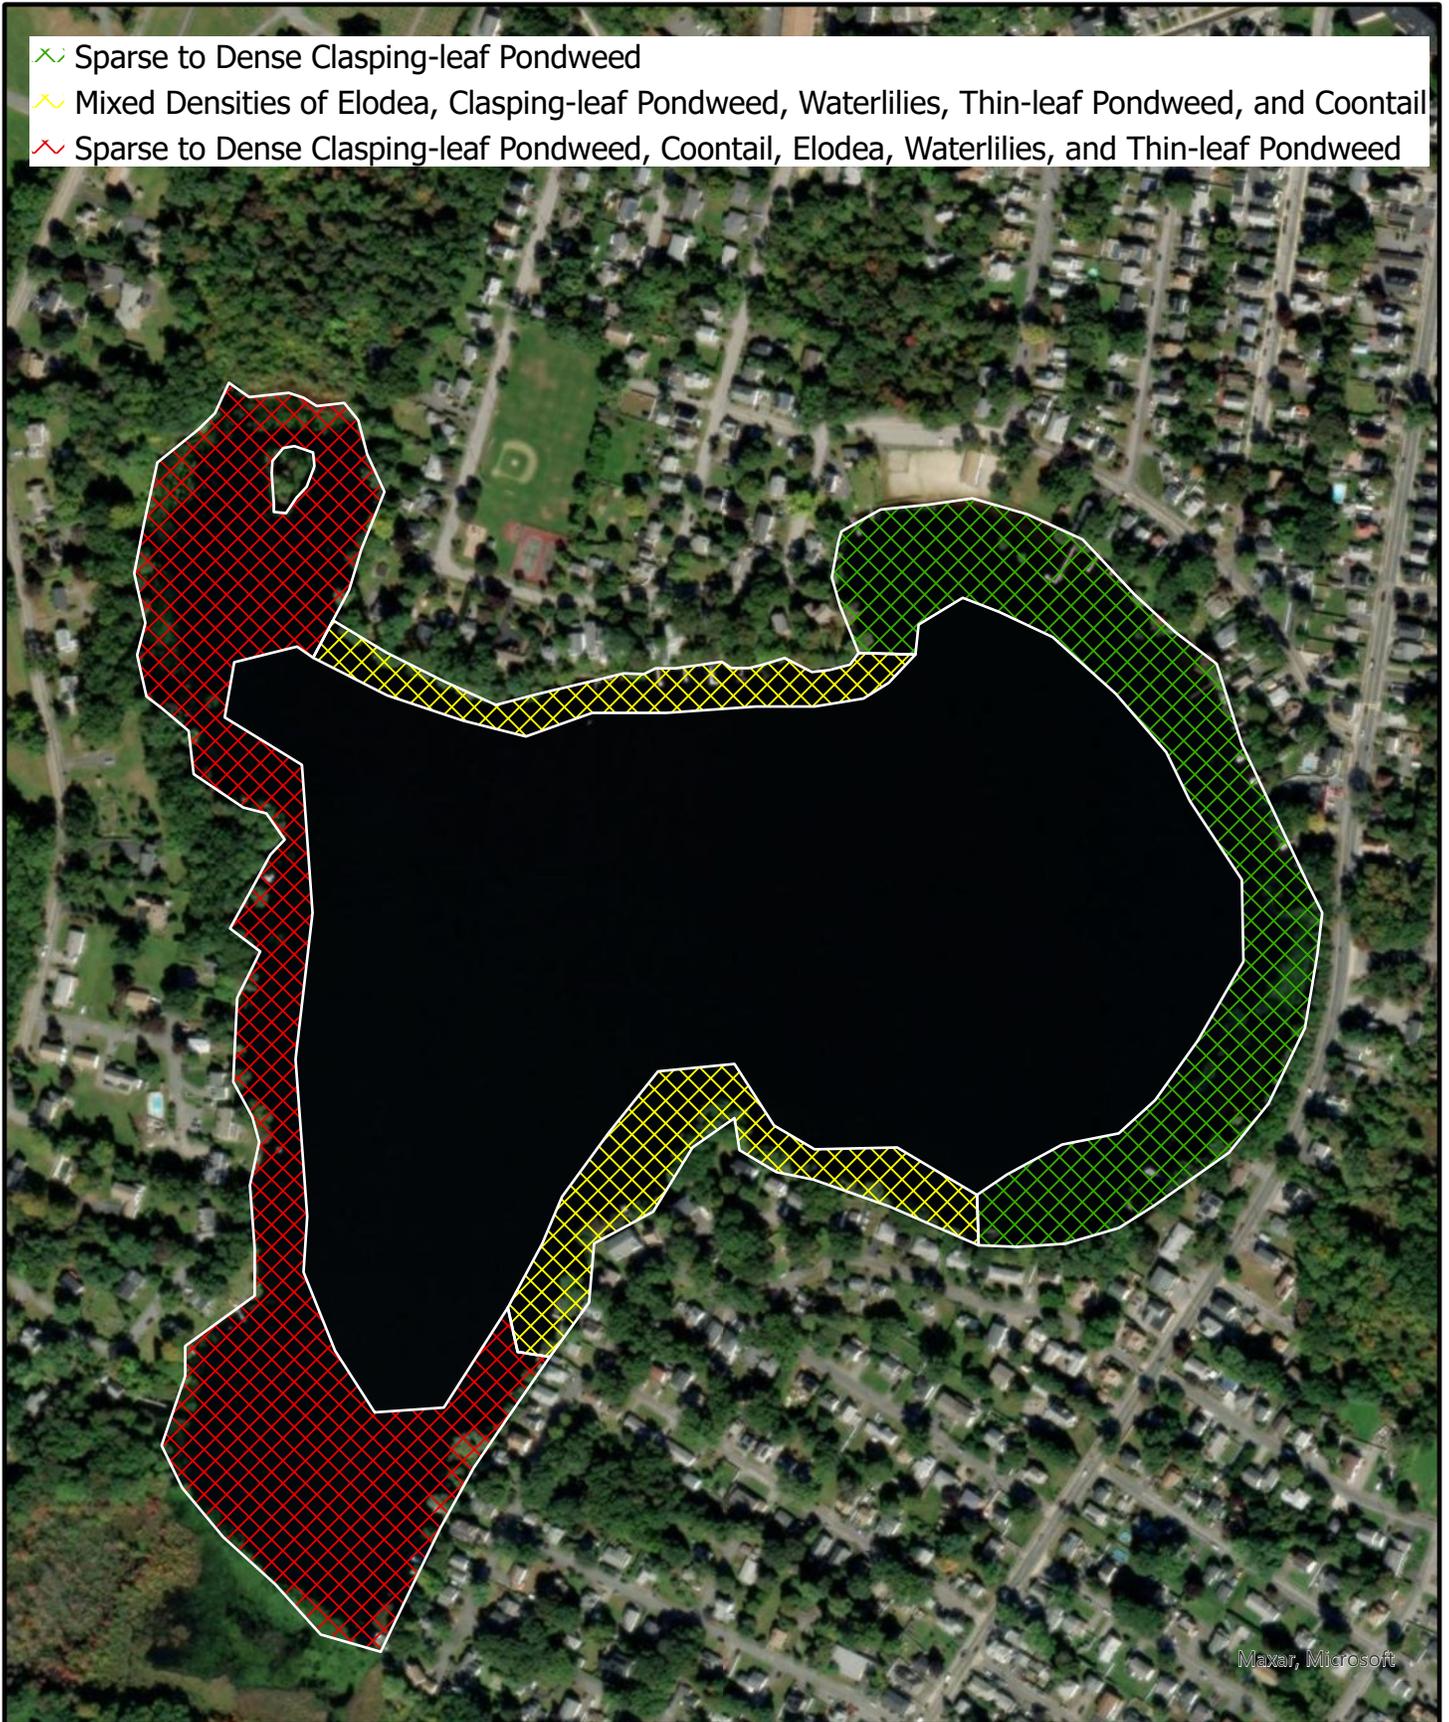
Sparse to Dense Claspingleaf Pondweed, Coontail, Elodea, Waterlilies, and Thin-leaf Pondweed
