FIELD NOTES SUMMARY

Customer: City of Framingham
Pond Name: Norton Pond
Site Location: Framingham, MA
Date: 7/30/24

Customer: City of Framingham
Pond Name: Mohawk Pond
Site Location: Framingham, MA
Date: 7/30/24

Customer: City of Framingham
Pond Name: Sudbury River
Site Location: Framingham, MA
Date: 7/30/24

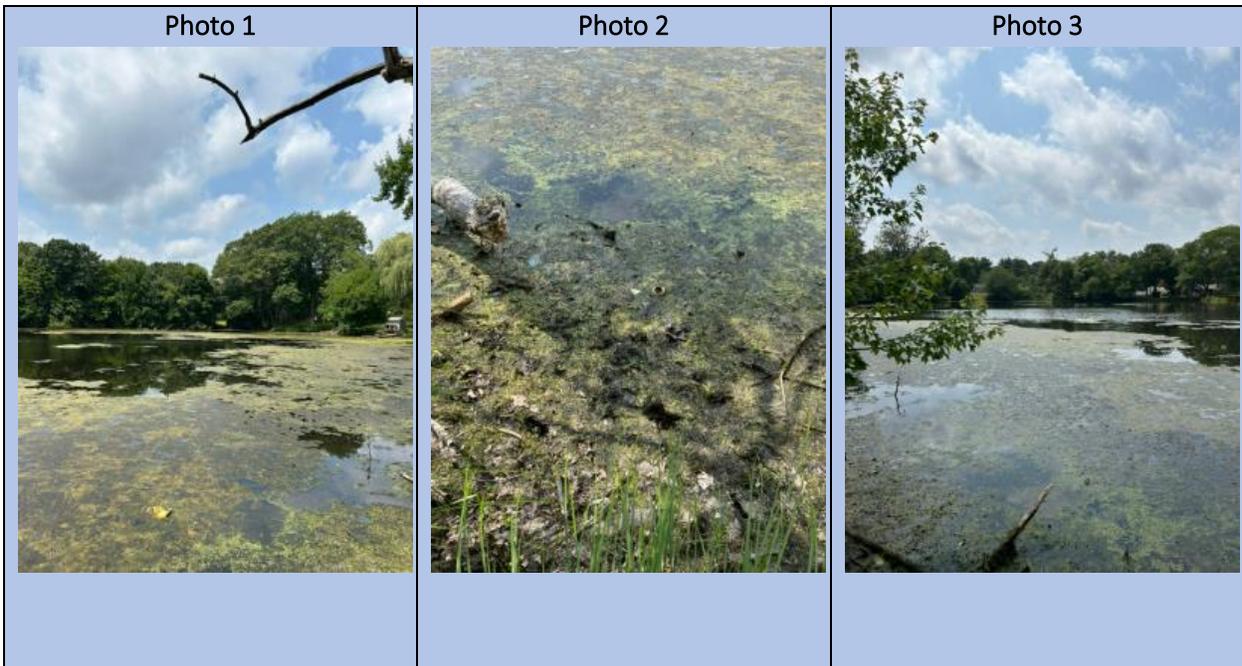
A site visit was conducted at Norton Pond to determine current condition and any upcoming management needs. Dense mats of filamentous algae were observed around the pond's perimeter, while the center remained largely free of algae with only a few scattered patches. Additionally, duckweed and watermeal were interspersed with the algae mats. An algae treatment is recommended for the next visit to address the algae bloom, treatment of nuisance watermeal and duckweed should be conducted at the same time.

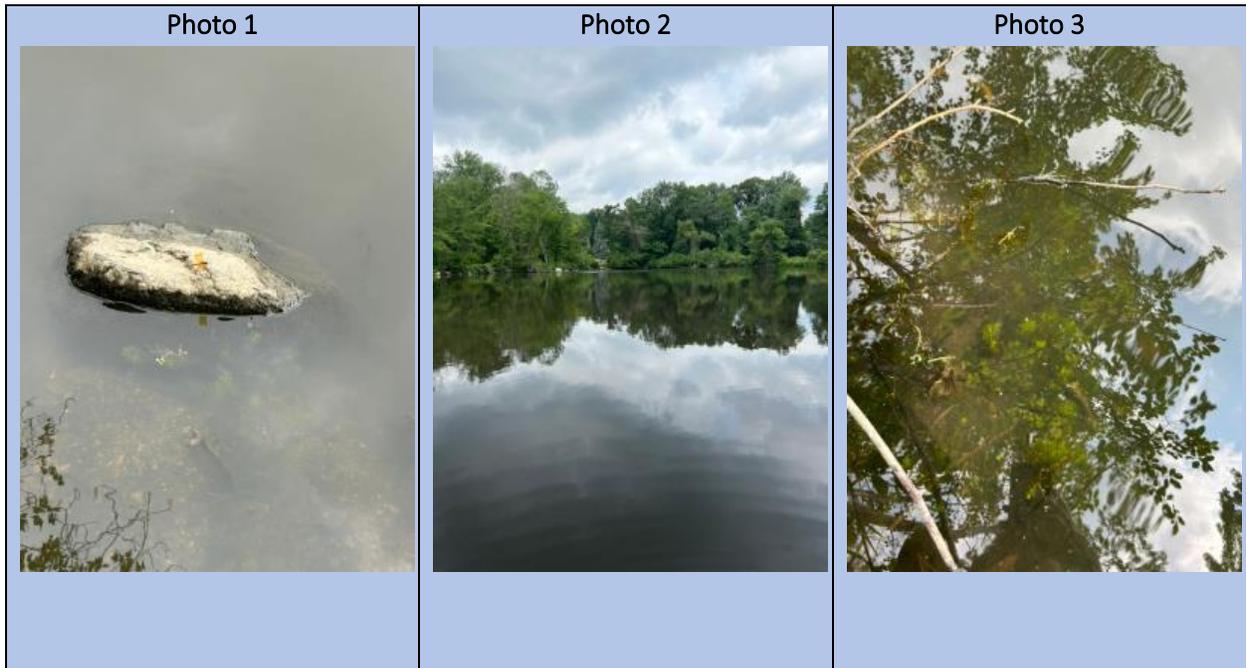
An interim visit was conducted at Mohawk Pond. The purpose of the visit was to assess the previous management and to determine upcoming/future management needs of the pond. The survey confirmed that the previous treatment successfully managed both filamentous algae and variable milfoil. Minimal regrowth of variable milfoil was observed (Photo 3), it does not warrant treatment at this time. The dissolved oxygen measurement indicated that the pond is in good health.

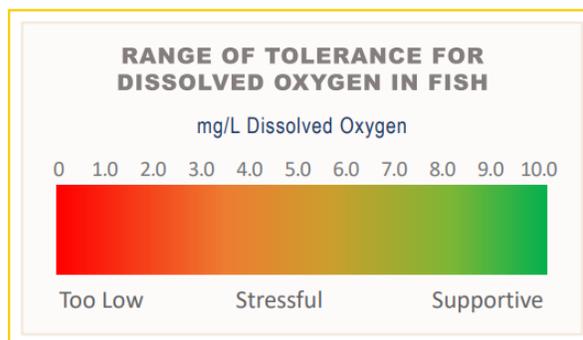
While on-site, dissolved oxygen (DO) and temperature readings were collected using a calibrated YSI meter with optical sensor. Dissolved oxygen is the amount of oxygen in water that is available to aquatic organisms. DO is necessary to support fish spawning, growth, and activity. Tolerance varies by species, but the figure below provides a general range of fish tolerance (Source: epa.gov).

Dissolved oxygen can be affected by many outside factors, such as: temperature, time of day, and pollution. Dissolved oxygen levels are typically lowest early in the morning. Healthy water should generally have concentrations of about 6.5-8+ mg/L.

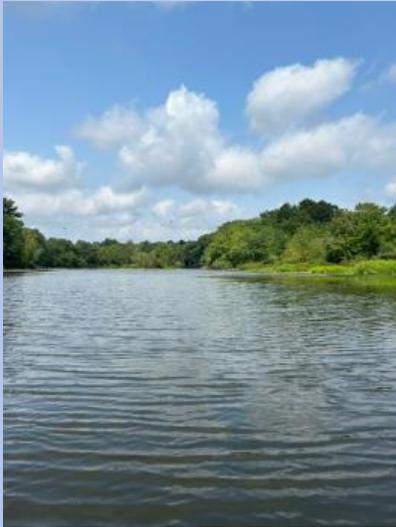
Photo 1

Additional Notes from the Biologist
<p>A site visit was conducted at the Sudbury River to evaluate water chestnut populations. The survey focused largely on water chestnut; however, we documented additional species during the visit. The survey indicated that the water chestnut remains at a level where hand pulling is an effective removal method. As the water chestnut seeds continue to develop and drop in August, it is important that removal of the water chestnut occurs as soon as possible. Additionally, fanwort was observed in high densities throughout most of the stretch of river, with some areas experiencing surface mats and flowering. Attached is a map showing the locations where water chestnut was found. We recommend that hand-pulling efforts be completed by mid-August. Should you need our assistance with hand-pulling, please let us know.</p>
