FIELD NOTES SUMMARY

Customer: The City of Framingham
Pond Name: Learned Pond
Site Location: Framingham, MA
Date: 5/27/25

Customer: The City of Framingham
Pond Name: Big Farm Pond
Site Location: Framingham, MA
Date: 5/27/25

Customer: The City of Framingham
Pond Name: Little Farm Pond
Site Location: Framingham, MA
Date: 5/27/25

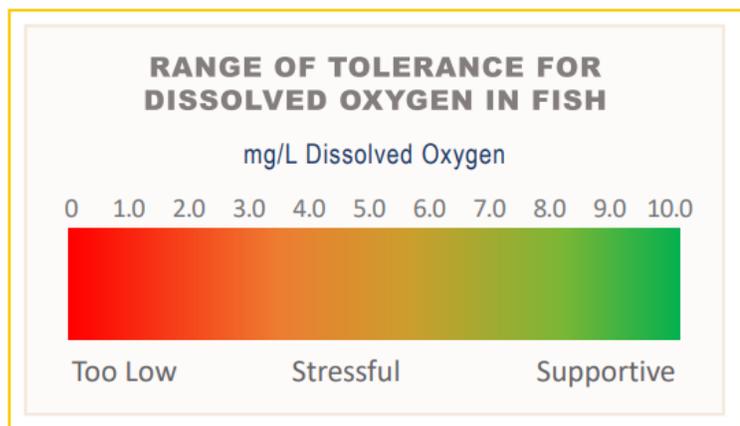
While on-site, dissolved oxygen (DO) and temperature readings were collected using a calibrated YSI meter with optical sensor. Dissolved oxygen is the amount of oxygen in water that is available to aquatic organisms. DO is necessary to support fish spawning, growth, and activity. Tolerance varies by species, but the figure below provides a general range of fish tolerance (Source: epa.gov). Dissolved oxygen can be affected by

many outside factors, such as: temperature, time of day, and pollution. Dissolved oxygen levels are typically lowest early in the morning. Healthy water should generally have concentrations of about 6.5-8+ mg/L.

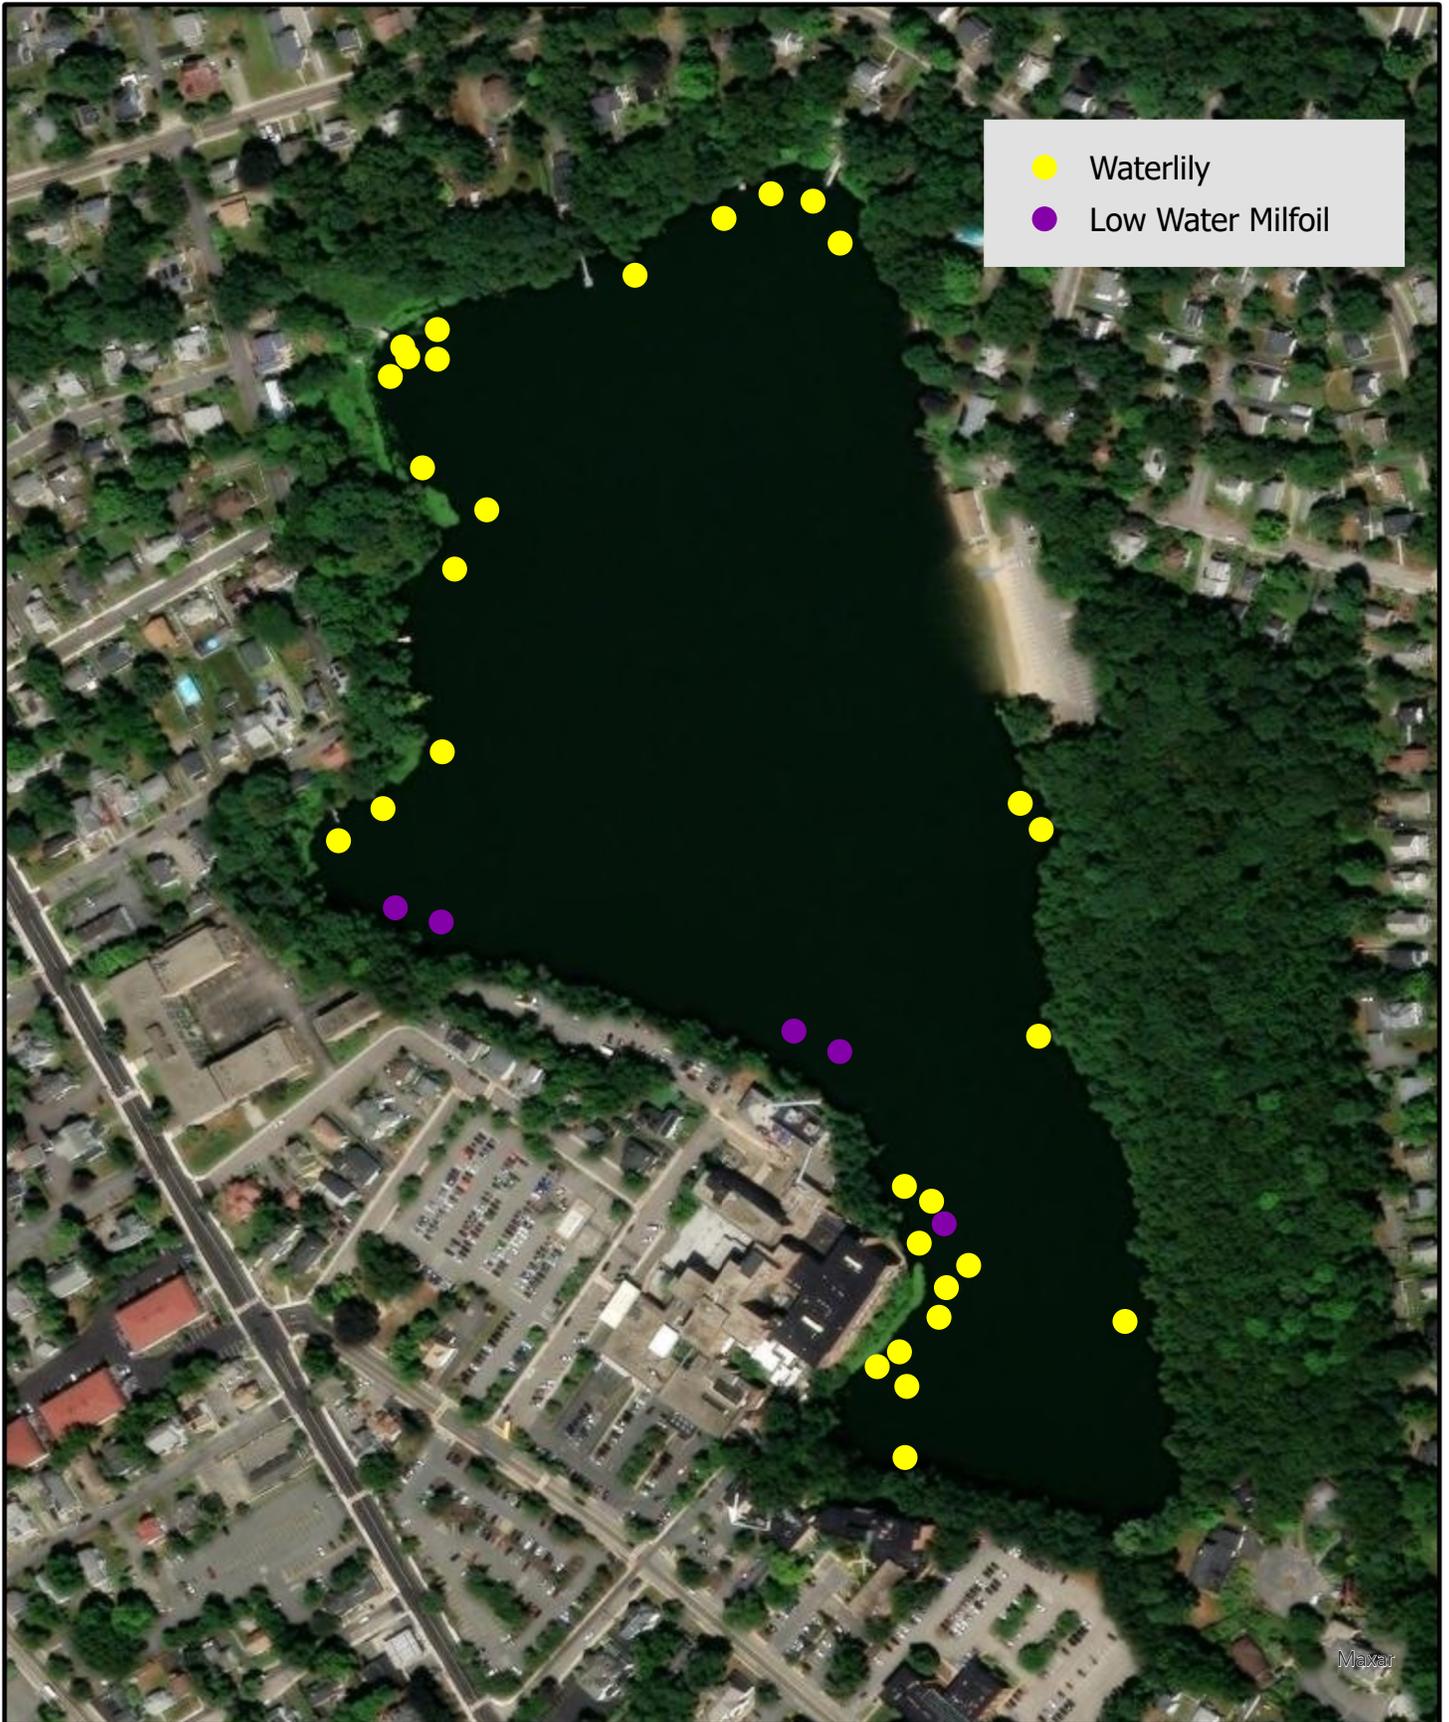
Learned Pond
Survey Map
Framingham, MA

The site visit consisted of collecting basic water quality data in addition to samples and completing a survey. The Learned Pond survey was conducted at 4:15 PM on Tuesday, May 27th, 2025. A few small groupings of cattails were present at the boat launch. Scarce, moderately sized patches of water lilies dotted the pond's perimeter. Benthic algae was observed in scattered densities within the littoral zone. Scattered, dense patches of low-water milfoil were observed at its characteristic depth when moving along the pond's western/southwestern perimeter. No overly significant nuisance vegetation was observed otherwise. The northern edge of the pond was especially sparse. No surface algal blooms were observed at the time of visit.

- Waterlily
- Low Water Milfoil

Water clarity was above average at the time of visit. Based on the survey data collected, we do not recommend treatment at this time.

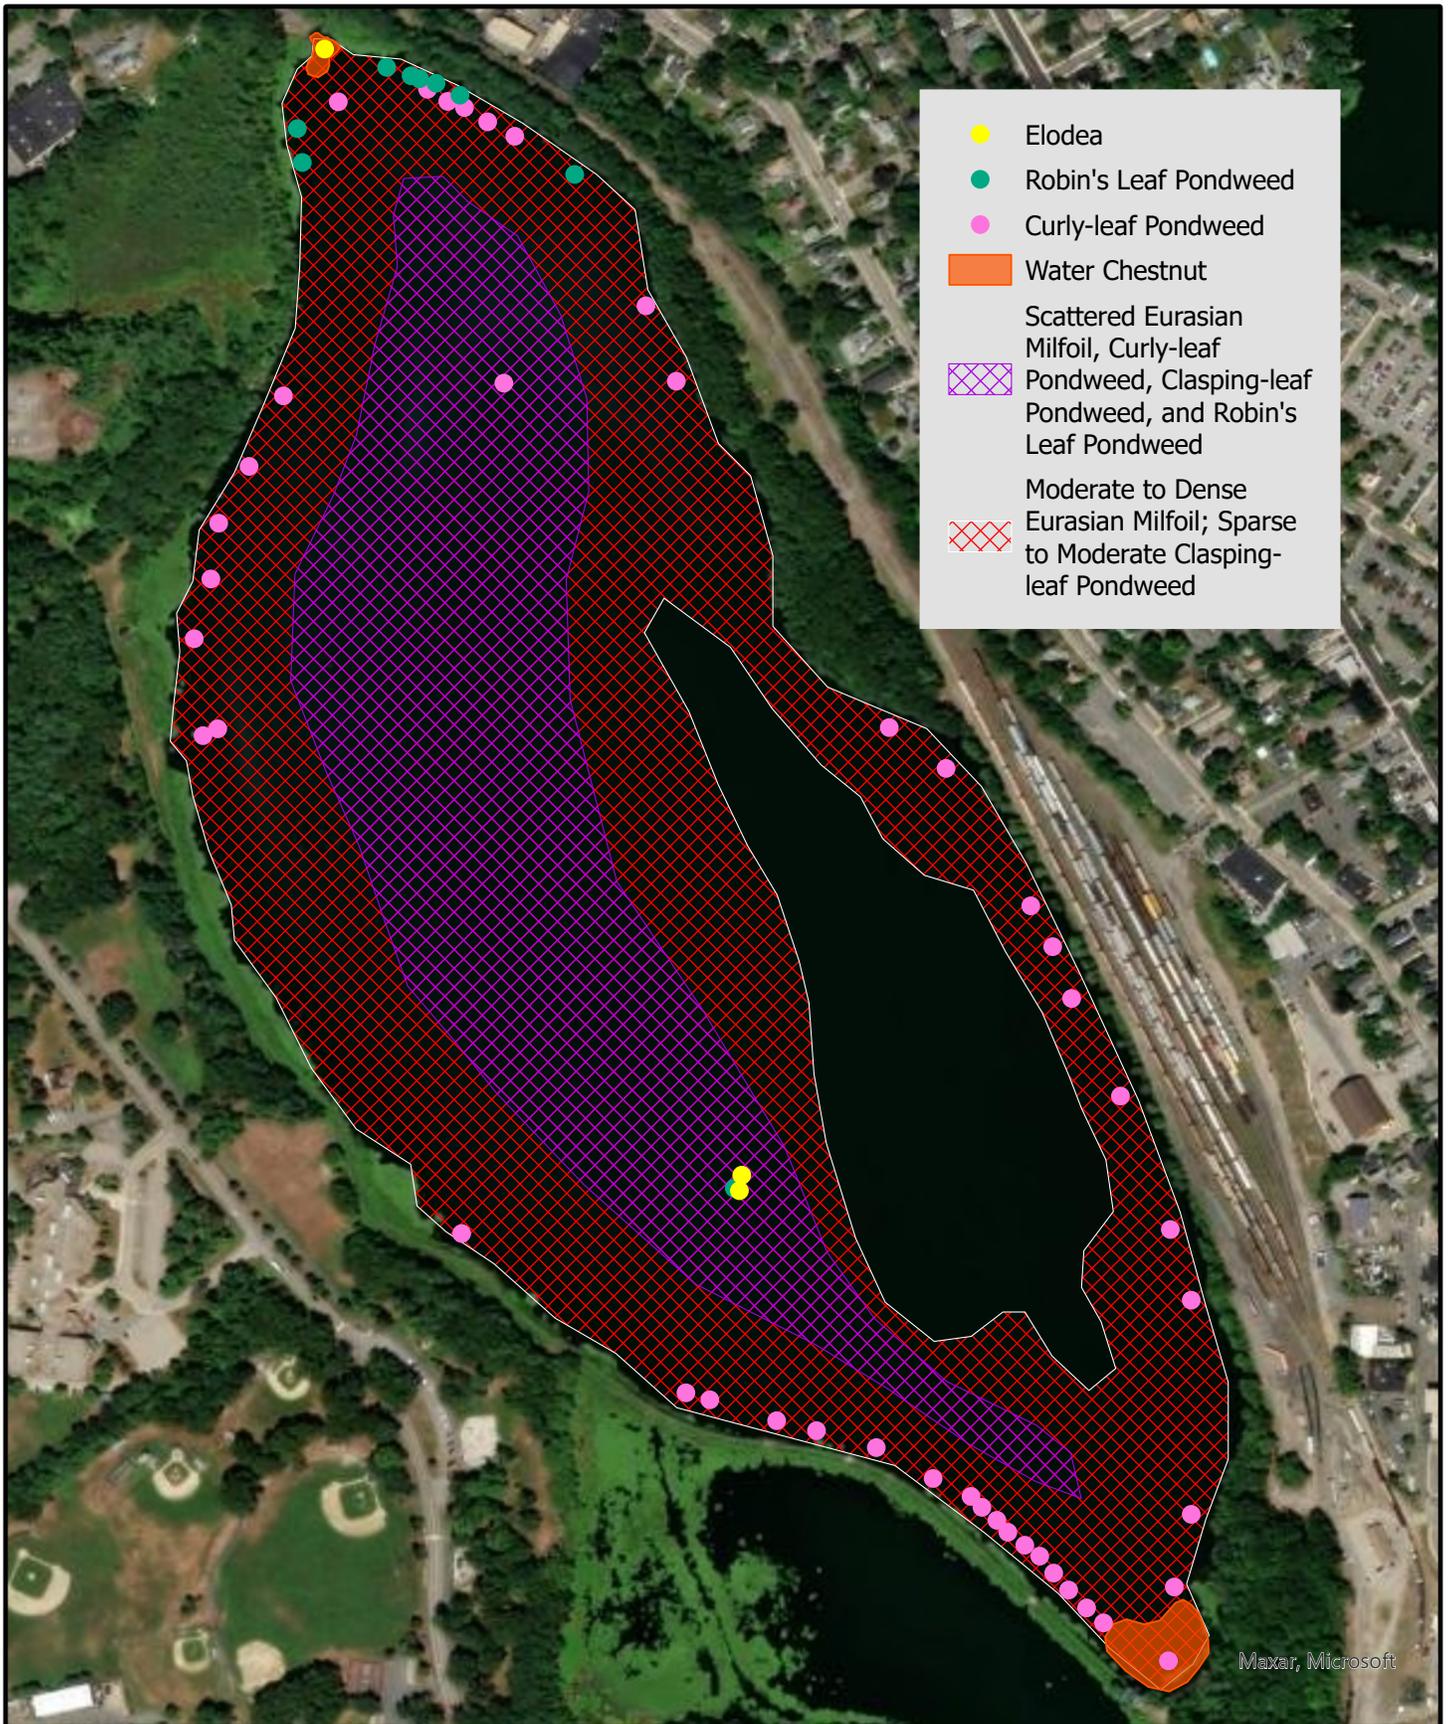
Scattered patches of varying densities of several different species were mixed in with each other at a high density along the pond's littoral zone. The most dominant species included curly-leaf pondweed, Eurasian milfoil, Robbins pondweed, clasping-leaf pondweed, elodea, and water chestnut. In addition, curly-leaf and Eurasian milfoil were observed extending into the pond's mid-section. A few small pockets of coontail were also observed within these stands. Aquatic species density began to drop off moving southward, with Eurasian milfoil becoming extremely prominent towards the southeastern perimeter, along with a few small sections of curly-leaf pondweed. Young cattails were observed mixed in with water lilies along the western/southwestern perimeter. A few small patches of broadleaf arrowhead were observed towards the boat launch and the western bank.

No significant algal blooms were observed. Water clarity was average at the time of visit. Given the Natural Heritage Endangered Species Program restrictions, no management will occur in 2025. It is worth considering hand-pulling of water chestnut if NHESP allows. Water chestnut spreads rapidly and requires long-term management given the reproductive cycle of this plant. If managed before further spread, it will help long-term and allow for hand-pulling of this species to continue in lieu of treatment.

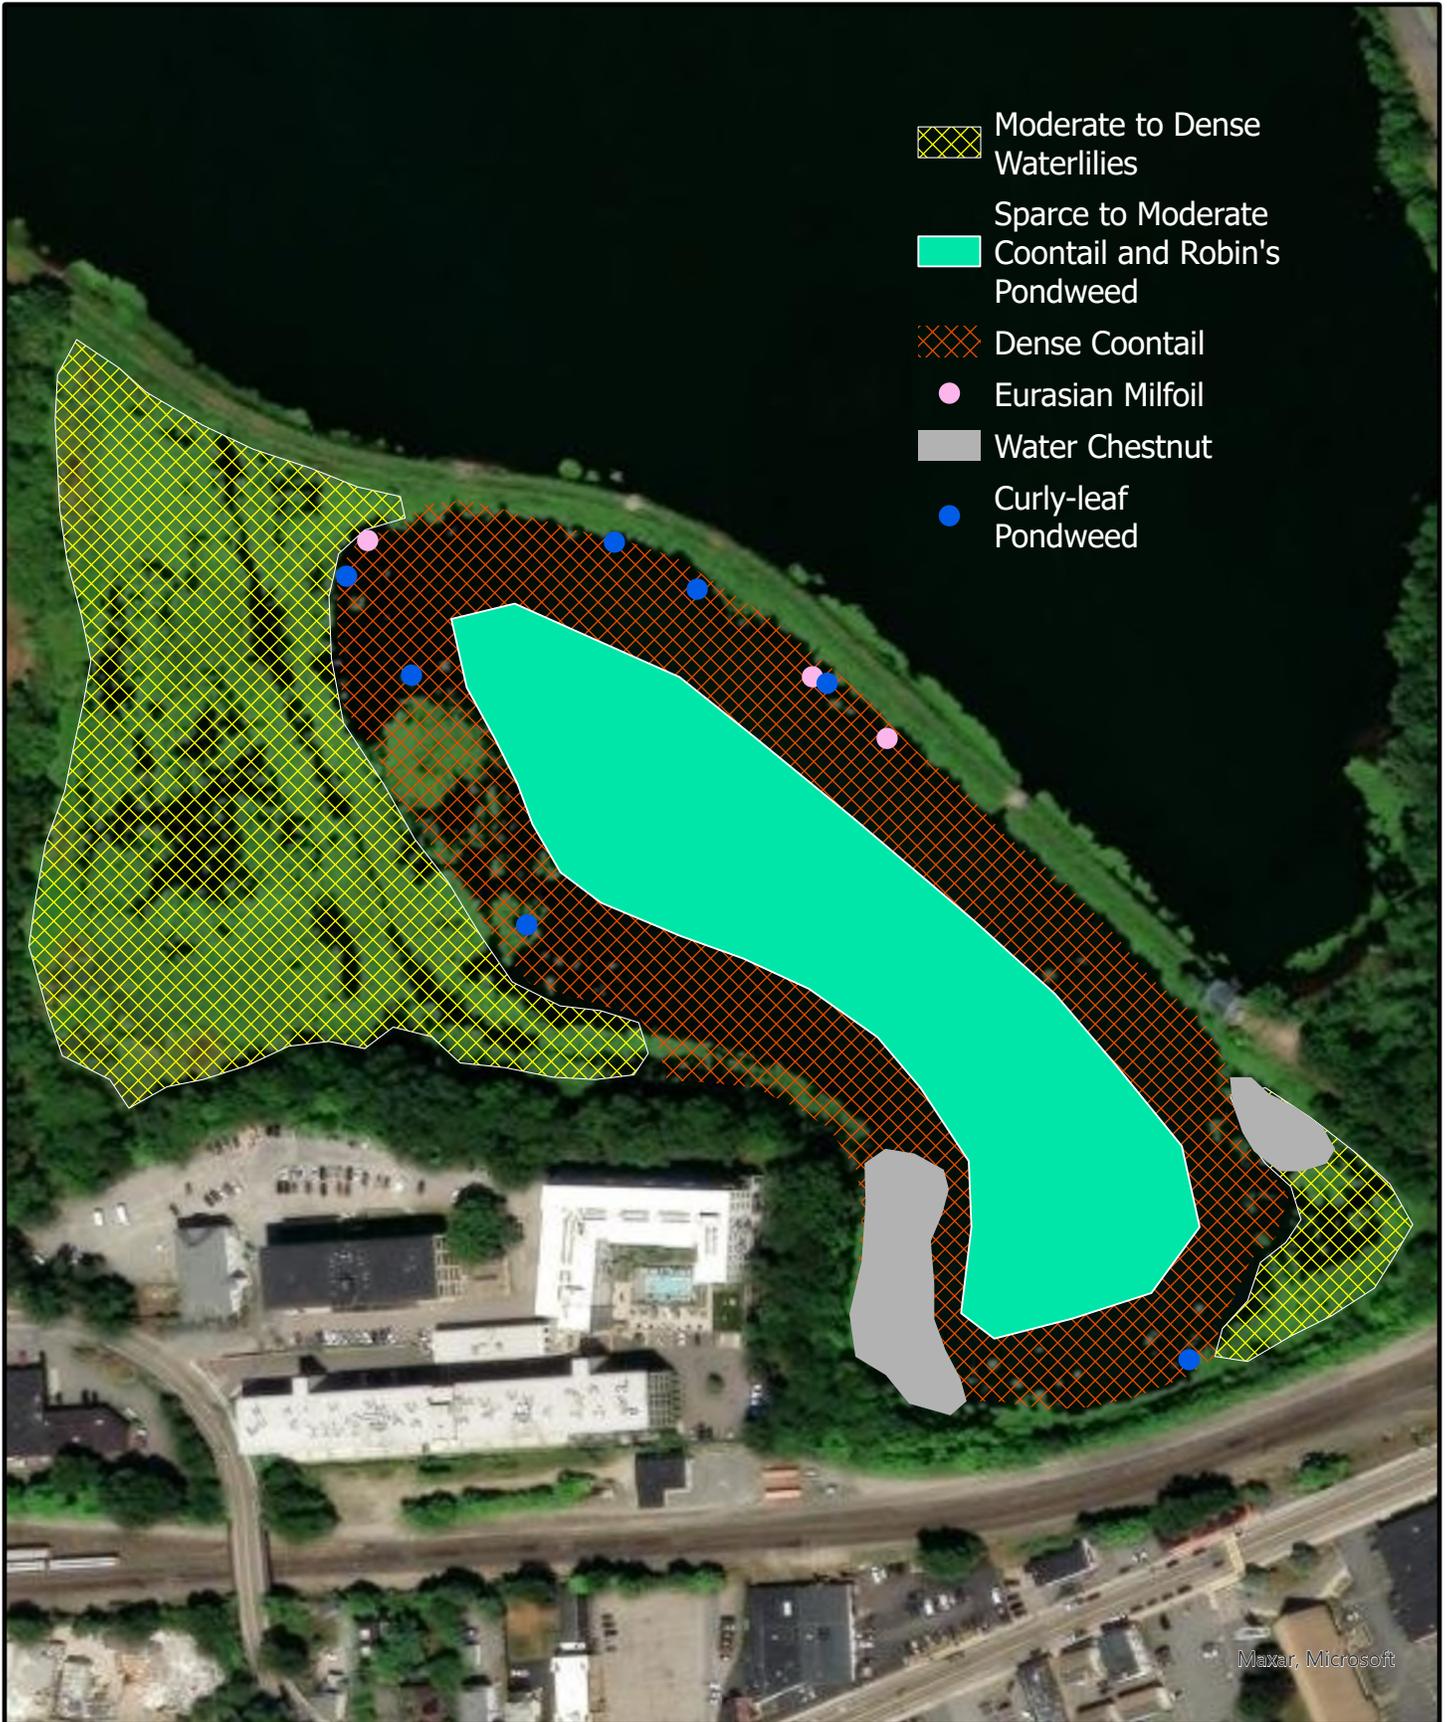
The site visit consisted of conducting a survey in addition to collecting basic water quality data and water samples. The vegetation assemblage was fairly similar to that of previous years. Highly dense stands of Robbins pondweed and coontail dominated the pond's littoral zone with 60-70% coverage overall. Eurasian milfoil and curly-leaf pondweed were found in sparse, scattered densities along the pond's perimeter. Waterlilies dotted the perimeter of the pond with a large concentration on the southwestern edge. Only a few sparse, small patches of filamentous algae and water chestnut were observed throughout the whole pond.

Due to Natural Heritage Endangered Species Program restrictions, no management will occur in 2025. At a minimum, consideration should be given to seeking NHESP approval to allow for hand-pulling of the invasive water chestnut. If this approval is gained, this could likely be completed by volunteers.

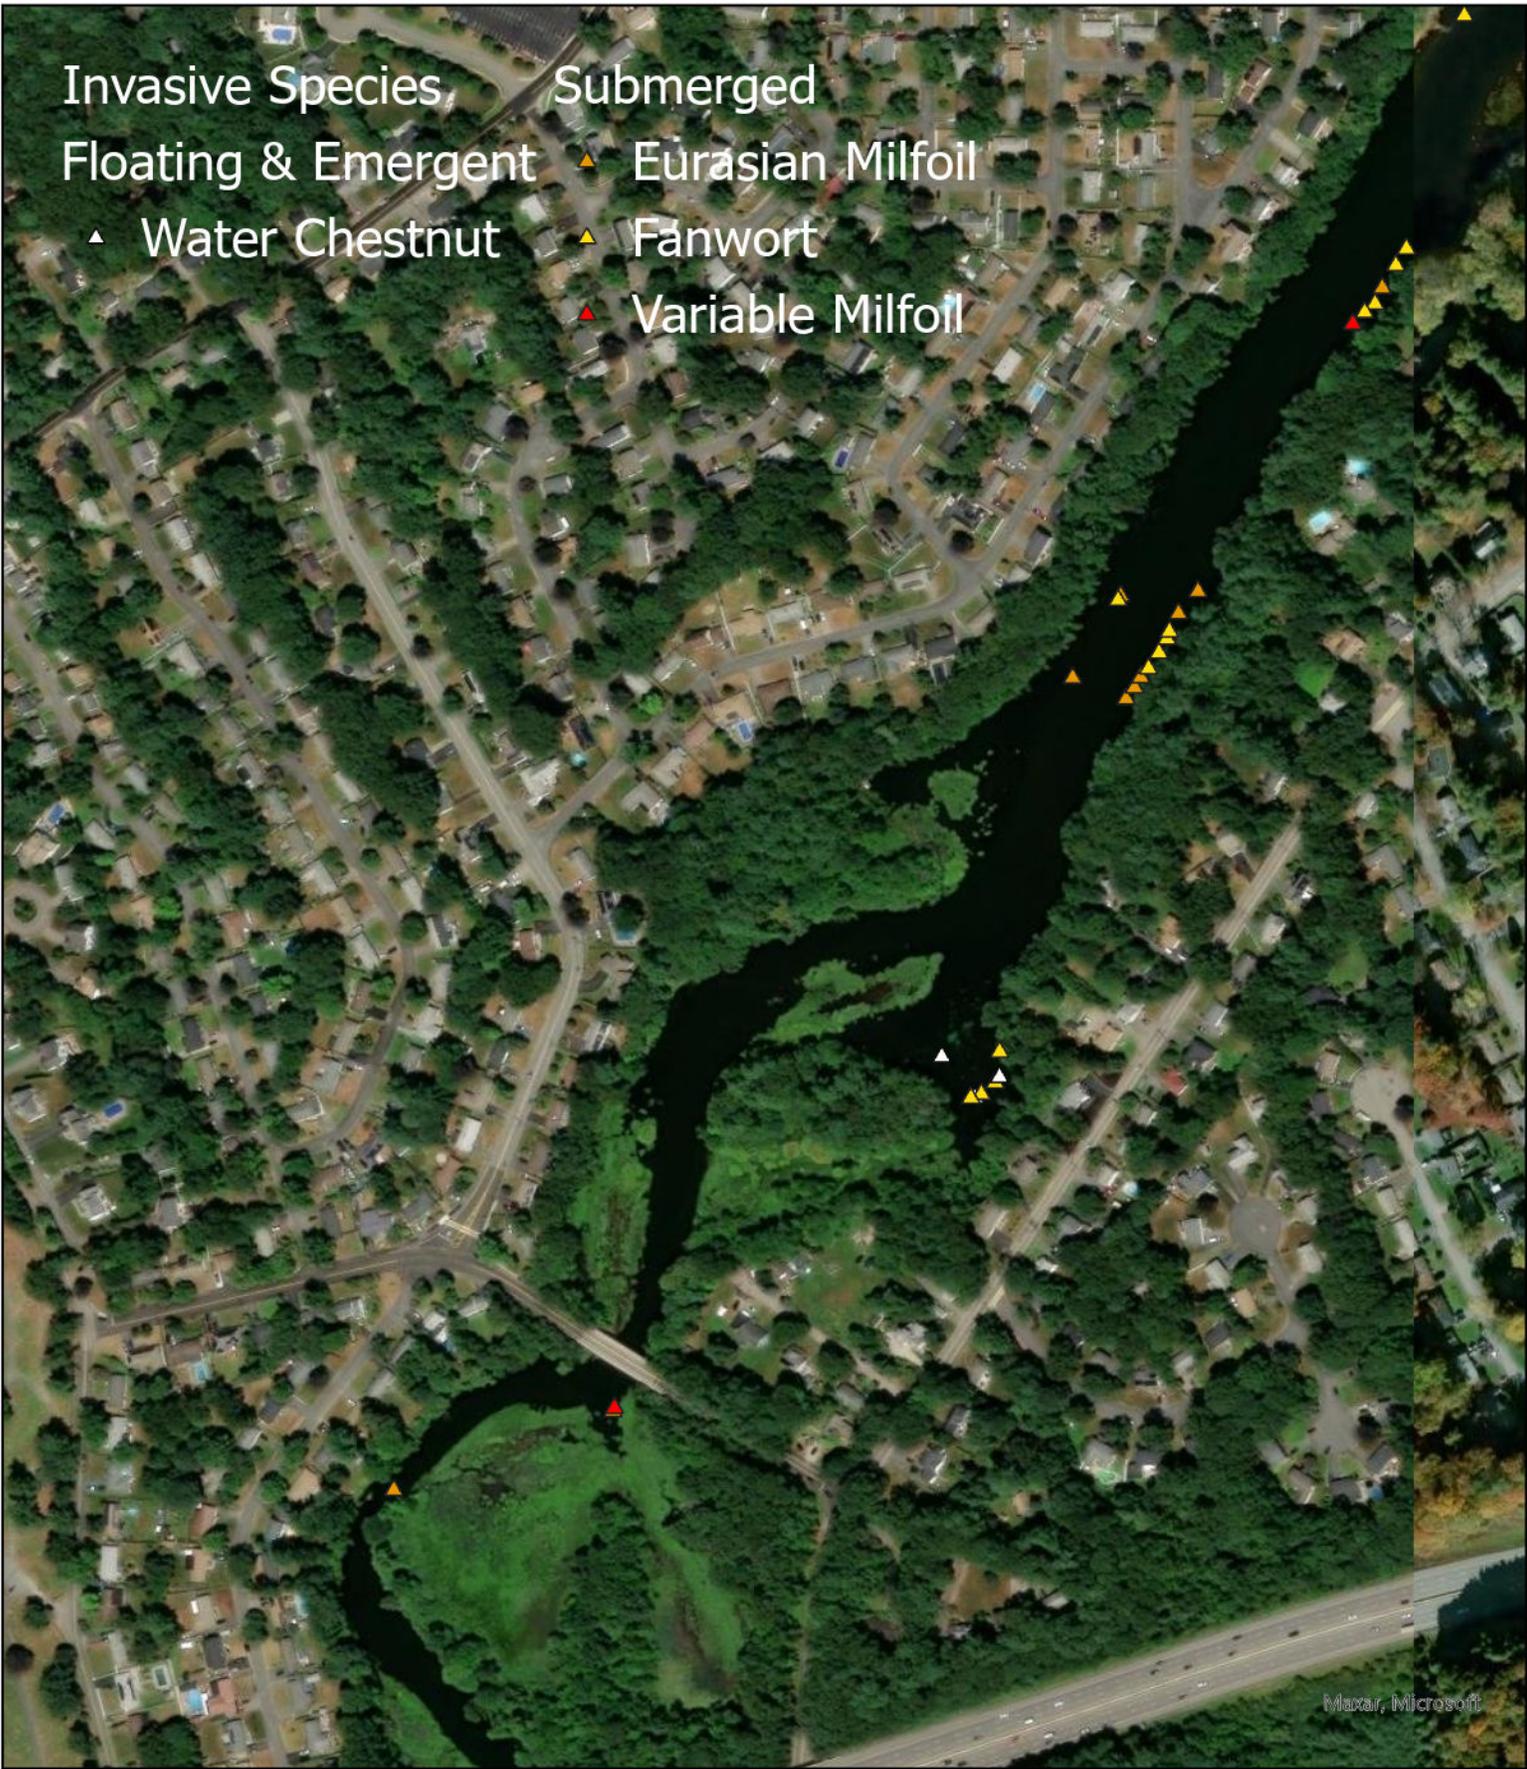
Sudbury River (Framingham)
Vegetation Assemblage
Framingham, MA

The Sudbury River survey was conducted at 2:30 PM on Tuesday, May 27th, 2025. The littoral zone of the pond was dominated by large, dense patches of fanwort which spread throughout the littoral zone. Small, scarce patches of variable and Eurasian milfoil were mixed in with the fanwort stands. Water chestnut was primarily observed towards the pond's northeastern edges. Small, dense patches of arrowhead lined the northern perimeters of the pond accompanied by several stretches of duckweed. Sparse, but moderate-sized patches of smartweed and cattails were found at multiple shoreline locations. Large, dense patches of waterlilies were observed primarily on the pond's southern perimeter. Nuisance vegetation densities began to drop off moving southward, disappearing almost entirely just before the interstate bridge. A small patch of elodea was observed on the pond's southwestern edge.

Invasive Species,
Floating & Emergent
▲ Water Chestnut

Submerged
▲ Eurasian Milfoil
▲ Fanwort
▲ Variable Milfoil

No significant algal blooms were observed. Water clarity was average at the time of visit. We recommend the management of water chestnut to continue, through either treatment or hand-pulling. The methodology of management will be confirmed upon arrival for the following site visit, which will consist of a brief survey prior to management.
