FIELD NOTES SUMMARY

Customer: City of Framingham
Pond Name: Gleason Pond
Site Location: Framingham, MA
Date: 6/19/25

Customer: City of Framingham
Pond Name: Sudbury River
Site Location: Framingham, MA
Date: 6/19/25

Customer: City of Framingham
Pond Name: Norton Pond
Site Location: Framingham, MA
Date: 6/19/25

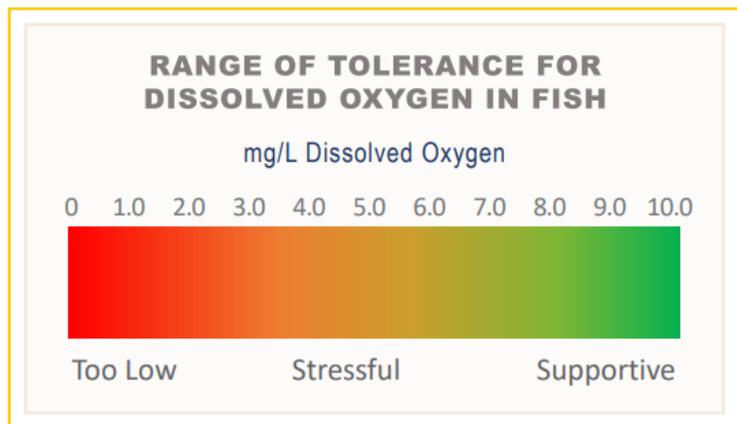
While on-site, dissolved oxygen (DO) and temperature readings were collected using a calibrated YSI meter with optical sensor. Dissolved oxygen is the amount of oxygen in water that is available to aquatic organisms. DO is necessary to support fish spawning, growth, and activity. Tolerance varies by species, but the figure below provides a general range of fish tolerance (Source: epa.gov).

Dissolved oxygen can be affected by many outside factors, such as: temperature, time of day, and pollution. Dissolved oxygen levels are typically lowest early in the morning. Healthy water should generally have concentrations of about 6.5-8+ mg/L.

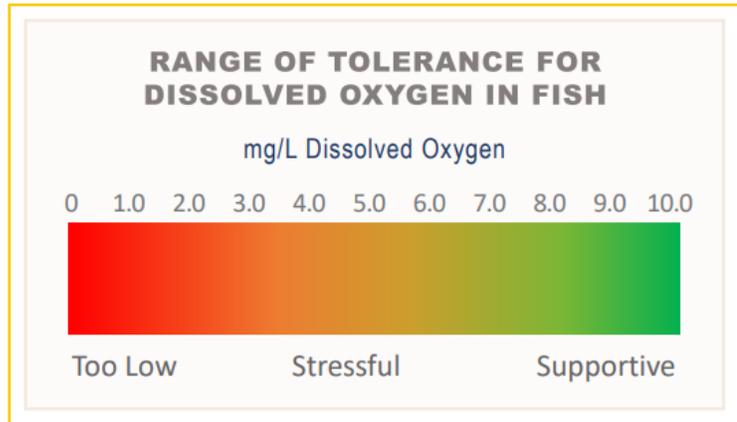
While on-site, dissolved oxygen (DO) and temperature readings were collected using a calibrated YSI meter with optical sensor. Dissolved oxygen is the amount of oxygen in water that is available to aquatic organisms. DO is necessary to support fish spawning, growth, and activity. Tolerance varies by species, but the figure below provides a general range of fish tolerance (Source: epa.gov). Dissolved oxygen can be affected by many outside factors, such as: temperature, time of day, and pollution. Dissolved oxygen levels are typically lowest early in the morning. Healthy water should generally have concentrations of about 6.5-8+ mg/L.

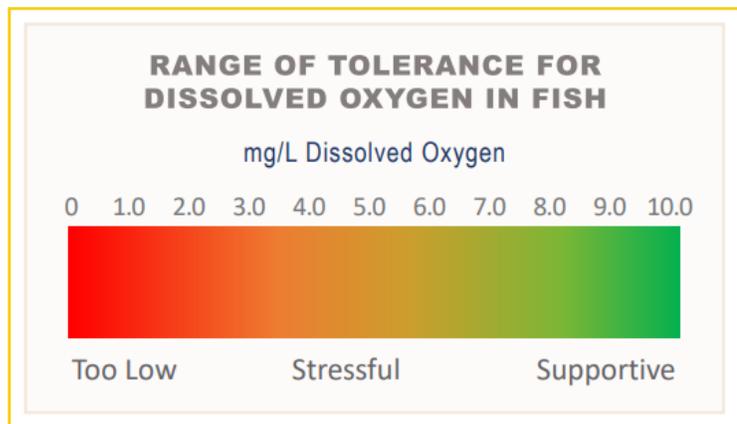
While on-site, dissolved oxygen (DO) and temperature readings were collected using a calibrated YSI meter with optical sensor. Dissolved oxygen is the amount of oxygen in water that is available to aquatic organisms. DO is necessary to support fish spawning, growth, and activity. Tolerance varies by species, but the figure below provides a general range of fish tolerance (Source: epa.gov). Dissolved oxygen can be affected by many outside factors, such as: temperature, time of day, and pollution. Dissolved oxygen levels are typically lowest early in the morning. Healthy water should generally have concentrations of about 6.5-8+ mg/L.

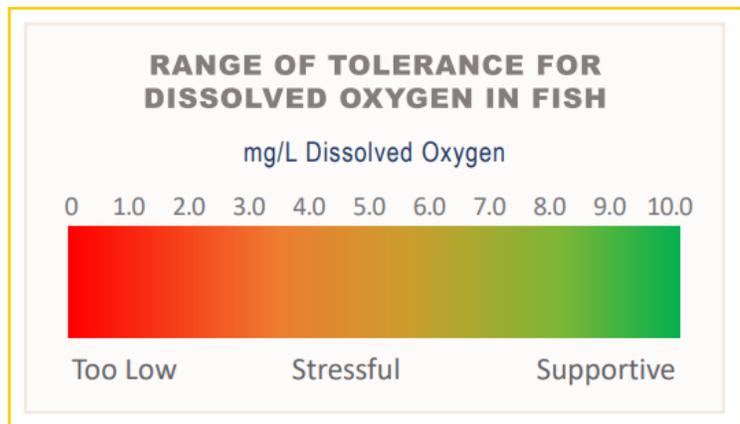
While on-site, dissolved oxygen (DO) and temperature readings were collected using a calibrated YSI meter with optical sensor. Dissolved oxygen is the amount of oxygen in water that is available to aquatic organisms. DO is necessary to support fish spawning, growth, and activity. Tolerance varies by species, but the figure below provides a general range of fish tolerance (Source: epa.gov). Dissolved oxygen can be affected by many outside factors, such as: temperature, time of day, and pollution. Dissolved oxygen levels are typically lowest early in the morning. Healthy water should generally have concentrations of about 6.5-8+ mg/L.
