**CITY OF FRAMINGHAM
CAPITAL PROJECT/EQUIPMENT REQUEST - FY2025-2034 CIP**

<p>AFLUO Company</p>	<p>PROJECT</p> <p>Town of Framingham Roof Survey</p> <p>Memorial Building</p> <p>150 Concord Street, Framingham, MA</p>	<p>SCALE:</p> <p>AS NOTED</p>
		<p>DATE:</p> <p>21 JUNE 2013</p>

Framingham Fire Station #7
789 Water Street

(ROOF INSPECTION DATA – INTERIM/PRELIMINARY REPORT)

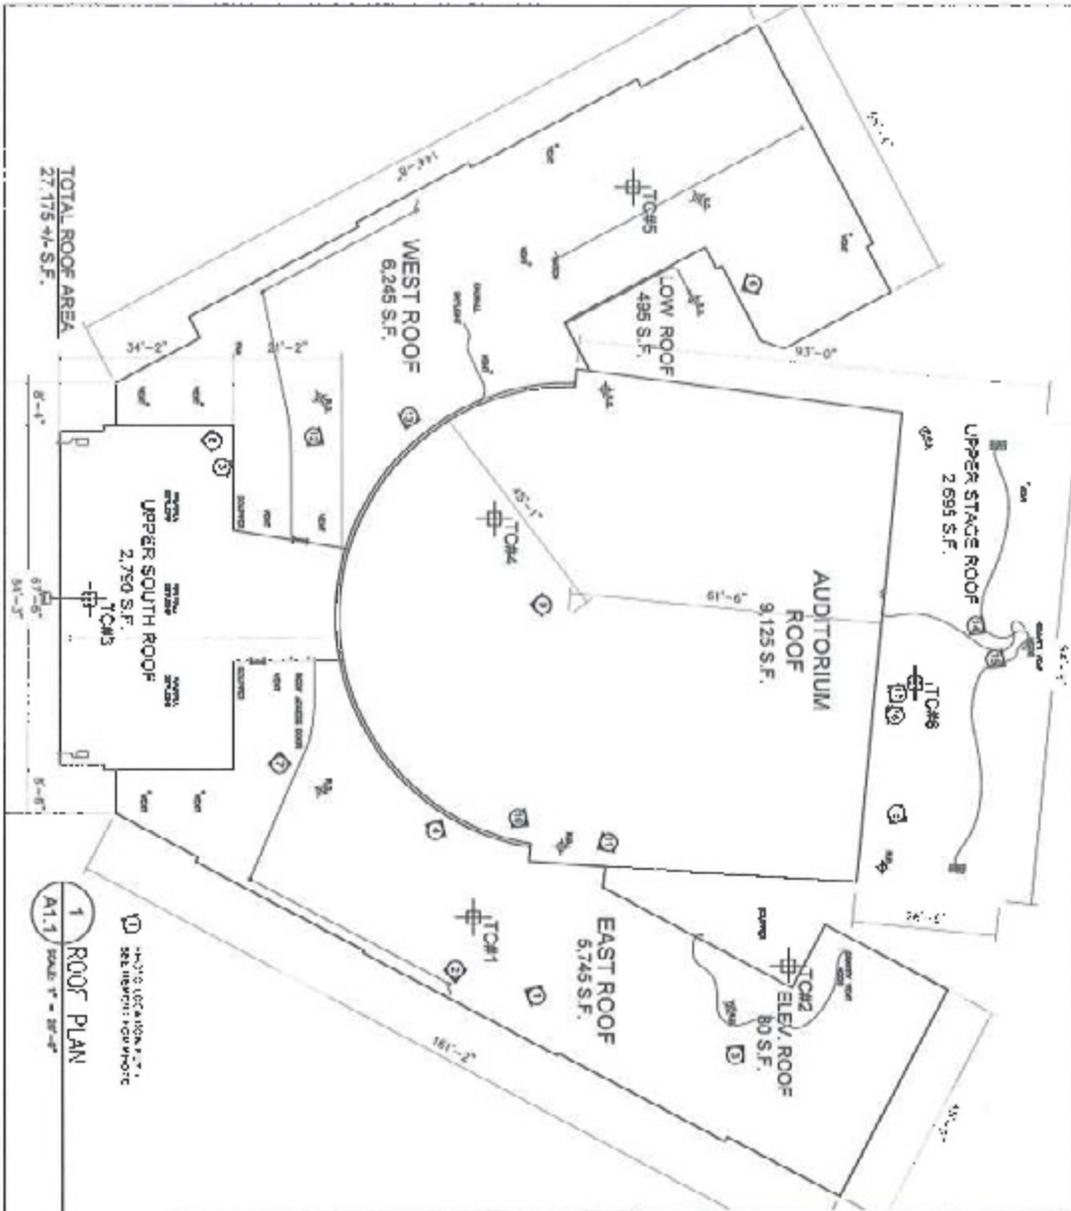
1 ROOF PLAN
A1.1 SCALE: 1" = 32'-0"

TOWN OF FRAMINGHAM	1226	Total Roof Square Footage	27,175	Roof Levels/Stories	7	Most Recent Roof Replacement	1995	Current Roof Age	18	CONDITION NARRATIVE	Roofing Warranty Expiration Date	Resigner of Record (Roofing Project)	Roof Replacement (Target Year)	Approximate Construction Estimate	Engineering Fee Estimate (7.5%)	Combined Estimate
Memorial Building Town Hall 150 Concord Street	1226		27,175		7		1995	18		Roof systems at this site were replaced in 1995, in a combined/single project. No active leakage issues are reported at this site, to our knowledge. All roof areas are suffering from a lack-of-maintenance and improperly-installed roof/conduit penetrations. The protective coating on sloped roof over the auditorium is badly in need of restorative coating & general maintenance. Masonry walls rising above the roof surfaces are in very poor condition and pose a risk of leakage and roof system damage.	2010	Whitman & Howard	2020	\$1,049,575	\$81,858	\$1,131,434

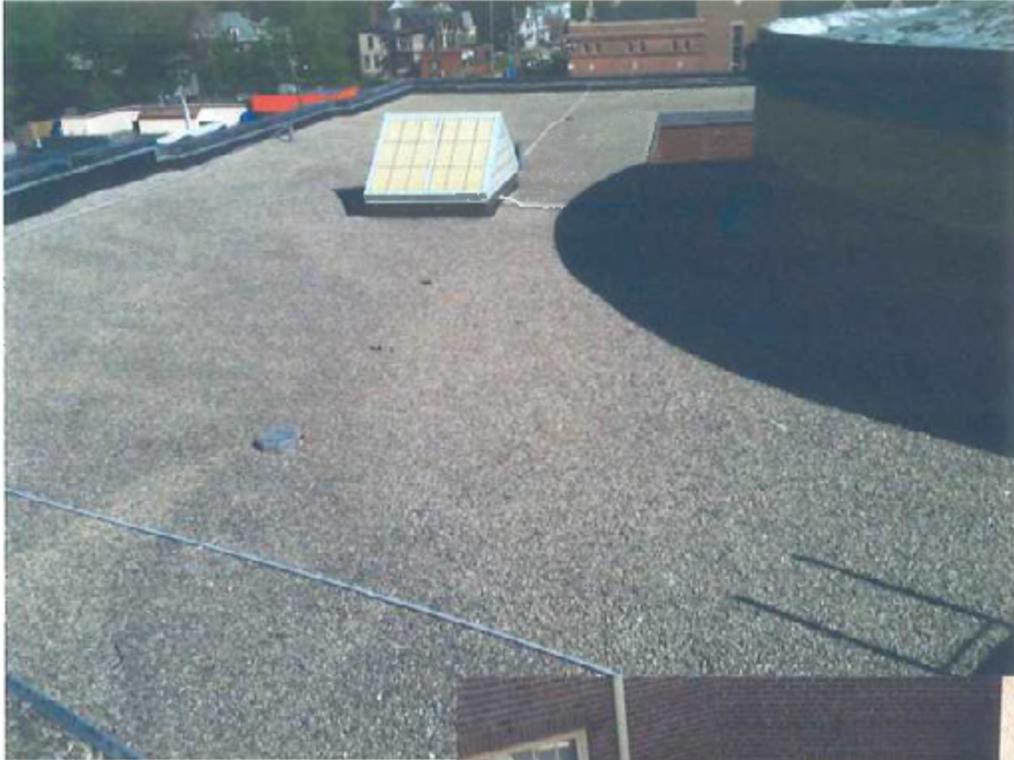
PHOTO #5 - Overview of Main West Roof showing skylight and rising Auditorium curved masonry wall (Above).

PHOTO #6 - Overview of lower roof. Note recently repaired roof drain (Right).

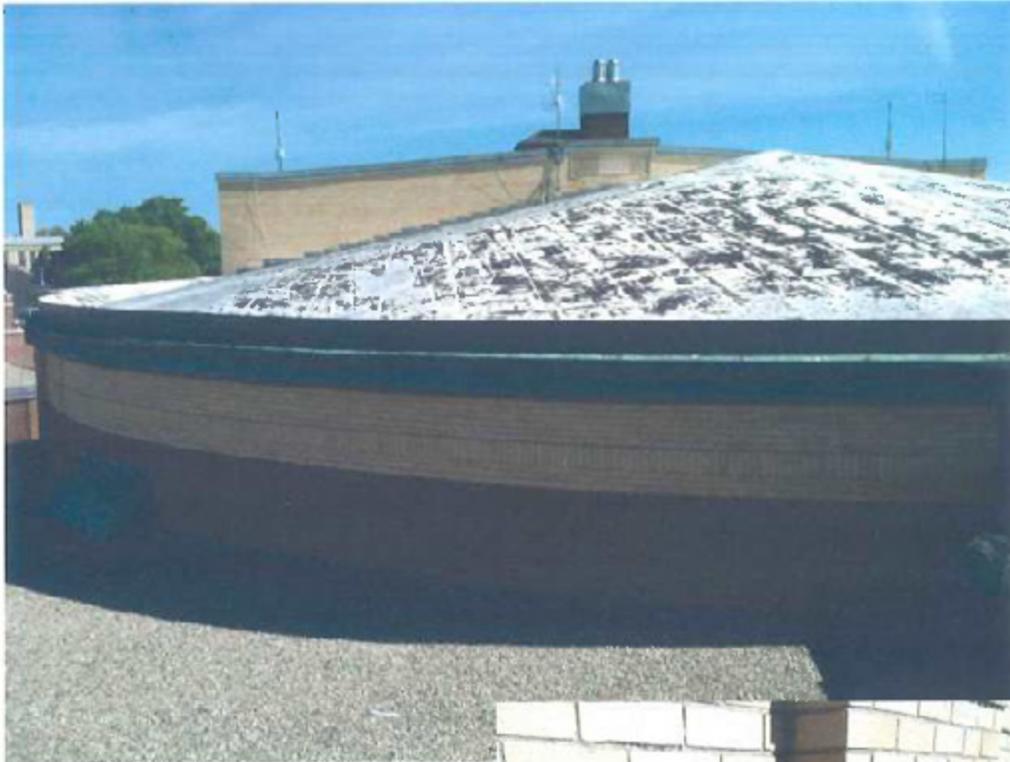
PHOTO #12 - Curved Auditorium Roof and rising curved masonry walls. Upper Stage Roof and rising stage wall seen in background (Above).

PHOTO #13 – Close-up of open masonry joints in rising Auditorium Walls (Right). Note that red brick mortar appears in much worse shape than yellow brick mortar.

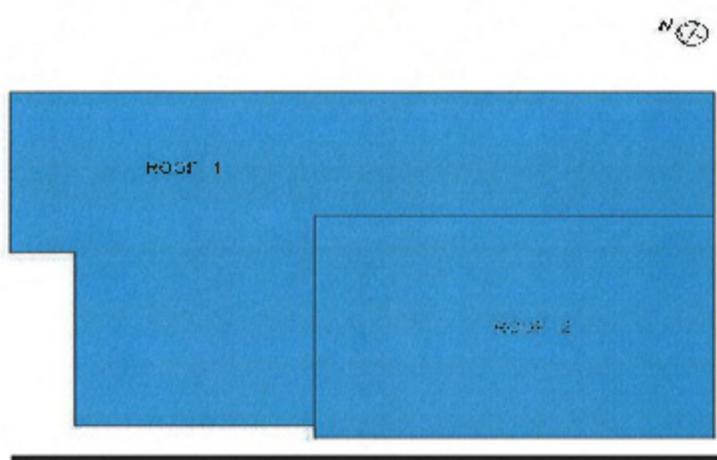
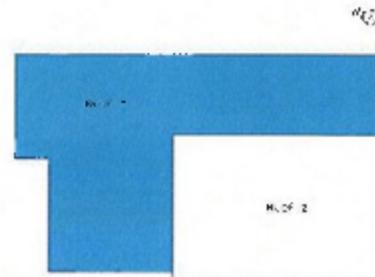
Roof Name Roof 01
Notes A 32' ladder is required to access roof
Service Activity Type OLI
Service Activity Date Jan 17 2014
Job Number 151759
Information Source Core
Year of Installation 1998 (Estimate)
Roof Leaks No
Leak Sensitivity High
Roof Size 2,828 sq. ft.
Is Ladder Required? No
Overall Roof Condition Fair Condition
Inspection Comments The roof appears to be in fair condition at this time.
Technician Chris Costa

Defect(s)	Magnitude	Severity
Blocked Drains	Extensive	Critical
Ponding	Moderate	Moderate

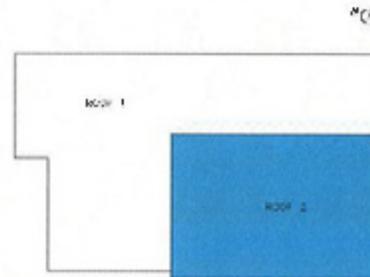
Roof Name Roof 02
Notes A 8' ladder is required to access roof.
Service Activity Type OLI
Service Activity Date Jan 20 2014
Job Number 151759
Information Source Core
Year of Installation 1998 (Estimate)
Roof Leaks No
Leak Sensitivity High
Roof Size 1,600 sq. ft.
Is Ladder Required? No
Overall Roof Condition Fair Condition
Inspection Comments The roof appears to be in fair condition at this time.
Technician Chris Costa

Defect(s)	Magnitude	Severity
Ponding	Moderate	Moderate

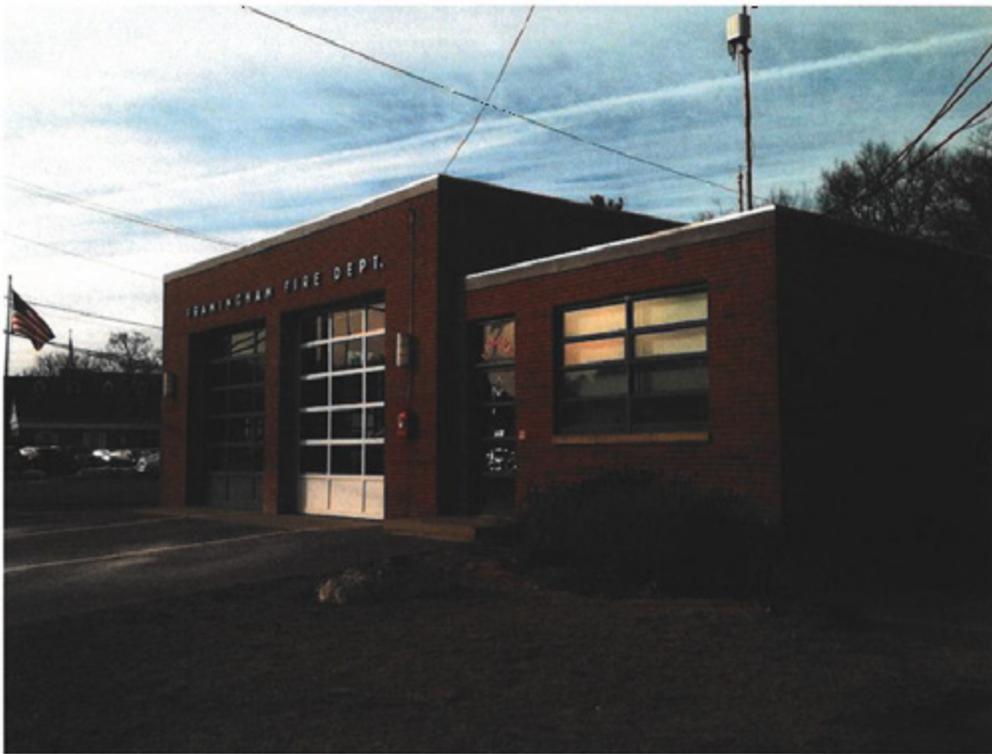
PHOTO #43: Overview photo showing Fire Station #7, located at 789 Water Street

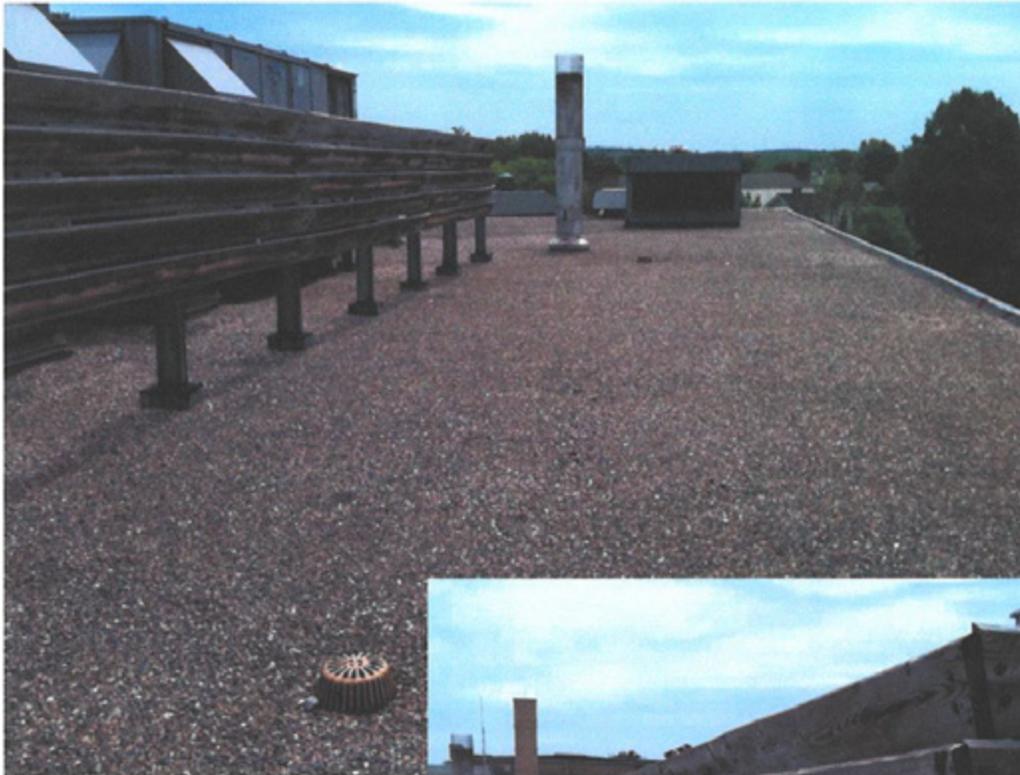
PHOTO #1 - Overview of Main Library roof looking south (Above). Note central wooden equipment screen designed to help conceal HVAC equipment.

PHOTO #2 - Detail of wooden equipment screen (Right). Note that while steel structure is in good condition the wooden screen and related fasteners has deteriorated.

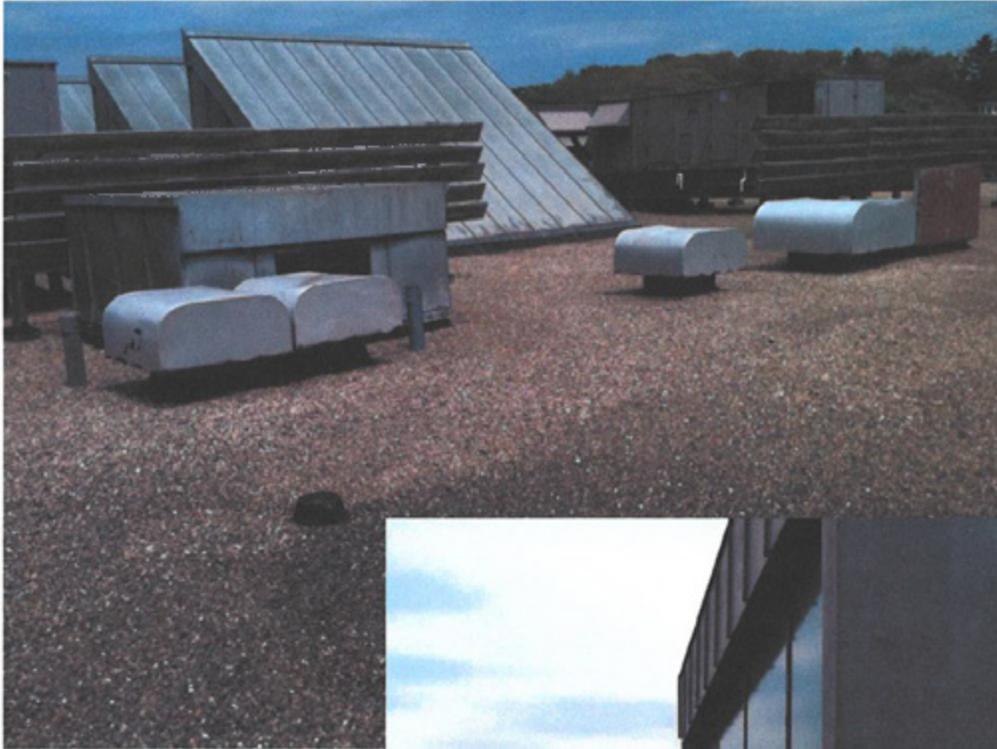
PHOTO #3 – The central portion of the roof features three large copper clad roof monitors that are surrounded by HVAC equipment (Above). The Roof monitors are standing seam copper with welded joints and appear to be in very good shape (**PHOTO #4** - Right).
