**CITY OF FRAMINGHAM  
CAPITAL PROJECT/EQUIPMENT REQUEST - FY2024-2033 CIP**

## **5. Exterior Envelope Repair Design - King Elementary and FHS**

# Exterior Envelope Repair Design - \$322,000

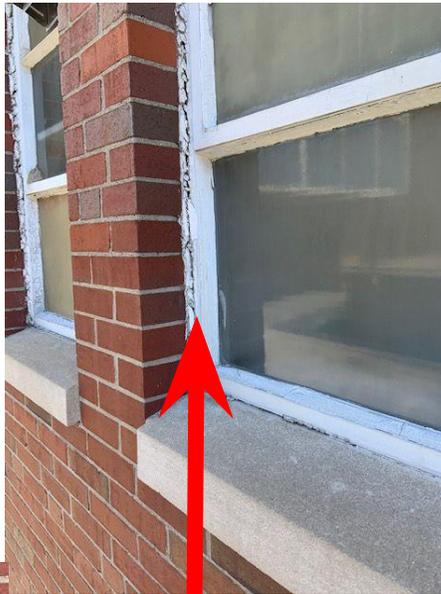
Asbestos Window Glazing

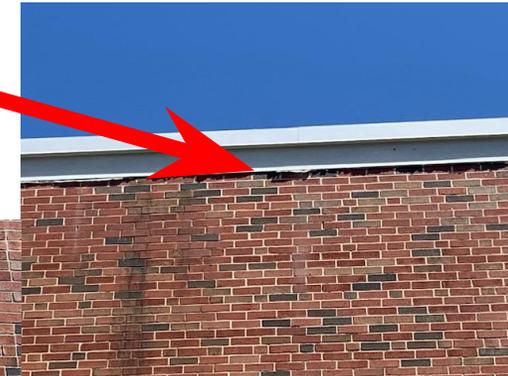
Deteriorating bricks, allowing moisture infiltration

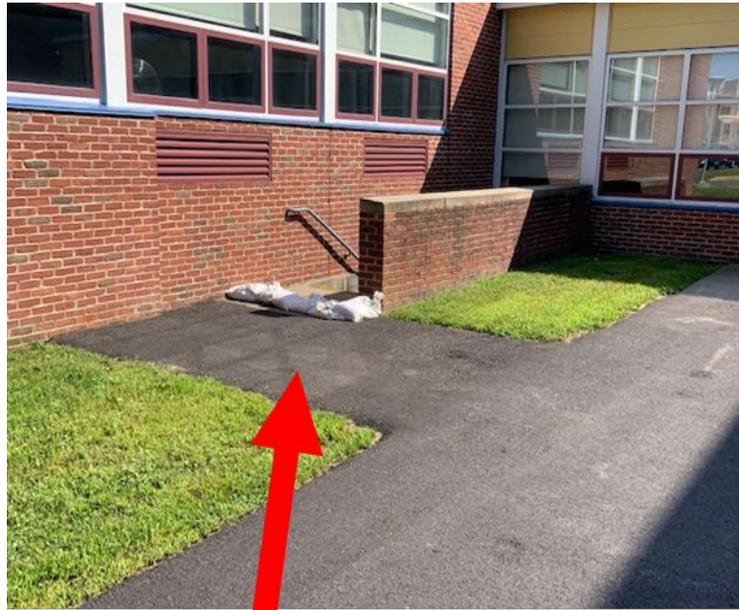
Lacking Stormwater Mitigation, Leading To Flooding Within Building

Repointing and Repaving Stormwater Catch Basins, Regrading Driveway

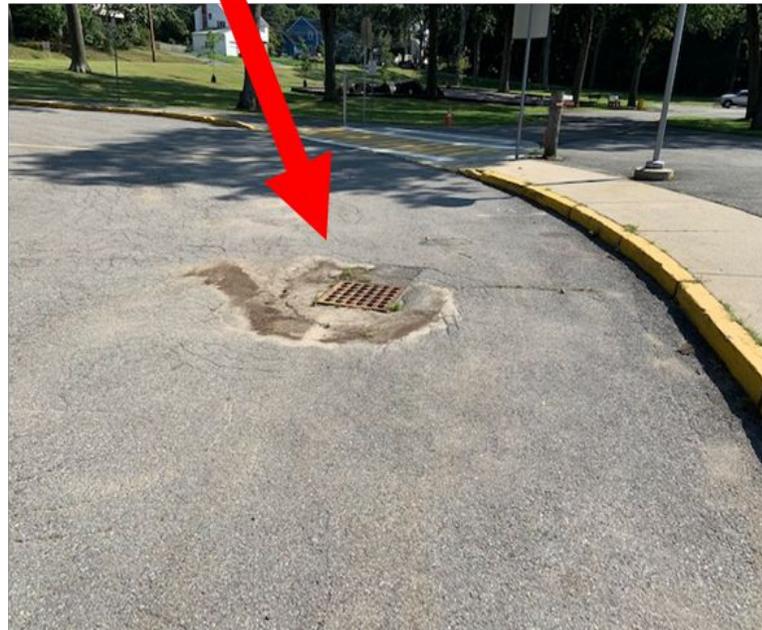
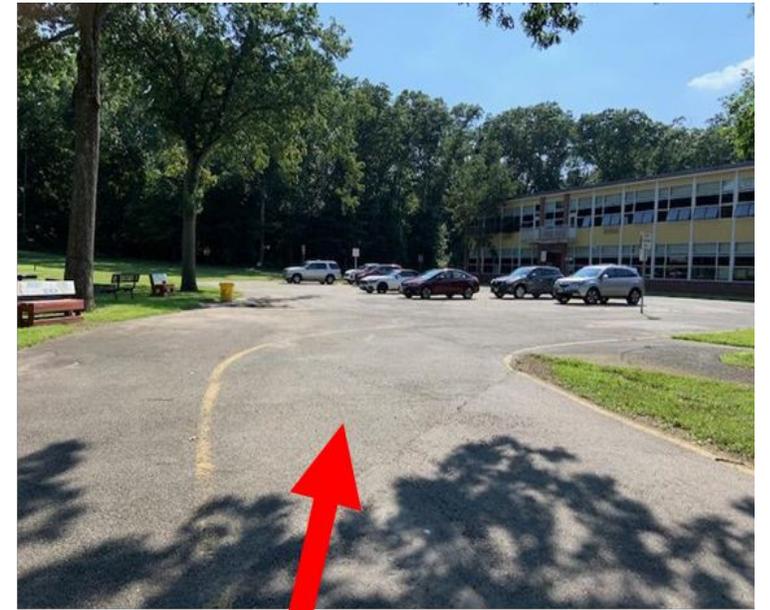
Temporary Parking Lot Requiring Repaving and Stormwater Mitigation

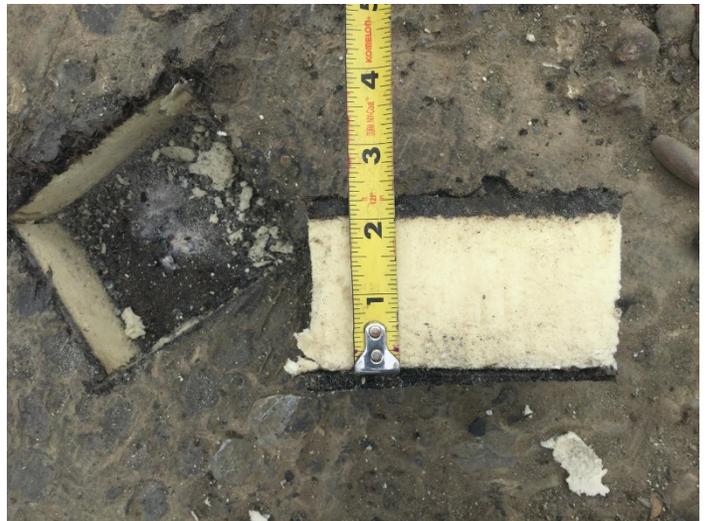
Photo 4 – Fourteen (14) individual test cut locations were selected based on the gather data. In general, the roofing system at the test locations consists of a gravel surface built-up roofing membrane installed over Polyiso rigid insulation, vapor retarder and a sloped light weight concrete deck.

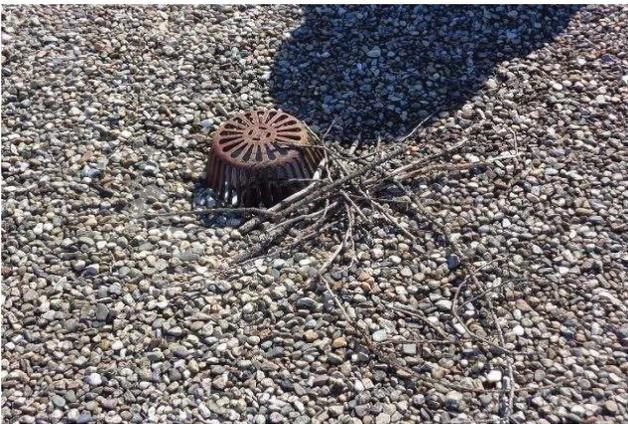
Debris.

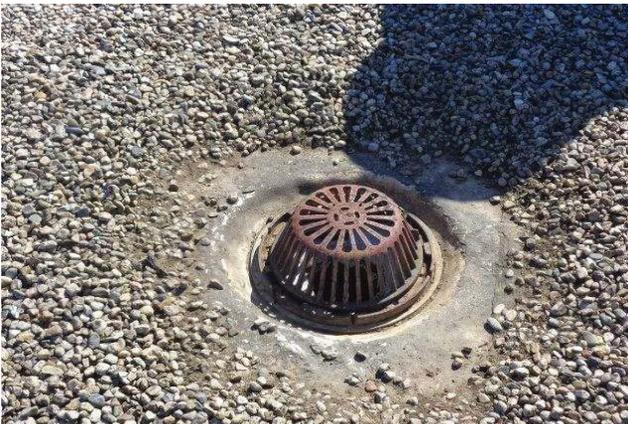
Removed debris.

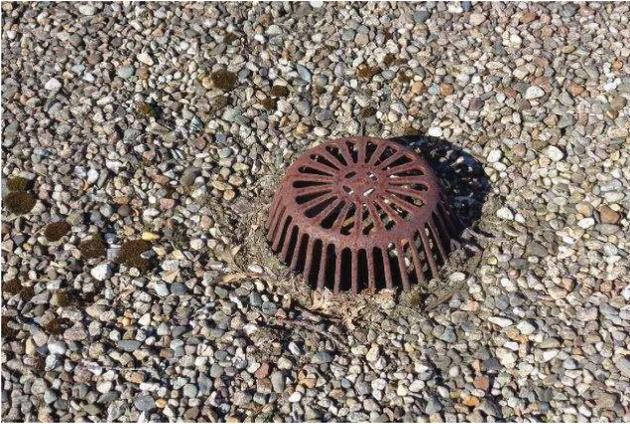
Debris.

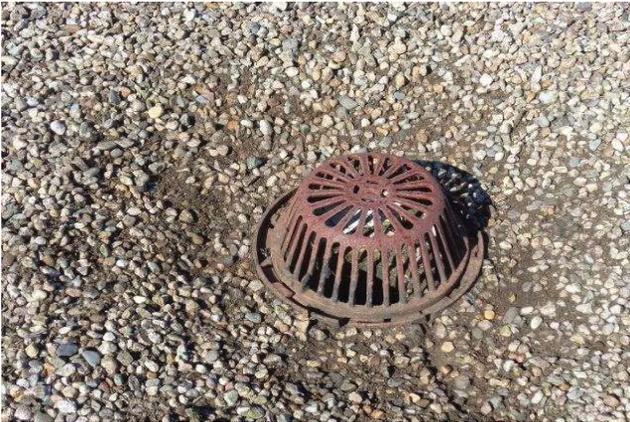
Removed debris.

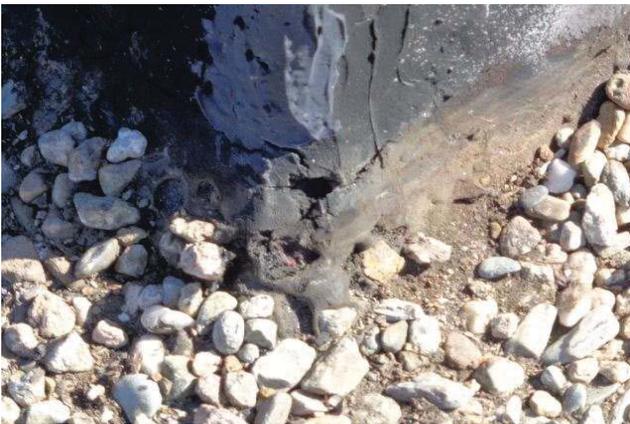
Open curb flashing corner.

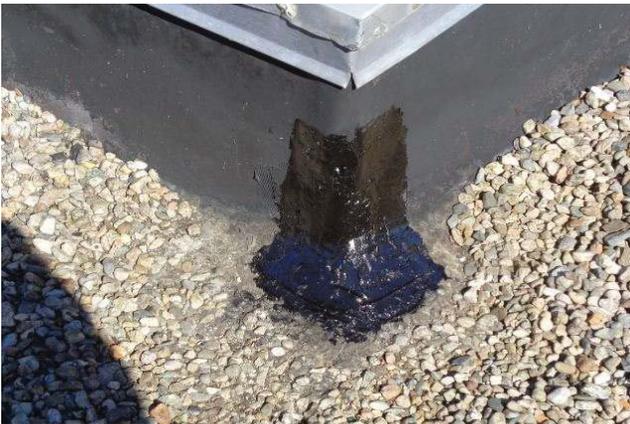
Repaired curb flashing corner.

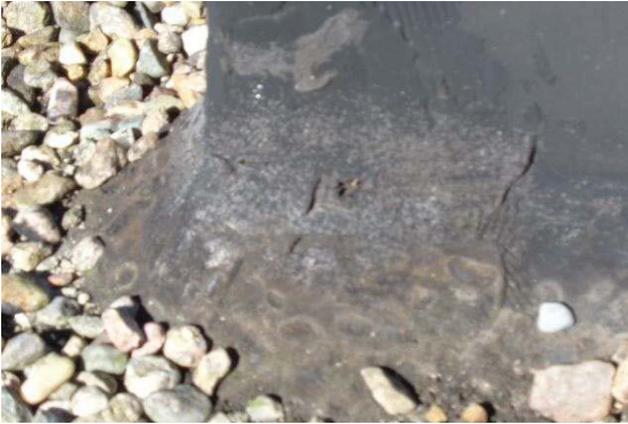
Open curb flashing corner.

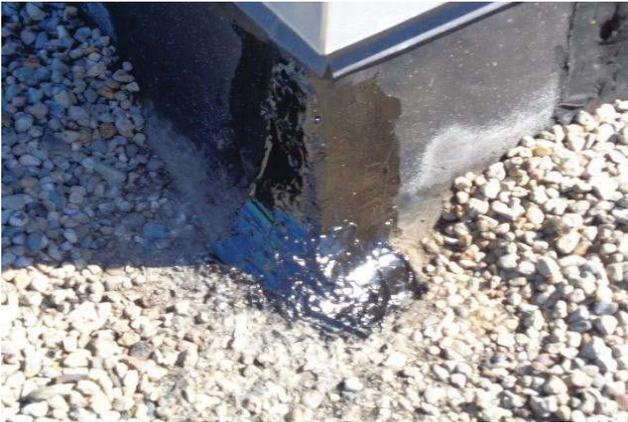
Repaired curb flashing corner.

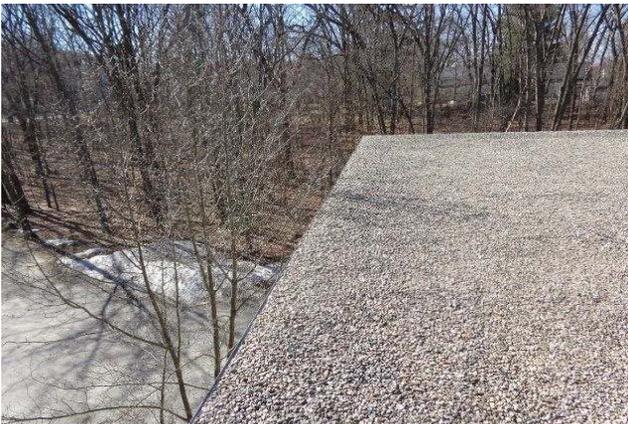
Tree limbs overhanging the roof surface.

Work Beyond Scope of Maintenance Agreement (Customer Responsibility)			
Task	Year	Project \$	Task Description
Repairs Required, Minor	2014		Recommend repointing the chimney.
Repairs Required, Minor	2014		Recommend installing a safety approved railing around hatch.
Repairs Required, Minor	2014		Recommend raising wall mounted ladder to OSHA approved height.
Tree Work	2014		Recommend trimming back the tree limbs that overhang the roof surface.

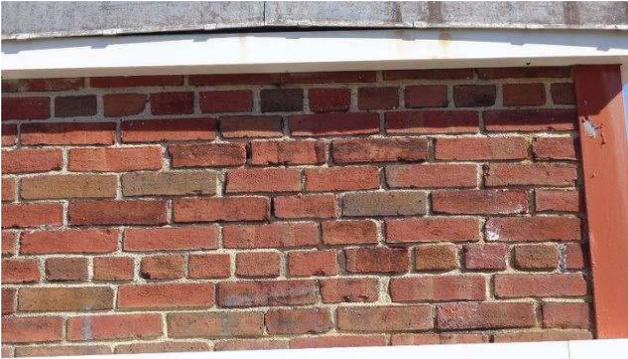
Open mortar joints.

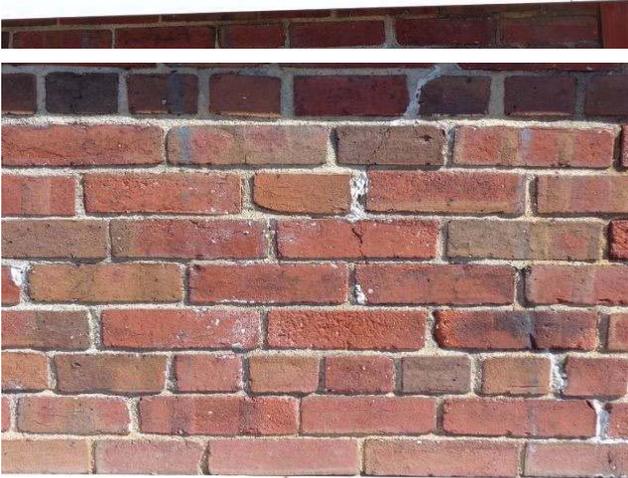
Open mortar joints.

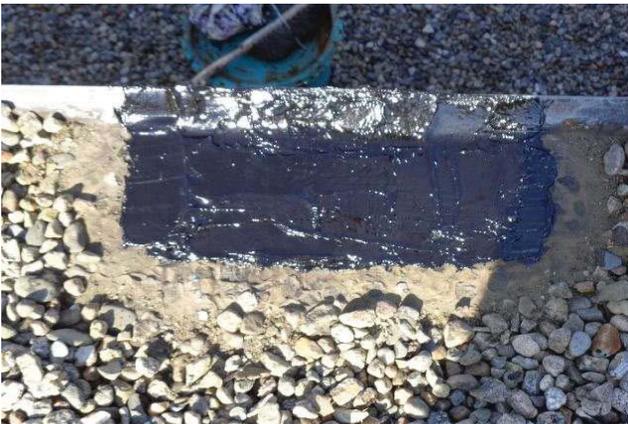
Reinforced previous repair.

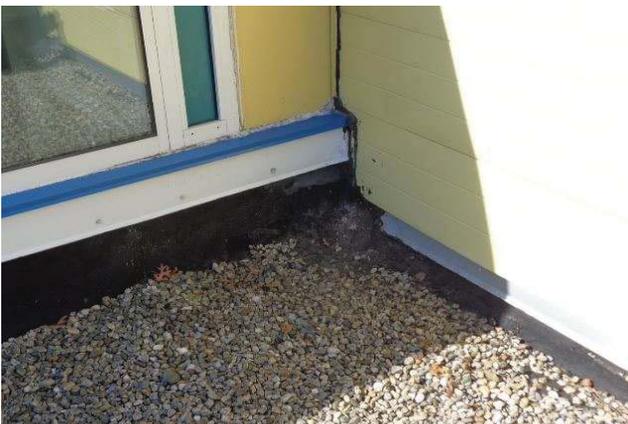
Removed debris.

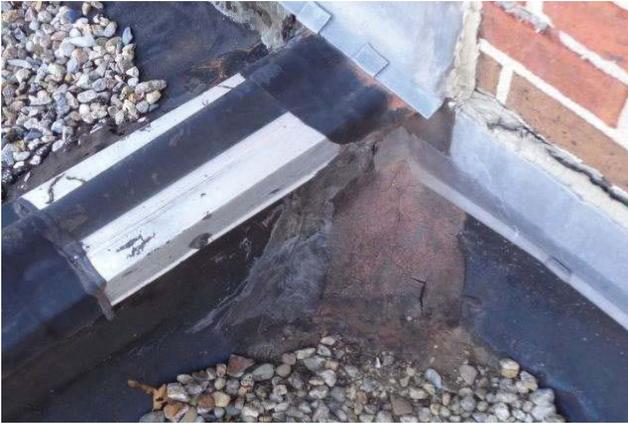
Open flashing corner.

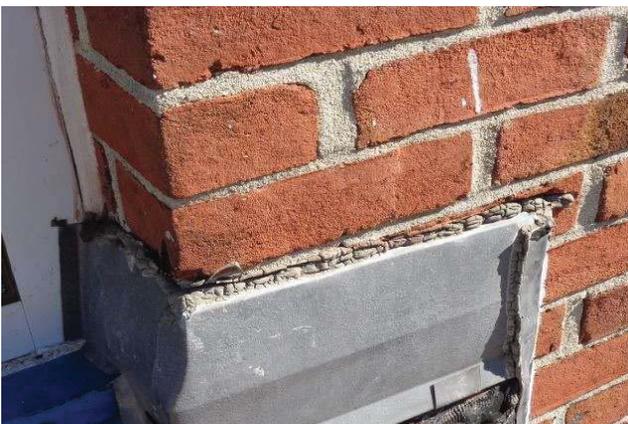
Open counterflashing.

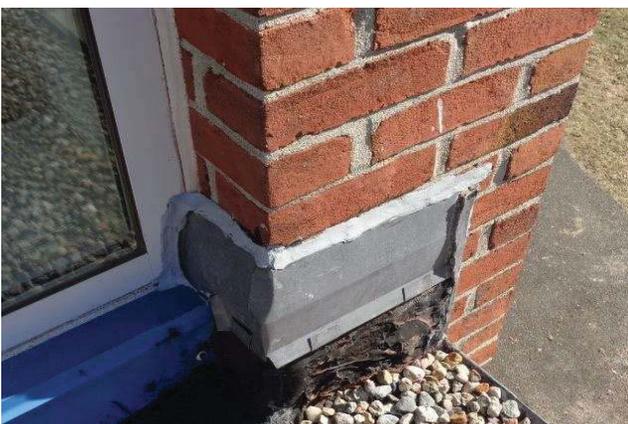
Sealed counterflashing.

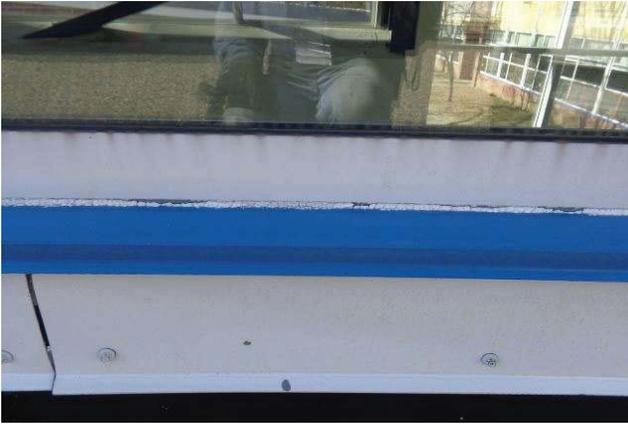
Open window sill.

Work Beyond Scope of Maintenance Agreement (Customer Responsibility)			
Task	Year	Project \$	Task Description
Recommendation	2014		Recommend sealing the open window sills and counterflashing.
Repairs Required, Minor	2014		Recommend replacing the damaged ventilator hood.
Repairs Required, Minor	2014		Recommend coating the weathered wall and curb flashings.

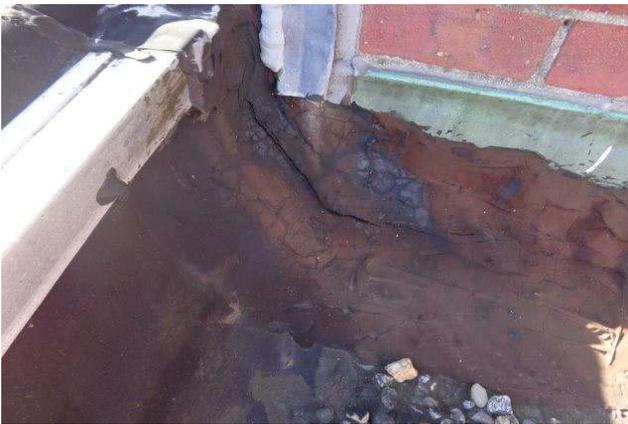
Open flashing corner.

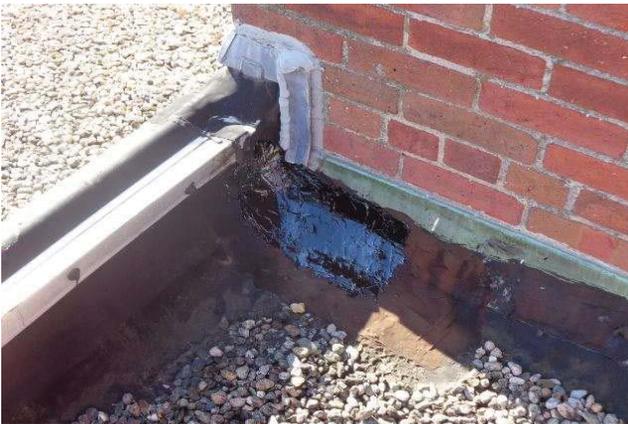
Repaired flashing corner.

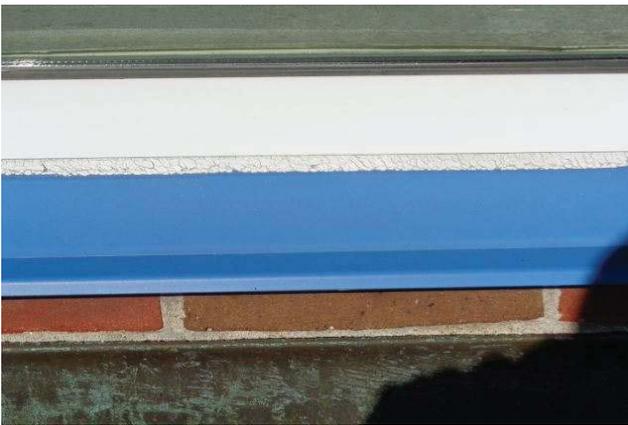
Open window sill.

Work Beyond Scope of Maintenance Agreement (Customer Responsibility)			
Task	Year	Project \$	Task Description
Recommendation	2014		Recommend removing the obsolete pitch pocket and conduit pipe from the roof.
Repairs Required, Minor	2014		Recommend sealing the open window sills.
Repairs Required, Minor	2014		Recommend repairing the crack in the brick wall.
Repairs Required, Minor	2014		Recommend coating the weathered wall flashings.

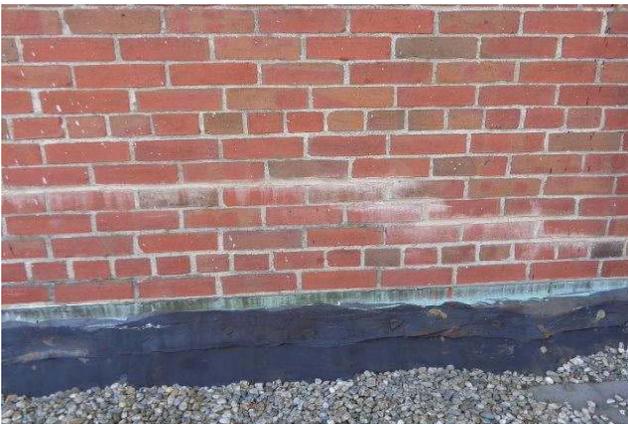
Open mortar joint.

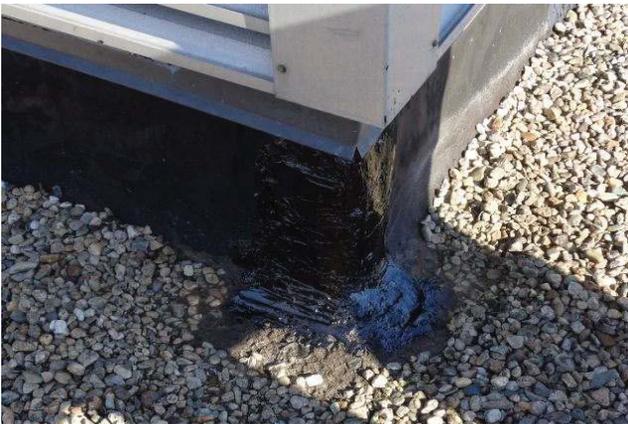
Repaired curb flashing corner.

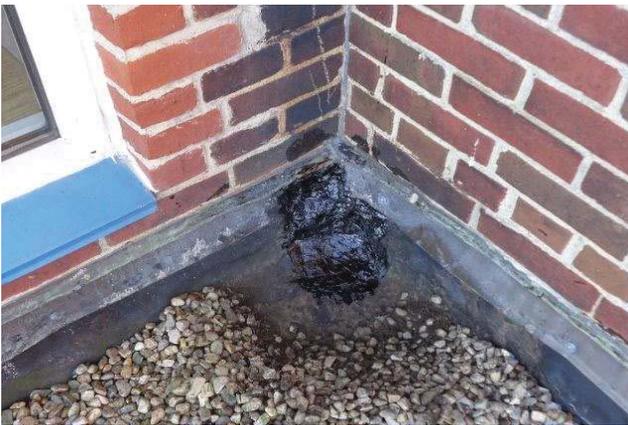
Repaired flashing corner.

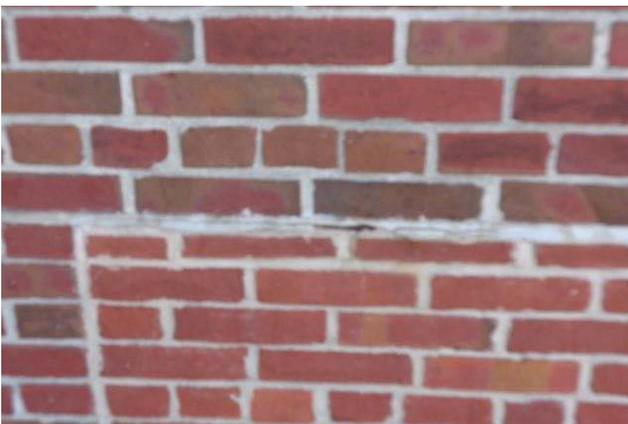
Type	Condition(s)	Magnitude
<b>Perimeter Type</b>	Gravel Stop	Fair Condition	
	Non-Parapet Wall	Fair Condition	
<b>Wall Type</b>	Brick Wall	Cracked	Moderate
		Fair Condition	
	Open Joints	Moderate	
<b>Perimeter Wall and Flashing Type</b>	Composite Ply	Fair Condition	
	Metal	Fair Condition	
	TRA Single Ply	Weathered	Minor
<b>Counterflashing Type</b>	Through Wall	Fair Condition	
<b>Counterflashing Material Type</b>	Copper	Fair Condition	
<b>Projection Flashings Type</b>	Lead Coated Copper	Fair Condition	
	TRA Single Ply	Fair Condition

Open mortar joints.

Work Beyond Scope of Maintenance Agreement (Customer Responsibility)			
Task	Year	Project \$	Task Description
Repairs Required, Minor	2014		Recommend coating the wall and curb flashings.
Repairs Required, Minor	2014		Recommend having a masonry contractor tuckpoint the brick walls.

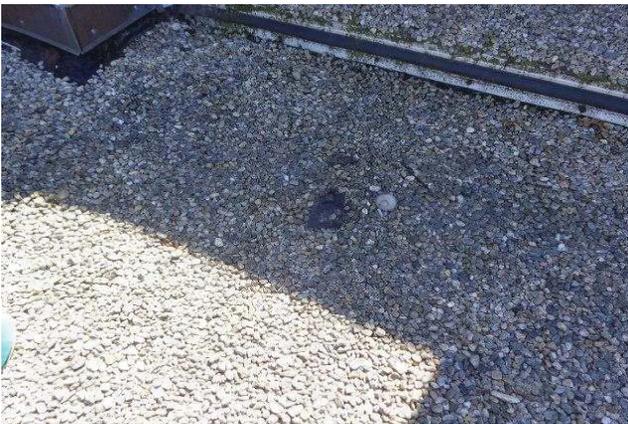
Debris.

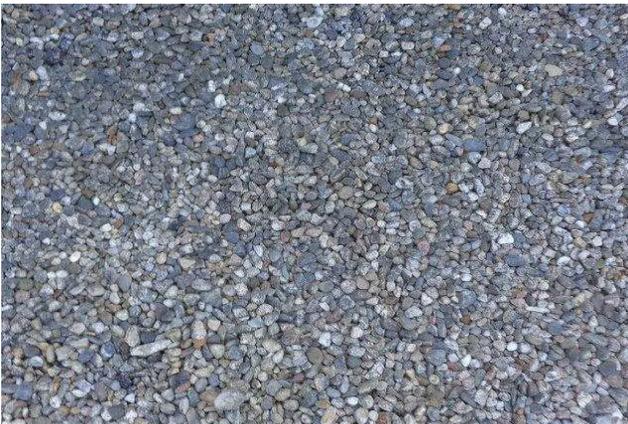
Removed debris.

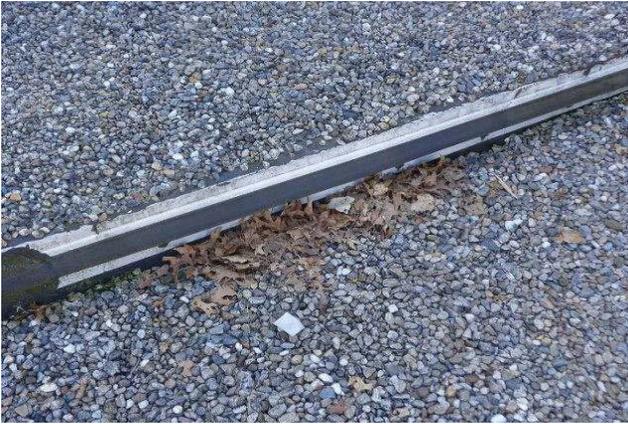
Debris.

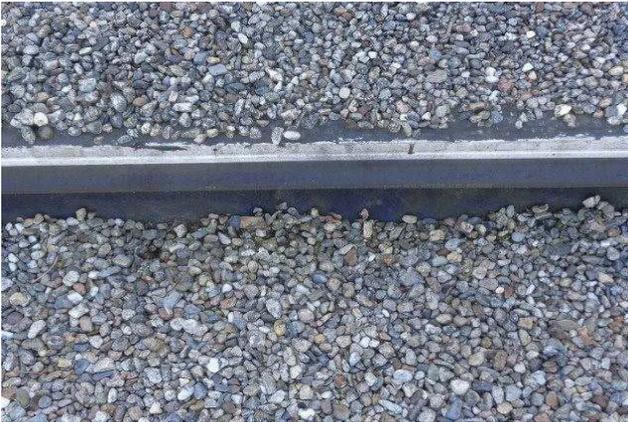
Removed debris.

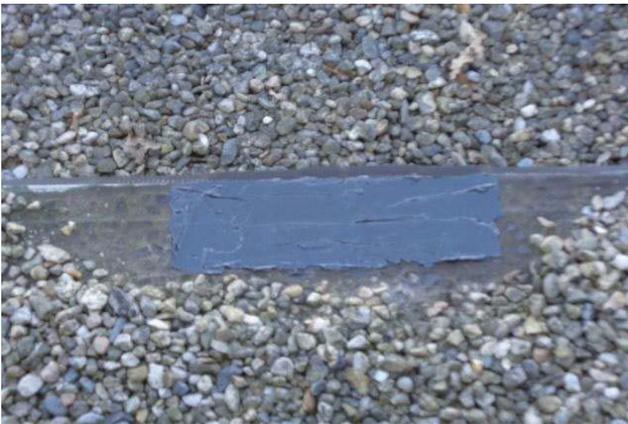
Repaired perimeter flashing.

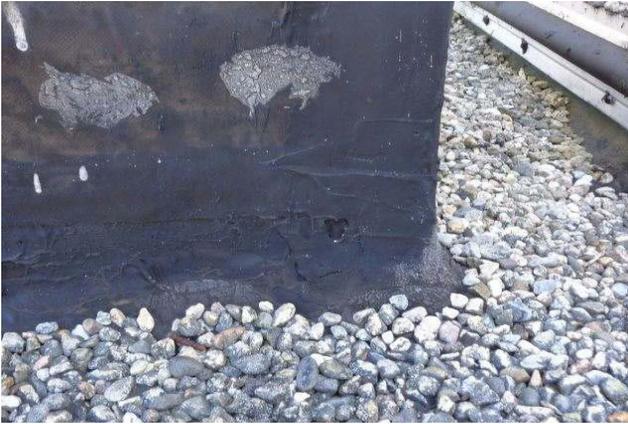
Open curb flashing corner.

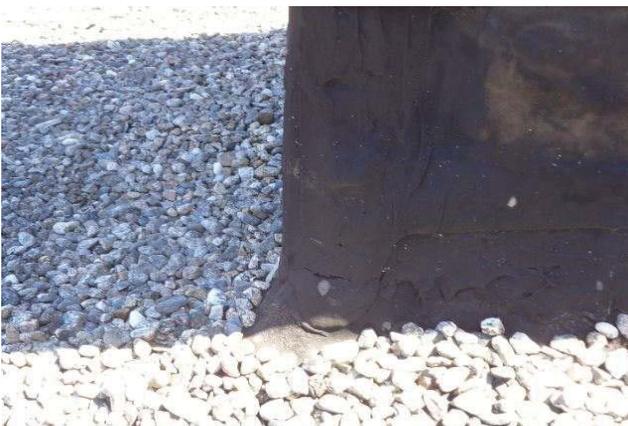
Open curb flashing corner.

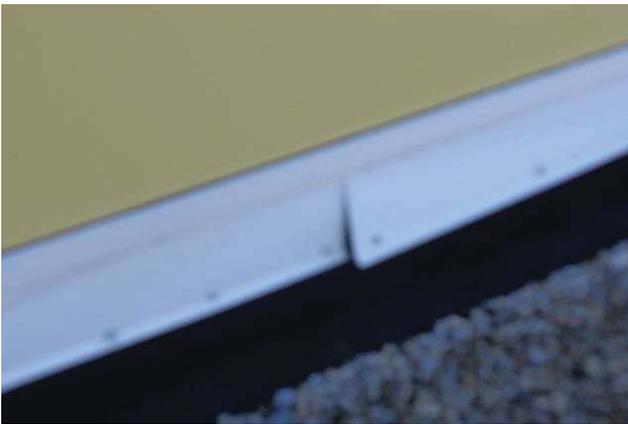
Open counterflashing.

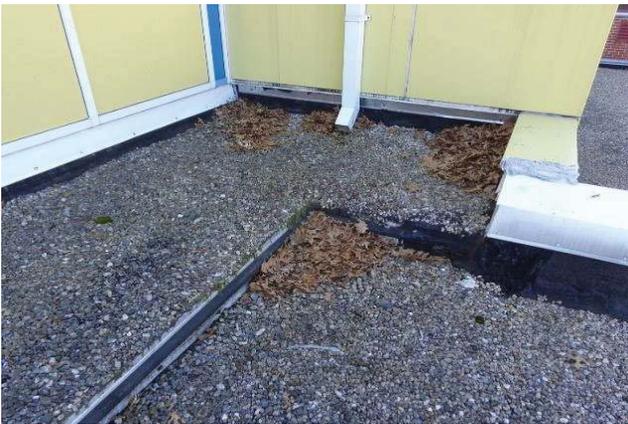
Debris.

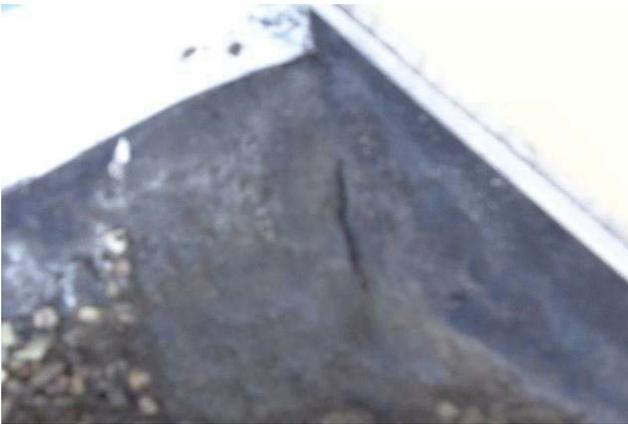
Open flashing corner.

Work Performed	
TremCare	Repaired open flashing corners.

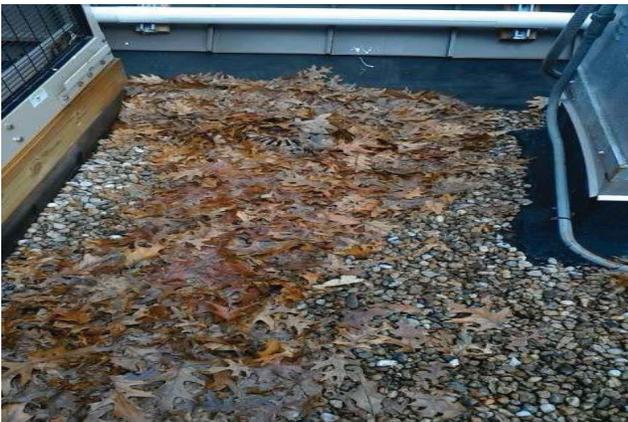
Debris in drain.

Work Beyond Scope of Maintenance Agreement (Customer Responsibility)			
Task	Year	Project \$	Task Description
Preventive Maintenance	2018		Recommend customer perform maintenance to drainage areas to keep proper drainage of the roof.
Repairs Required, Minor	2018		Recommend coating wall and curb flashings with a reflective coating.
Repairs Required, Minor	2018		Recommend coating rusted vent curb.
Repairs Required, Minor	2018		Recommend installing proper storm collars on 2 process pipes.

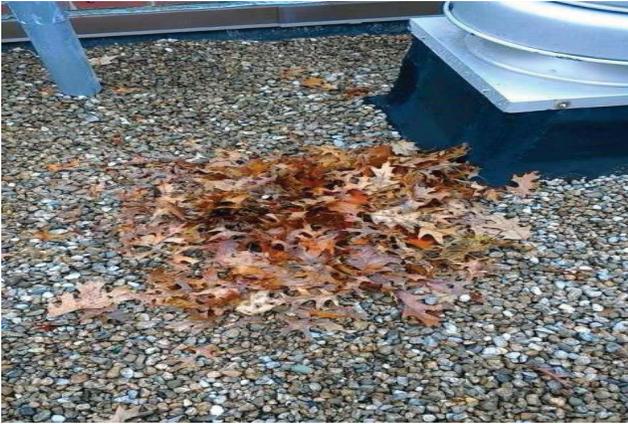
Debris on roof.

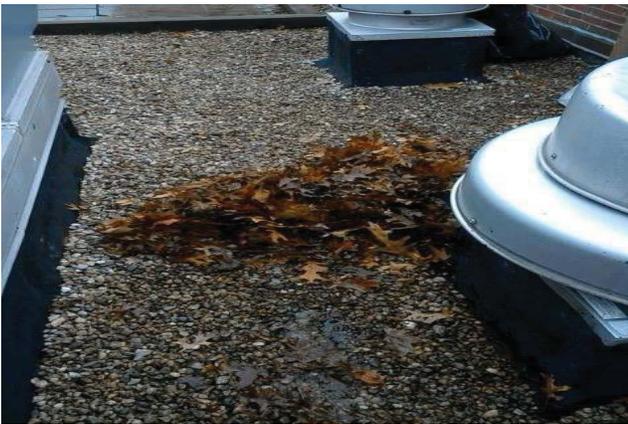
Debris on roof.

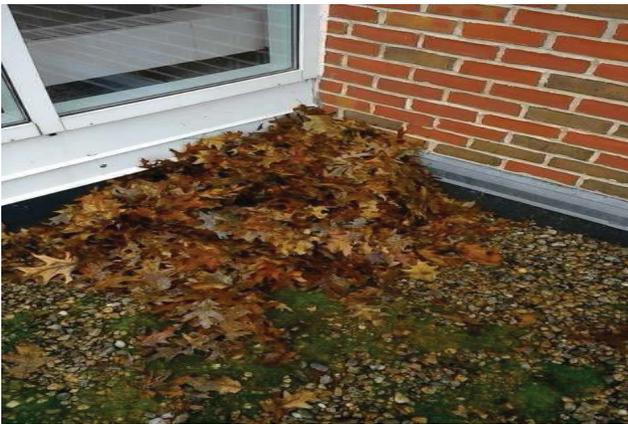
Debris on roof.

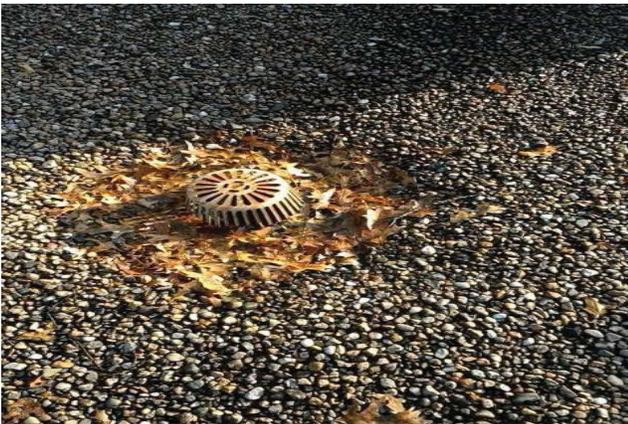
Debris in drain.

Work Performed	
Preventive Maintenance	Removed debris from the roof and drains. Repaired open curb flashing corners.

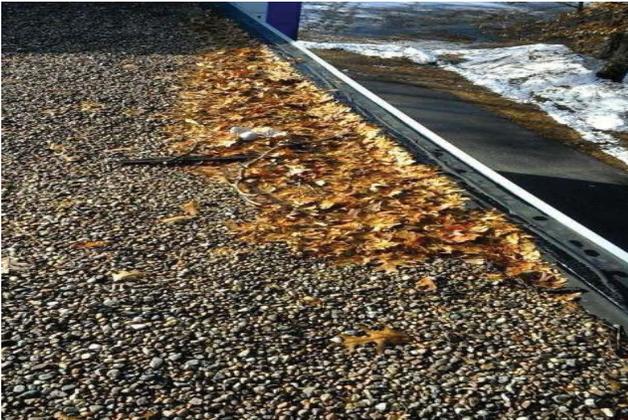
Debris on roof.

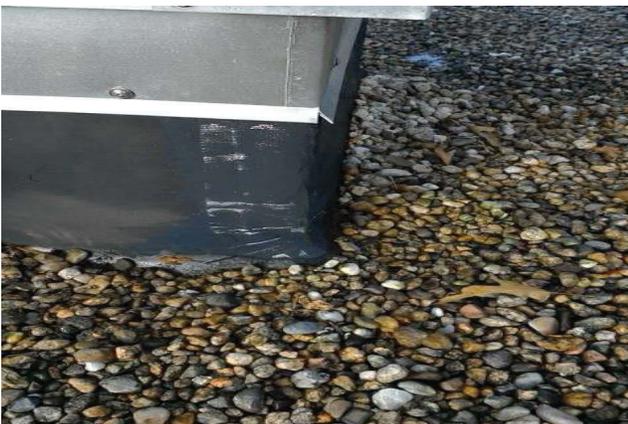
Exposed mesh at curb corner.

Coated exposed mesh.

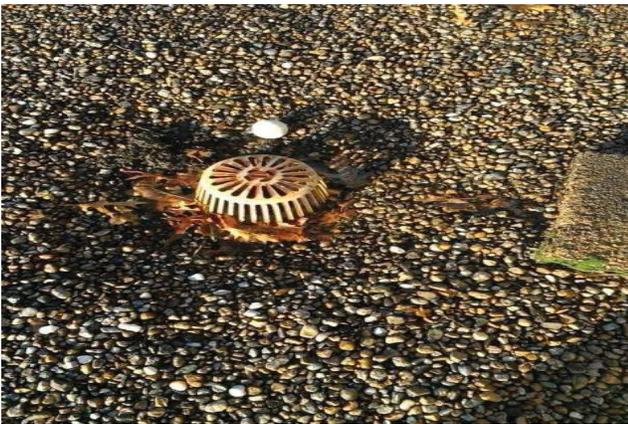
Debris in drain.

Removed debris from drain.

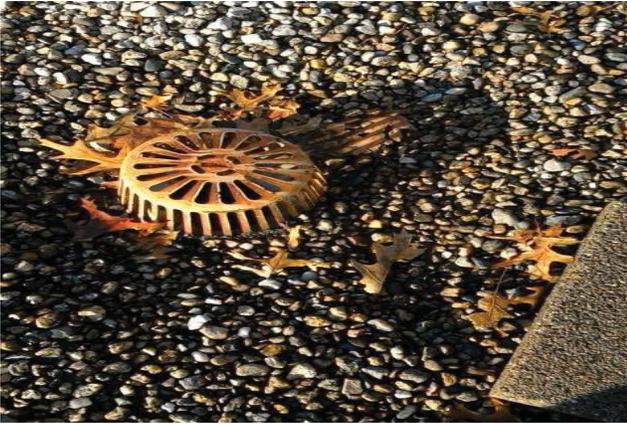
Debris in drain.

Removed debris from drain.

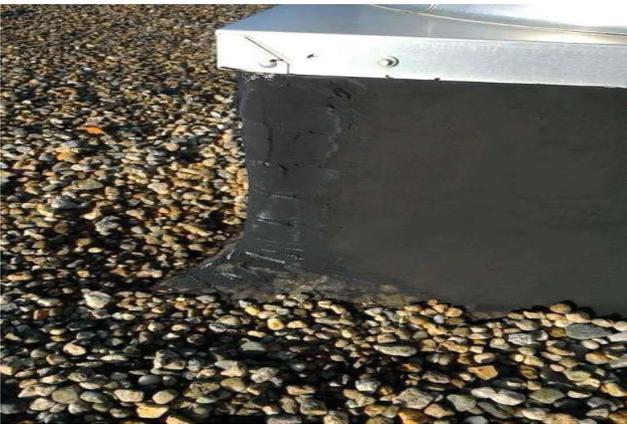
Exposed mesh.

Coated exposed mesh.

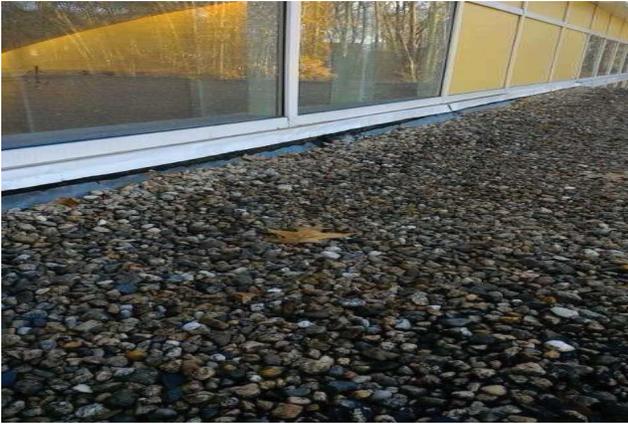
Lead base flashing pulling away from wall.

Work Beyond Scope of Maintenance Agreement (Customer Responsibility)			
Task	Year	Project \$	Task Description
Repairs Required, Minor	2018		Recommend repairing approximately 30 linear feet of lead flashing under the windows.
Repairs Required, Minor	2018		Recommend coating the weathered curb flashing.
Repairs Required, Minor	2018		Recommend replacing 4 deteriorating splash blocks.

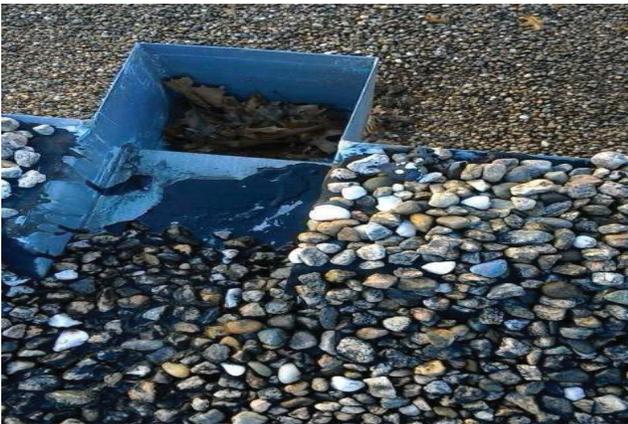
Debris in scupper.

Removed debris from scupper.

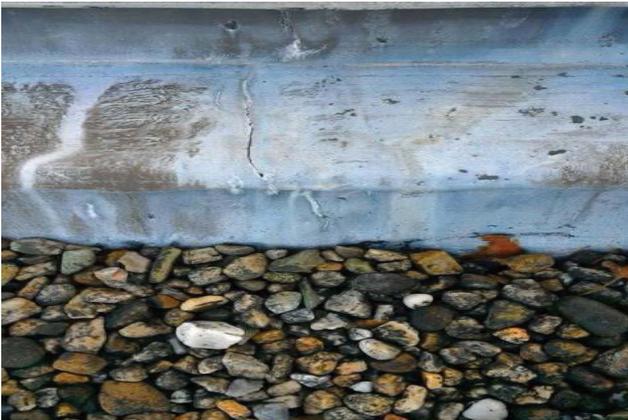
Split in lead base flashing.

Repaired split in lead base flashing.

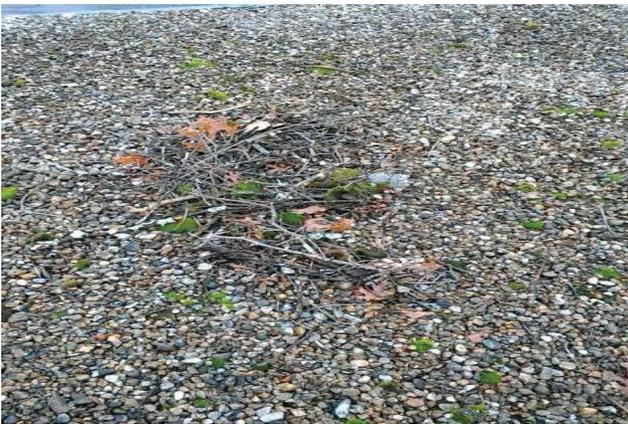
Debris on roof.

Removed debris.

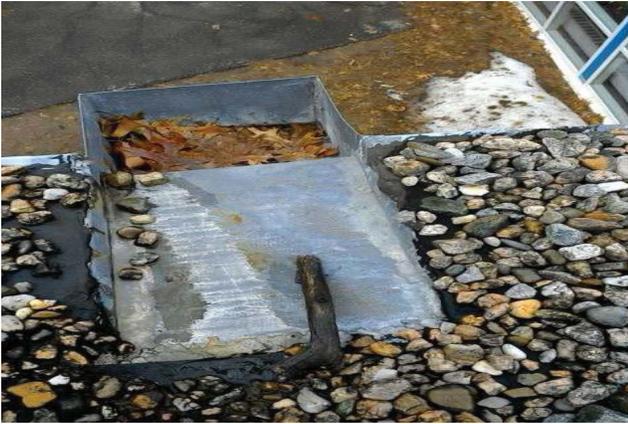
Debris in scupper.

Removed debris.

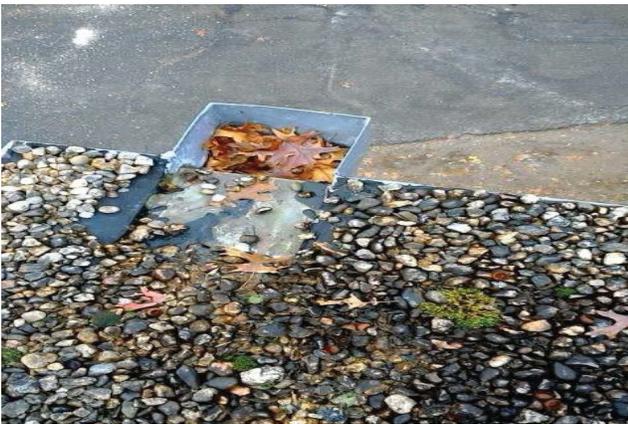
Debris in scupper.

Removed debris.

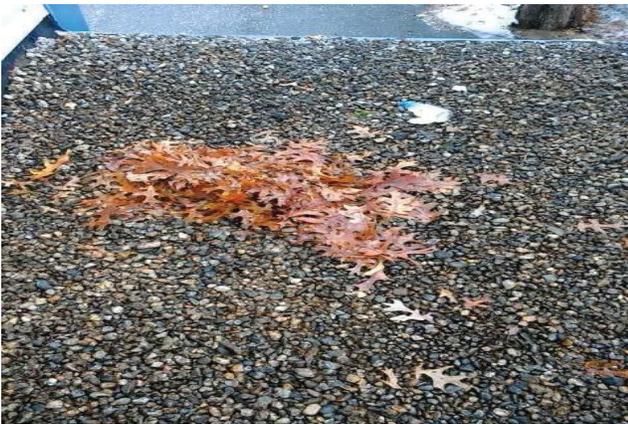
Debris on roof.

Removed debris.

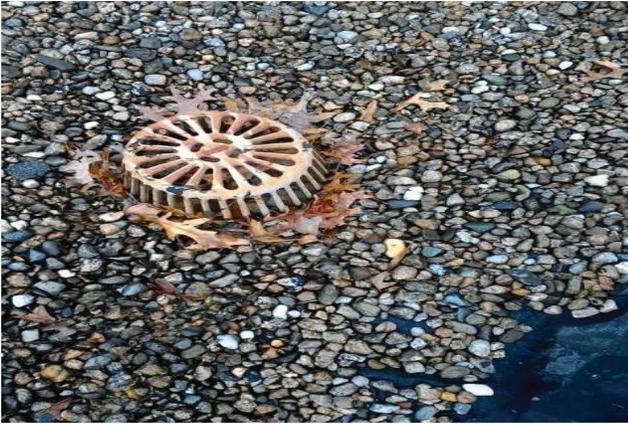
Debris in drain.

Removed debris.

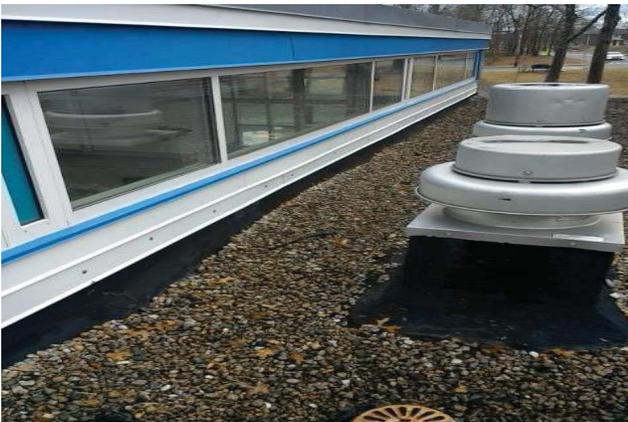
Overview of window sill in need of resealing.

Work Beyond Scope of Maintenance Agreement (Customer Responsibility)			
Task	Year	Project \$	Task Description
Repairs Required, Minor	2018		Recommend coating the wall and curb flashing with a reflective type coating.
Repairs Required, Minor	2018		Recommend sealing approximately 50 linear feet of window sill.
